Pipeline Coating Failures

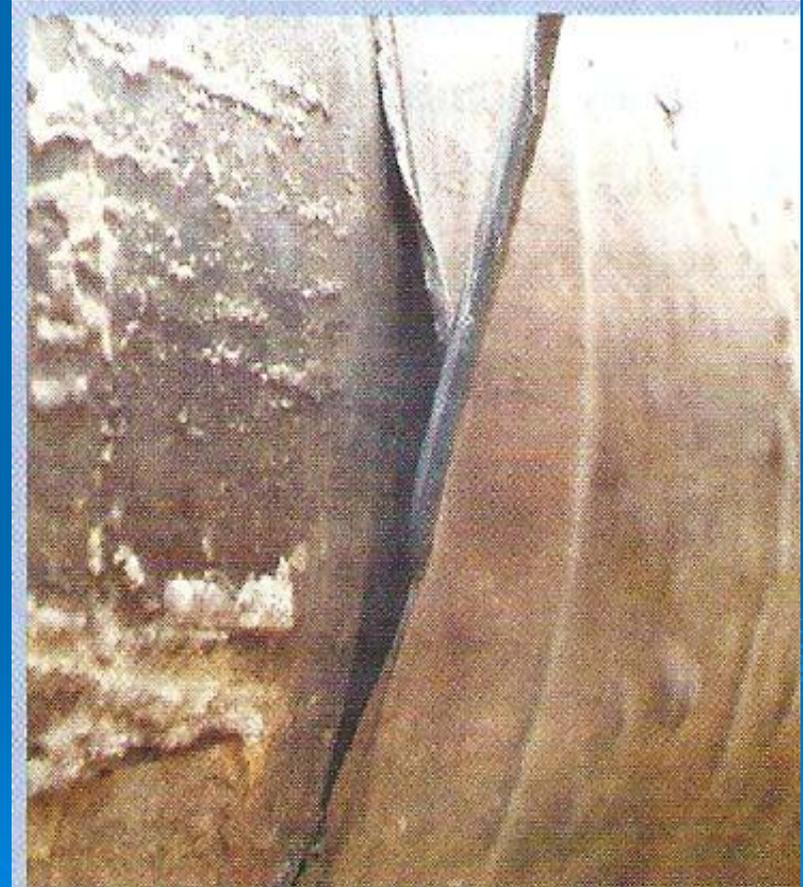
18 in Oil Pipeline

- Massive disbonding of HSS
 - Steel surface
 - 3LPE coating system
- Significant corrosion
 - Field joint
 - Steel surface
- No significant corrosion at lower operating temperatures.

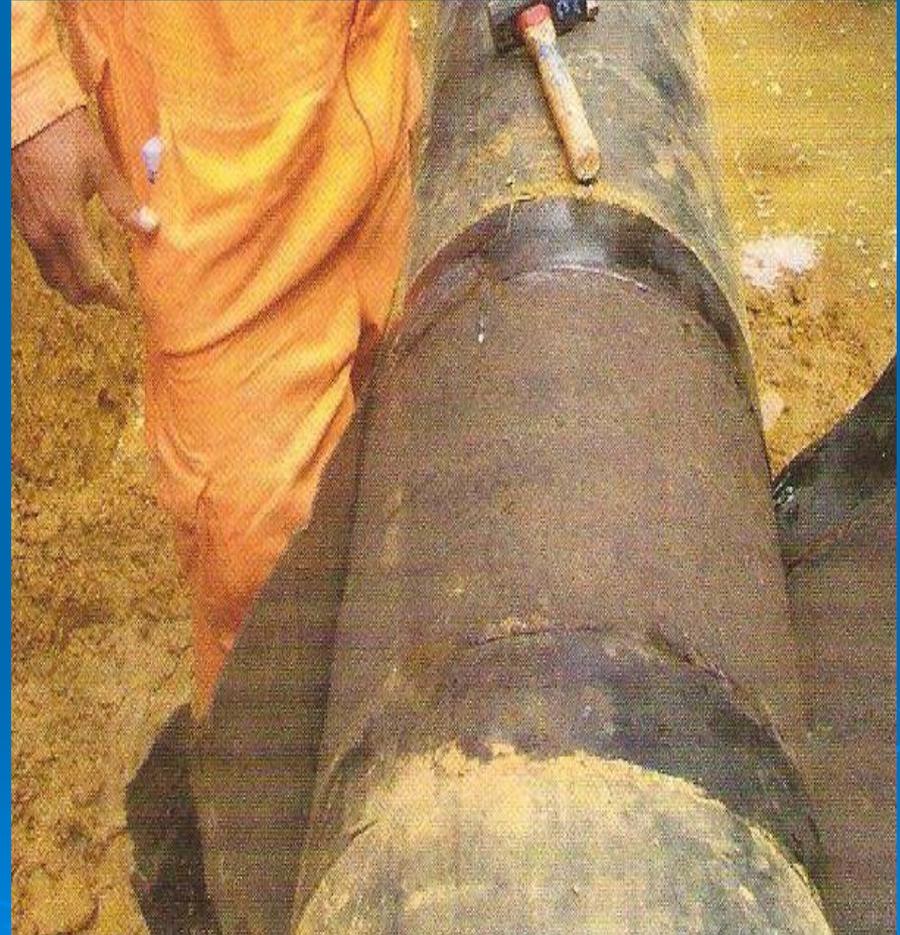
18 in Oil Pipeline

- Longitudinal cracking at the 3 and 9 o'clock positions.
- Showed signs of thermal aging
 - Brittleness
 - Lack of flexibility
- Issues:
 - Storage conditions
 - Soil exposures
 - Service conditions

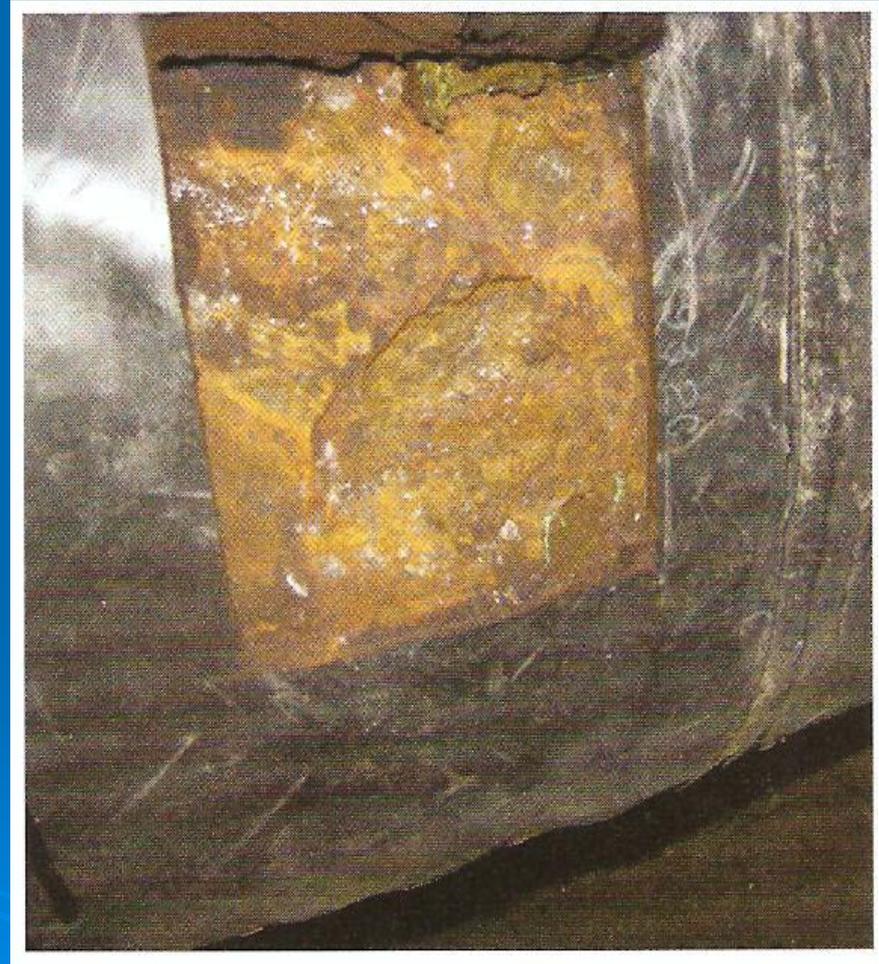
16 in Oil Pipeline

- Disbonding of HSS
 - Steel surface
 - 3LPE coating system
- Significant corrosion
 - Field joint
 - Steel surface
 - Salt crystals under HSS
- Disbondment fo coating system

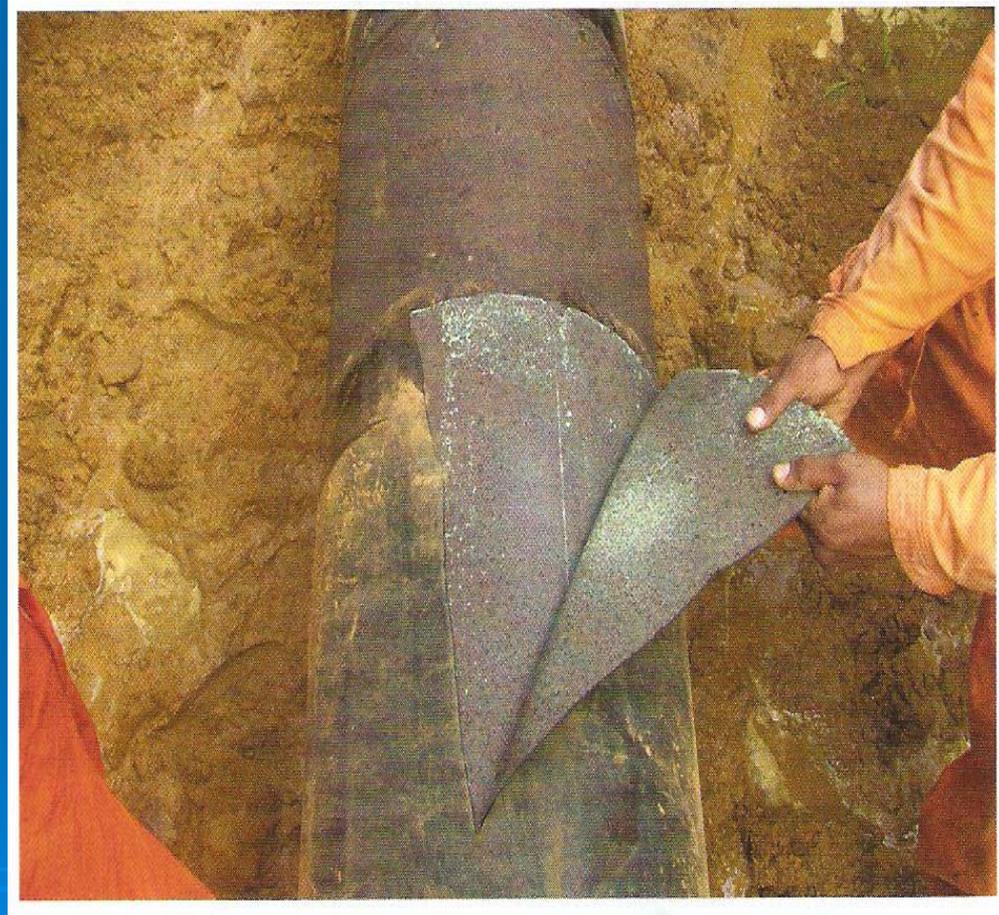
Causes of Disbondment

- Surface preparation
 - Minimum Near white blast
- Application
 - Fish mouths
 - Overlaps
- Service Conditions
 - Operating temperature
 - Soil conditions
- UV Degradation during storage.

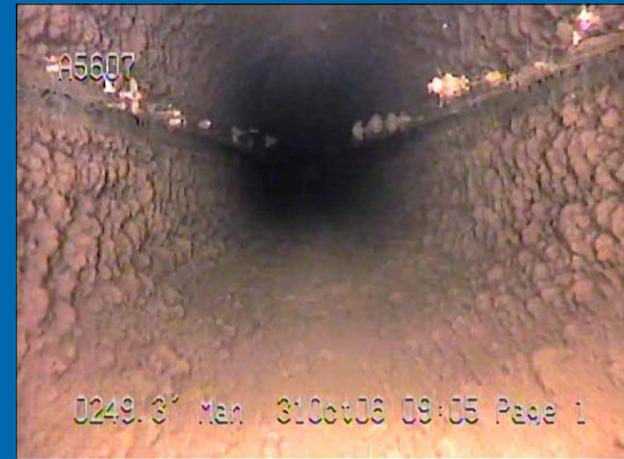
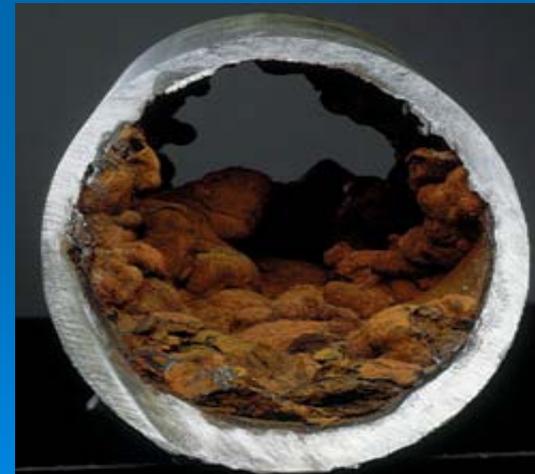
Photo: Extensive tuberculation can discolor and contaminate water as well as result in greatly reduced water flow and pressure.

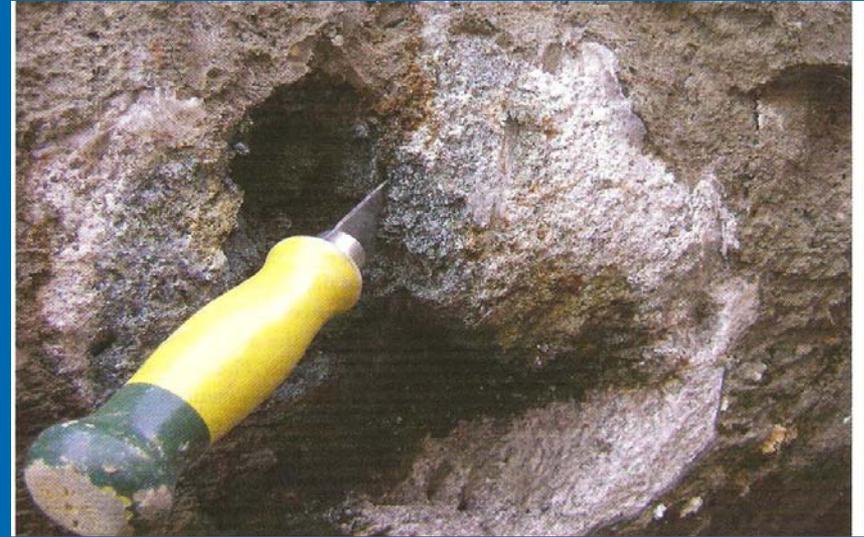
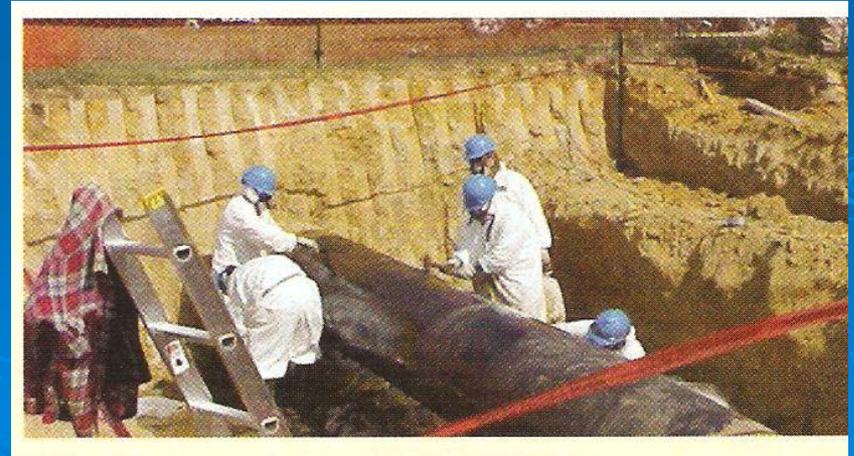
- Water main 48 in.
 - Failure location
 - 10 ft long
 - Along pipe wall
 - Concrete coating deteriorated and spalled
 - Reinforcement wires broke
 - Exposed steel substrate to soil conditions

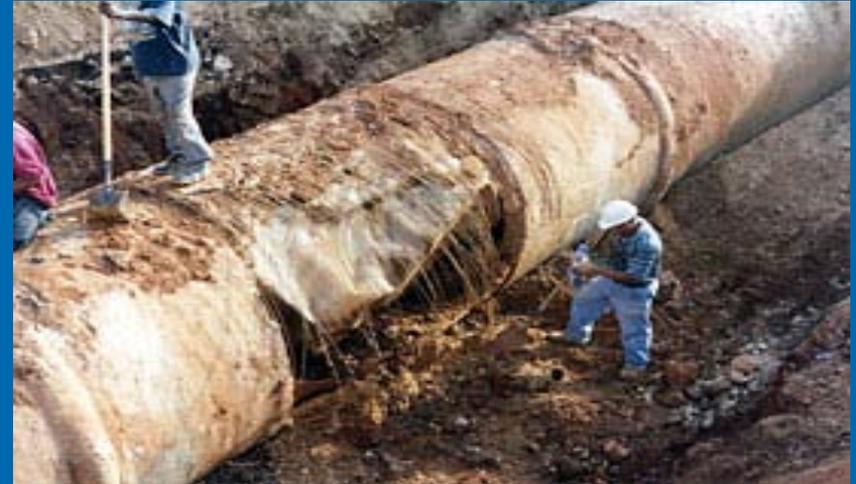
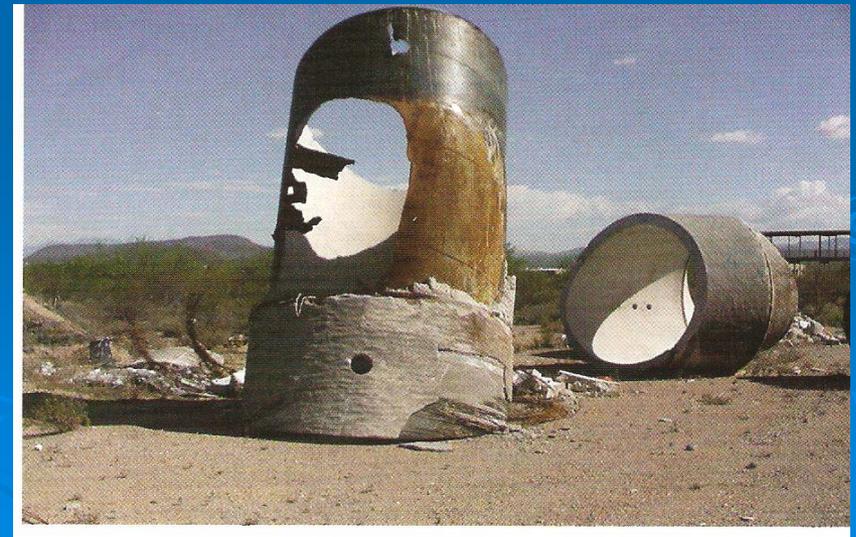
- Water main 48 in.
 - High sulfate levels
 - Water in soil
 - Corrosion of concrete, steel wires and steel pipe
 - Water pressure exceeded the strength of the deteriorated pipe
 - BURST!!
