# Pipe Coating Failures

Gregory C Hardig,  
CPR Corrosion Protection Resources LLC

Appalachian Underground Corrosion Short Course

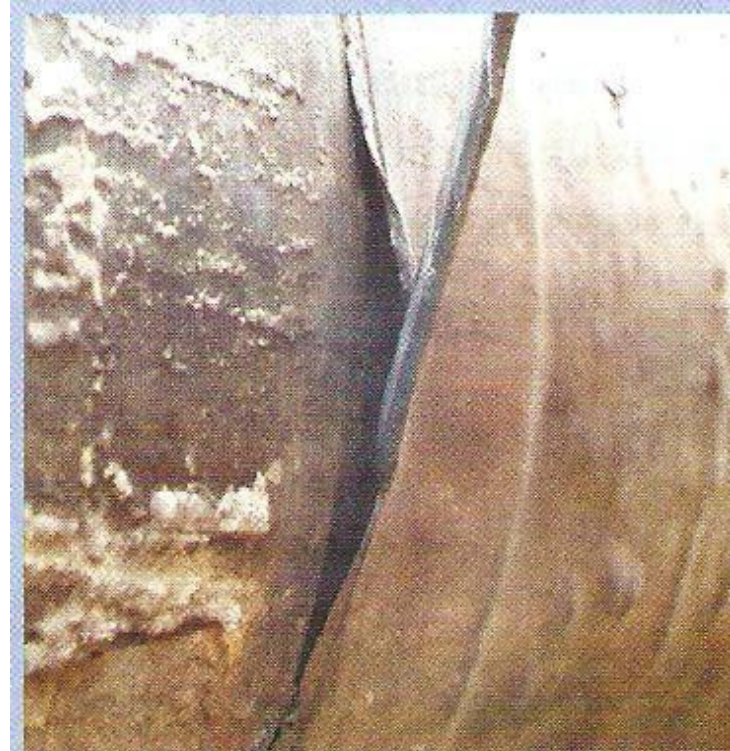
## 18 in Oil Pipeline

- 3 layer Polyethylene
- In Line Inspection (ILI)
  - Corrosion 1<sup>st</sup> 15 km
- 131F Operating Temp
- Service- 15 yrs
- Wet, compacted sand pH 5.4
- HSS
  - Hot melt type / Epoxy Primer
  - Surface Prep Power tool

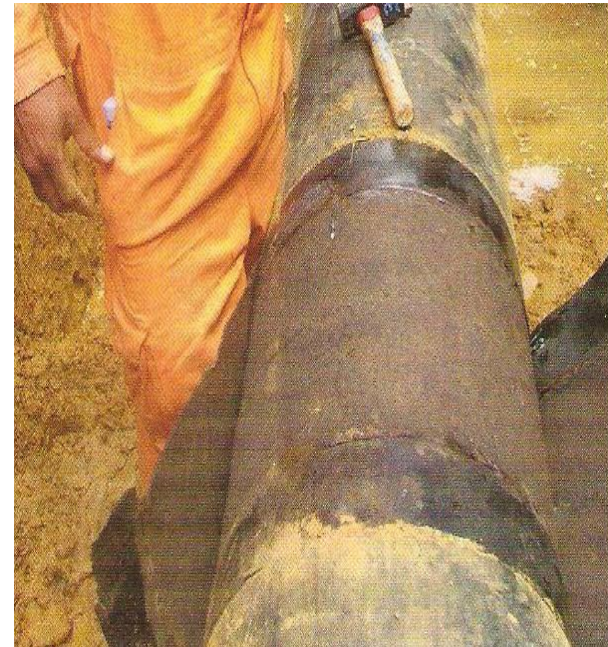
## 18 in Oil Pipeline

- Massive disbonding of HSS
  - Steel surface
  - 3LPE coating system
- Significant corrosion
  - Field joint
  - Steel surface
- No significant corrosion at lower operating temperatures.

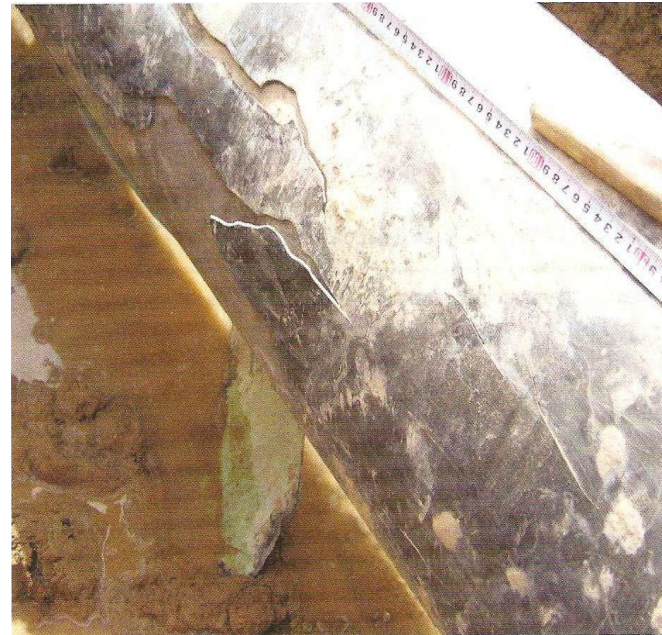
## 18 in Oil Pipeline

- Longitudinal cracking at the 3 and 9 o'clock positions.
- Showed signs of thermal aging
  - Brittleness
  - Lack of flexibility
- Issues:
  - Storage conditions
  - Soil exposures
  - Service conditions

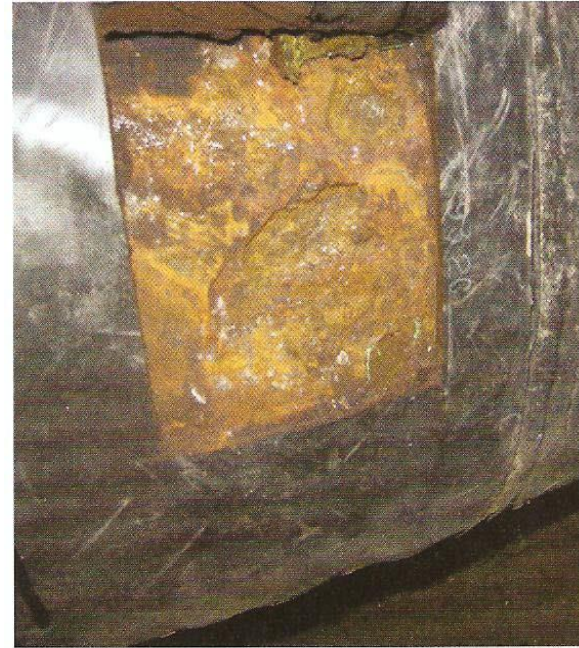
## 16 in Oil Pipeline

- 3 layer Polyethylene
- In Line Inspection (ILI)
  - Severe external corrosion
  - Pitting- “Craters” at field joints
- 122F Operating Temp
- Service- 12 yrs
- Brackish w/ 2g/liter chlorides
- HSS
  - Hot melt type / Epoxy Primer
  - Surface Prep- Wire brush
  - Millscale on surface
  - Overlap 1 cm (~ 1.2 in)

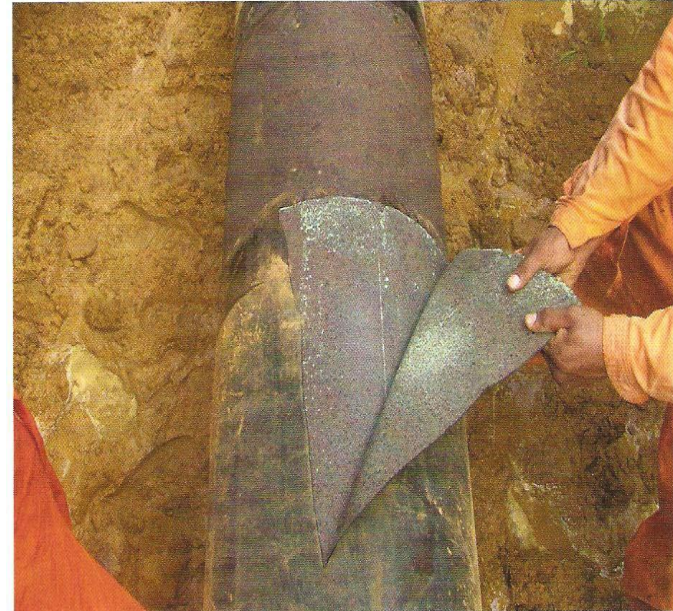
## 16 in Oil Pipeline

- Disbonding of HSS
  - Steel surface
  - 3LPE coating system
- Significant corrosion
  - Field joint
  - Steel surface
  - Salt crystals under HSS
- Disbondment fo coating system

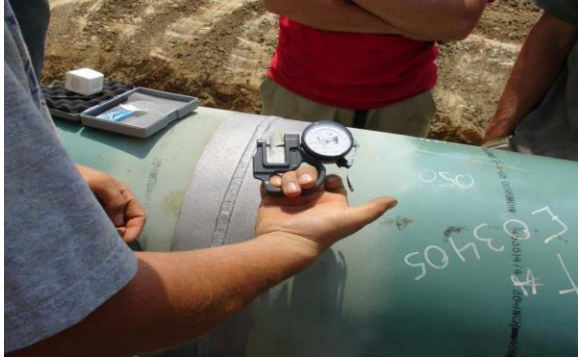
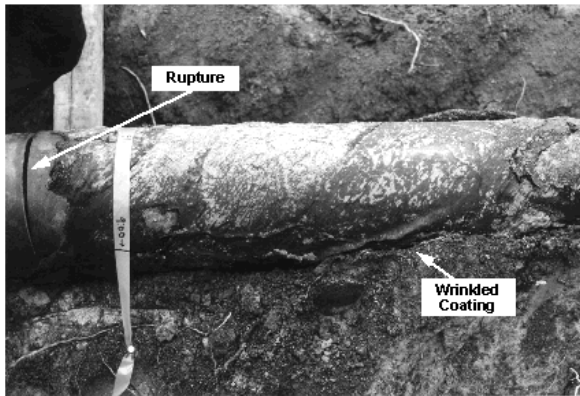
- Surface preparation
  - Minimum Near white blast
- Application
  - Fish mouths
  - Overlaps
- Service Conditions
  - Operating temperature
  - Soil conditions
- UV Degradation during storage.

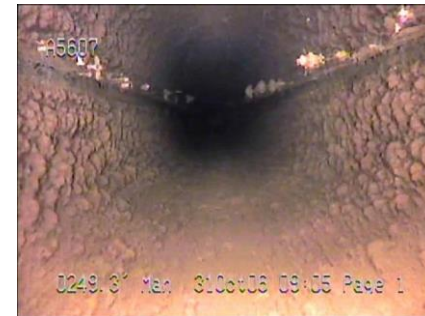
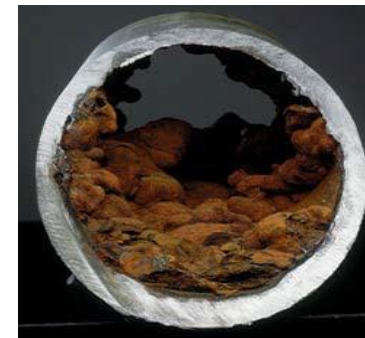
Photo: Extensive tuberculation can discolor and contaminate water as well as result in greatly reduced water flow and pressure.

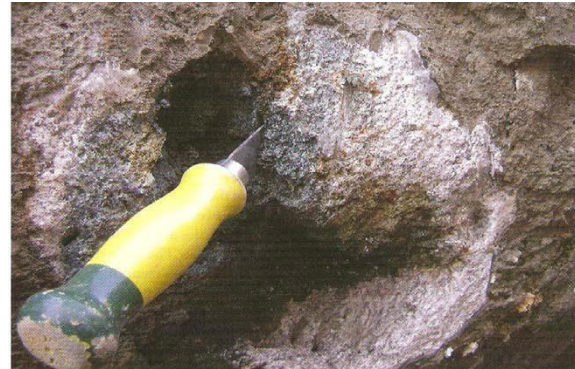
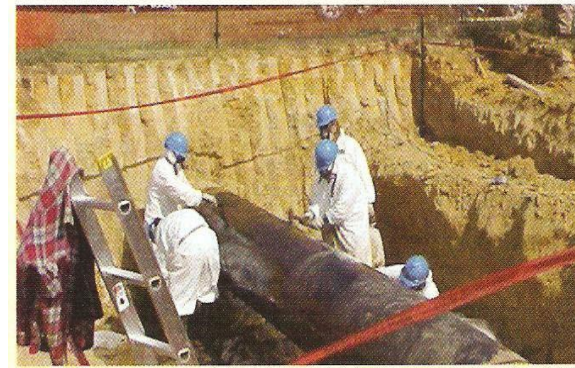
- Water main 48 in.
  - Failure location
    - 10 ft long
    - Along pipe wall
  - Concrete coating deteriorated and spalled
  - Reinforcement wires broke
  - Exposed steel substrate to soil conditions

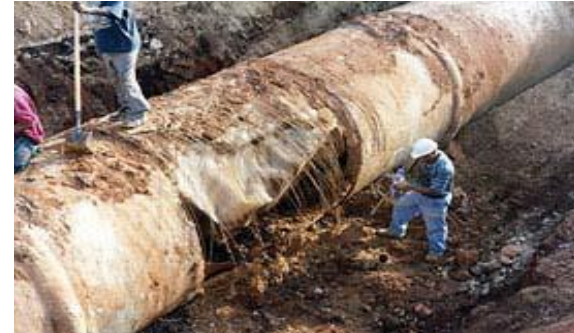
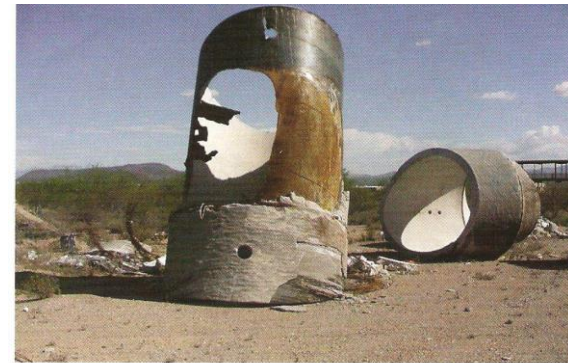
- Water main 48 in.
  - High sulfate levels
  - Water in soil
  - Corrosion of concrete, steel wires and steel pipe
  - Water pressure exceeded the strength of the deteriorated pipe
  - BURST!!
