Pipe Coating Failures

Gregory C Hardig,
Senior Certified Coatings Inspector Cert N-3494
CPR Corrosion Protection Resources LLC

Appalachian Underground Corrosion Short Course

Pipeline Coating Failures

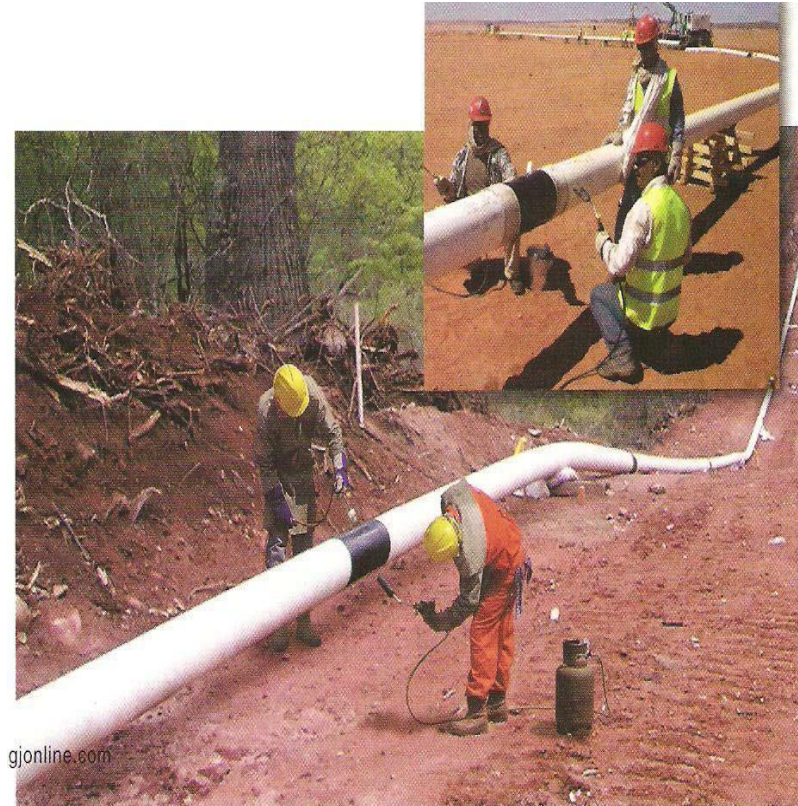
Construction (HSS)

18 in Oil Pipeline

- 3 layer Polyethylene
- In Line Inspection (ILI)
 - Corrosion 1st 15 km
- 131F Operating Temp
- Service- 15 yrs
- Wet, compacted sand pH 5.4
- HSS
 - Hot melt type / Epoxy Primer
 - Surface Prep Power tool

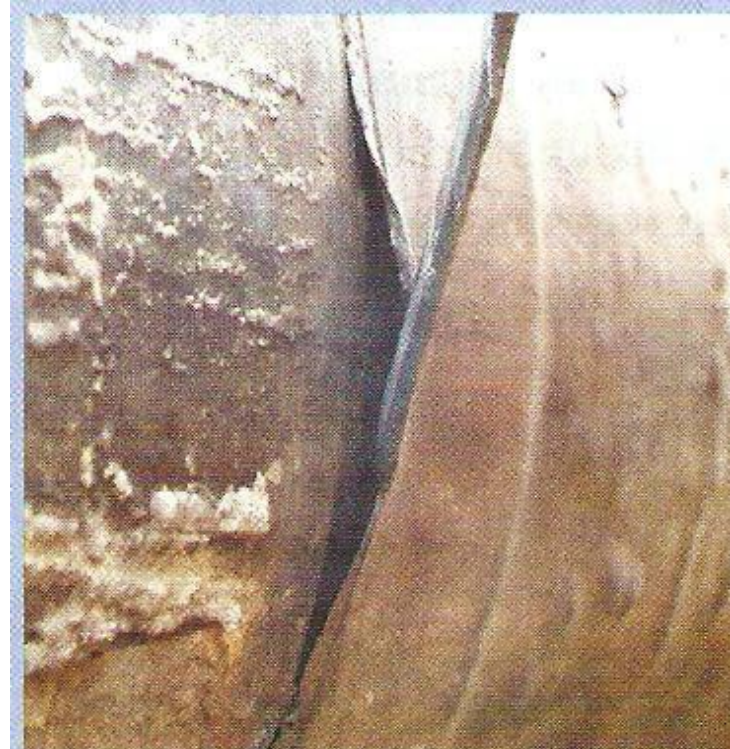
Construction (HSS)

18 in Oil Pipeline

- Massive disbonding of HSS
 - Steel surface
 - 3LPE coating system
- Significant corrosion
 - Field joint
 - Steel surface
- No significant corrosion at lower operating temperatures.

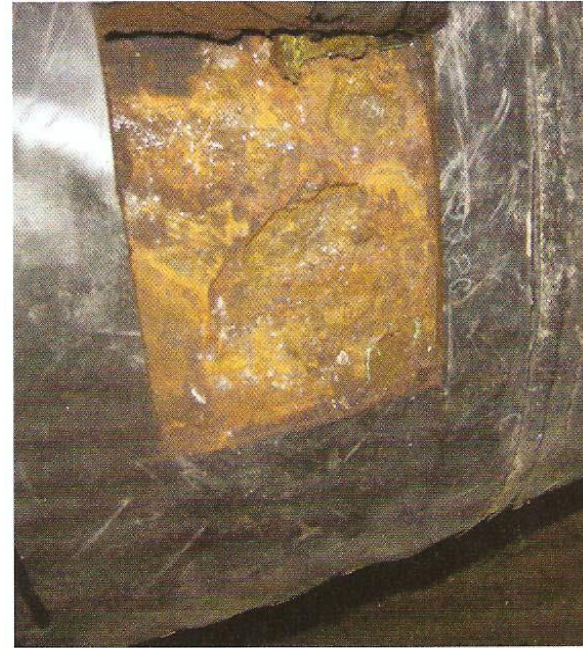
Construction (HSS)

16 in Oil Pipeline

- Disbonding of HSS
 - Steel surface
 - 3LPE coating system
- Significant corrosion
 - Field joint
 - Steel surface
 - Salt crystals under HSS
- Disbondment of coating system

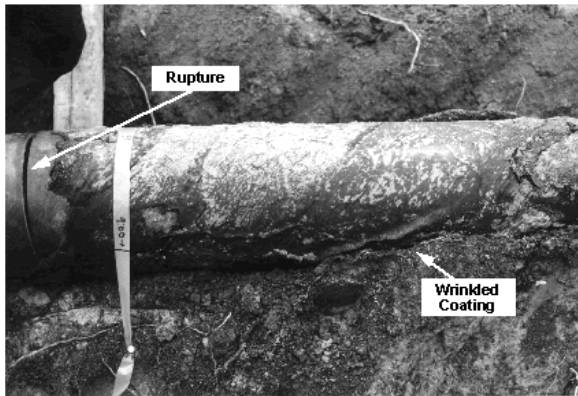
Causes of Disbondment

- Surface preparation
 - Minimum Near white blast
- Application
 - Fish mouths
 - Overlaps
- Service Conditions
 - Operating temperature
 - Soil conditions
- UV Degradation during storage.

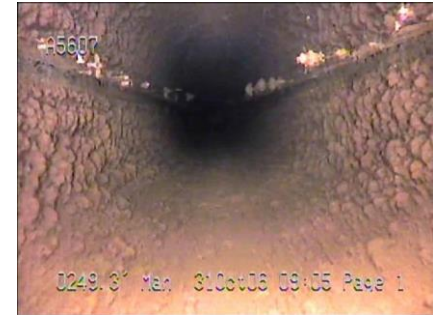
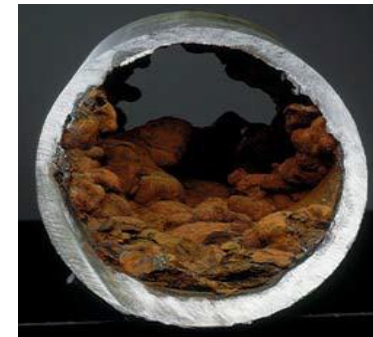
Photo: Extensive tuberculation can discolor and contaminate water as well as result in greatly reduced water flow and pressure.

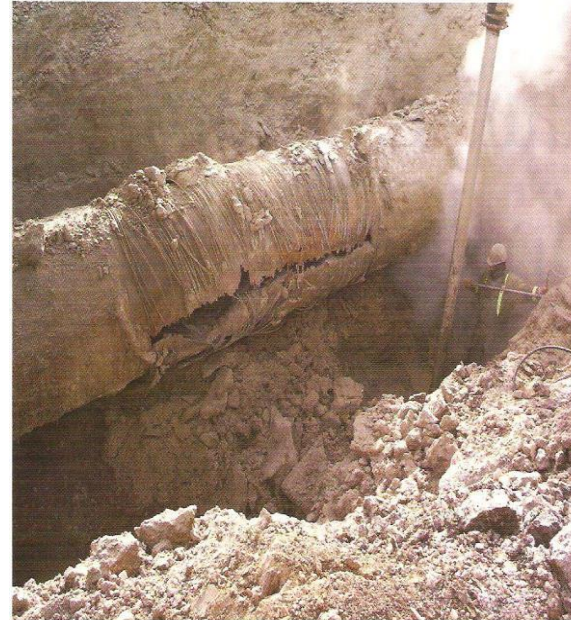
Case History

- Water main 48 in.
 - Pre- stressed Concrete Cylinder Pipe PCCP
 - 25 years service
 - Wrapped with High strength reinforcement wire- externally
 - Coated with cement rich mortar
 - No Cathodic Protection
 - Backfill native soil

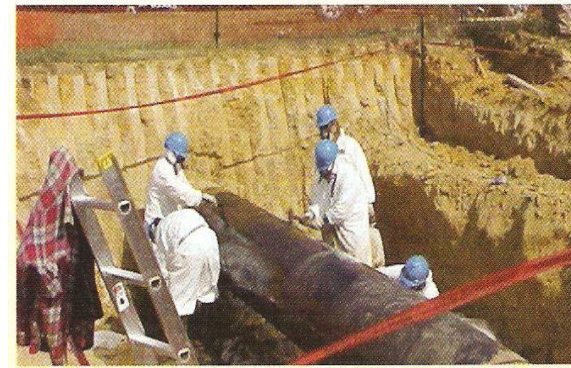
Case History

- Water main 48 in.
 - Failure location
 - 10 ft long
 - Along pipe wall
 - Concrete coating deteriorated and spalled
 - Reinforcement wires broke
 - Exposed steel substrate to soil conditions

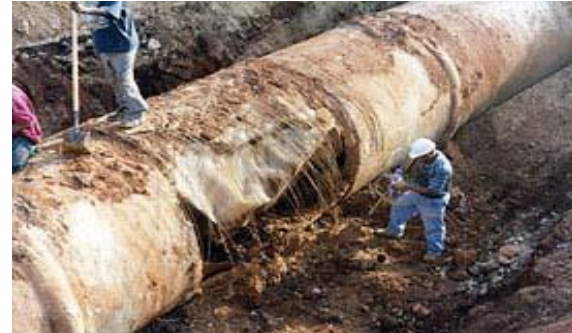
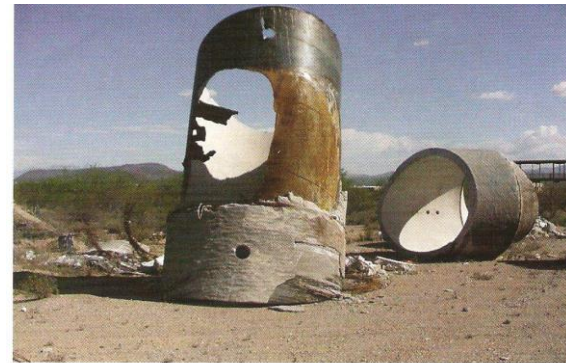
Case History

- Water main 48 in.
 - High sulfate levels
 - Water in soil
 - Corrosion of concrete, steel wires and steel pipe
 - Water pressure exceeded the strength of the deteriorated pipe
 - BURST!!
