NACE International
57th Annual
Appalachian Underground Corrosion Short Course
May 15, 2012
Morgantown, West Virginia

**CORROSION CONTROL CONSIDERATIONS FOR
DUCTILE IRON PIPE – A CONSULTANT’S PERSPECTIVE**

William S. Spickelmire
RUSTNOT Corrosion Control Services, Inc.
325 Chester Drive
Boise, Idaho 83706
208-384-9752
bspickelmire@rustnotconsulting.com

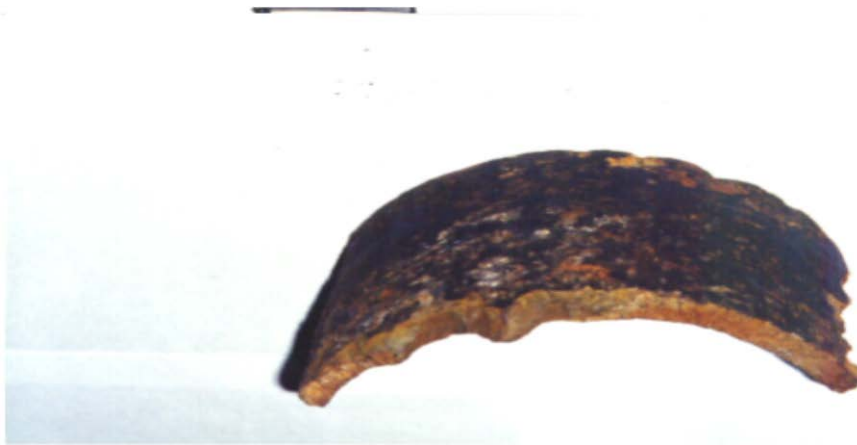
Figure 1
Exterior Surface of Pipe Appears To Be In Good Condition

Graphitized iron pipe responds with a dull sound when struck with a metal object, is soft like pencil lead and can be gouged or dug into with a knife or screwdriver. To fully evaluate the damage, the graphitization must be removed by abrasive blasting (sand blasting) or tested by other non-destructive evaluation methods (e.g., ultrasonic, remote eddy field current). Recent papers summarizing pipe material assessments utilized by both the City of Ottawa and the City of Calgary^{18 19} confirmed that the pipe needs to be abrasive blasted to remove surface debris in order to visually accurately identify actual metal loss as shown in Figure 1. This is because the smooth surface appearance of graphitized cast iron, and in some cases ductile iron, may lead one to believe that the pipe has no corrosion damage and still has sound structural integrity.

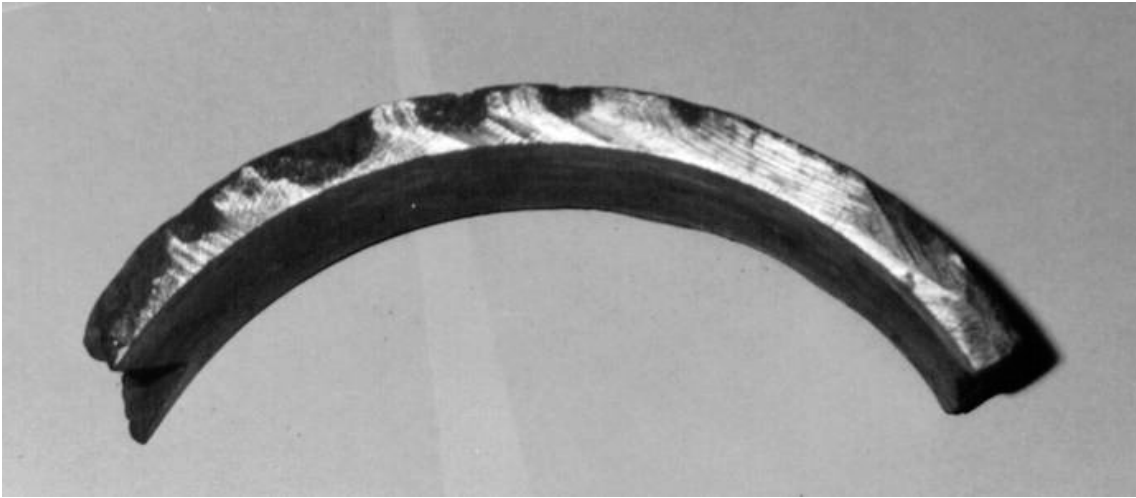
Figure 2
Soft Black Graphitization Pockets Visible on Pipe Edge When Cut

But when viewed from the side, the graphitization appears black at the carbon-rich areas where the iron has been selectively consumed, as shown in Figure 2. The surface of corroded cast or ductile iron pipe will show corrosion damage similar to steel pipe when the graphitization, which is soft like pencil lead, is removed.

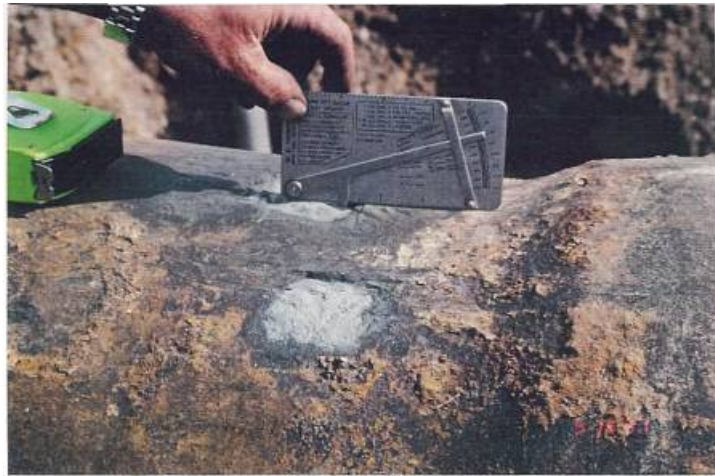
Figure 4
Sandblasted 24-Inch 33-Year-Old Ductile Iron Corrosion With 3/16-Inch Surface Graphitization Layer

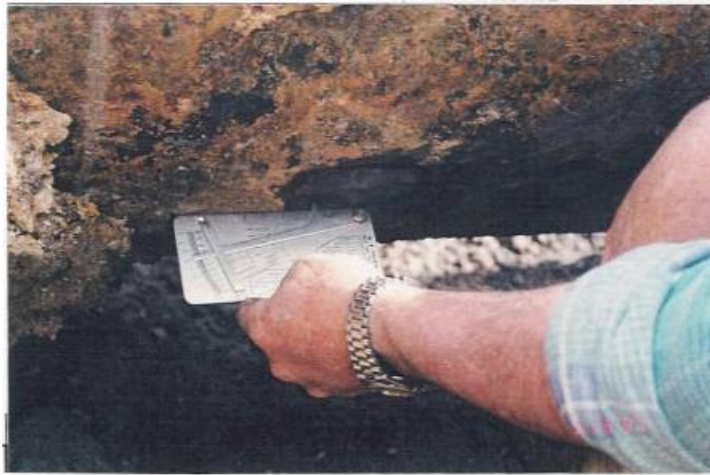
Figure 5
24-inch 33-Year-Old Ductile Iron Pipe with 2-inch by 3-inch Sized 0.310-mils Deep (75 Percent of Pipe Wall) Plug-Type Corrosion With Some Surface Graphitization

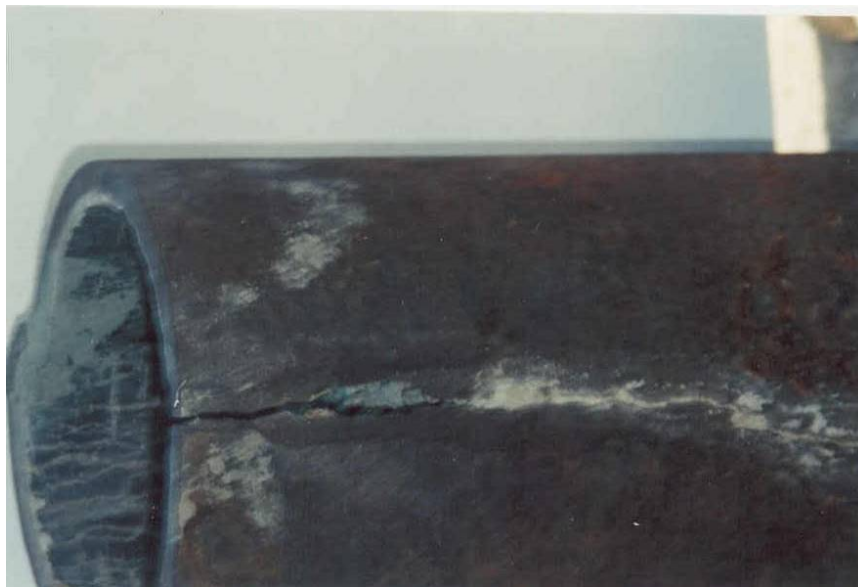
Figure 6
Sheridan Deep Graphitization Corrosion Along Crack on Ductile Iron Pipe in Less Than 15 Years

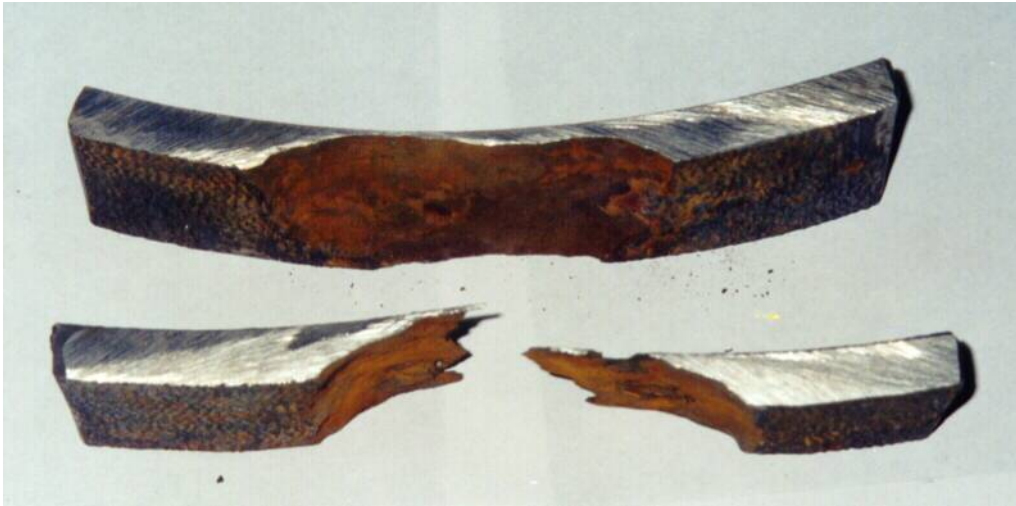
Figure 7

Sheridan 35-Year-Old Ductile Iron Corrosion Similar to Steel with No Graphitization Visible and Bright Metal At Bottom Of Corrosion Pit When Initially Exposed; Unprotected 60-Year-Old Coated Steel Line in Same Area With Minimum External Corrosion Problems

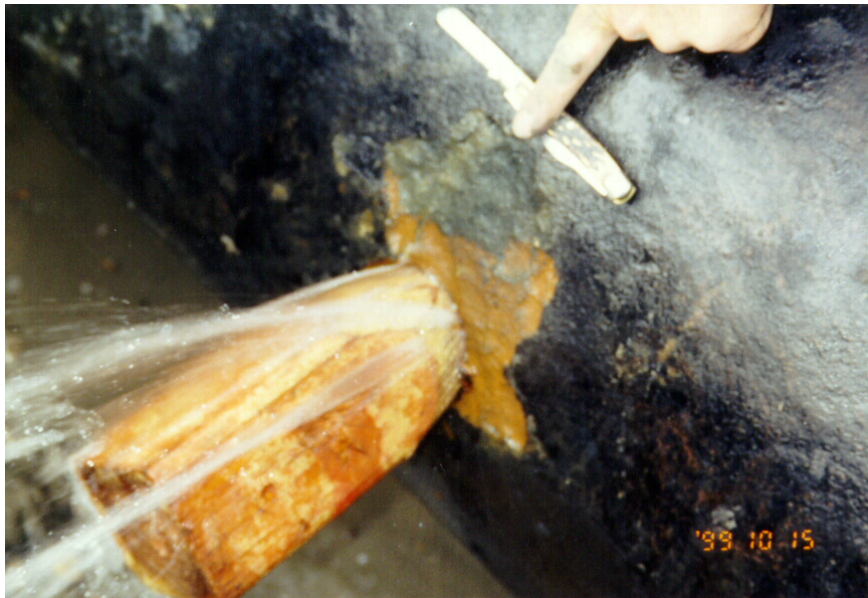
Figure 8

Laramie Plug Graphitization and Leak from 35-Year-Old Cast Iron and Ductile Iron Pipe Lines; Replacement Less Than 5 Years After First Leak and Major Graphitization Discovered

As shown on Figure 8, even though the pipe has major corrosion damage, the graphitization and cement mortar lining can hold water or sewage pressures for a period of time if not disturbed. Melvin Romanoff

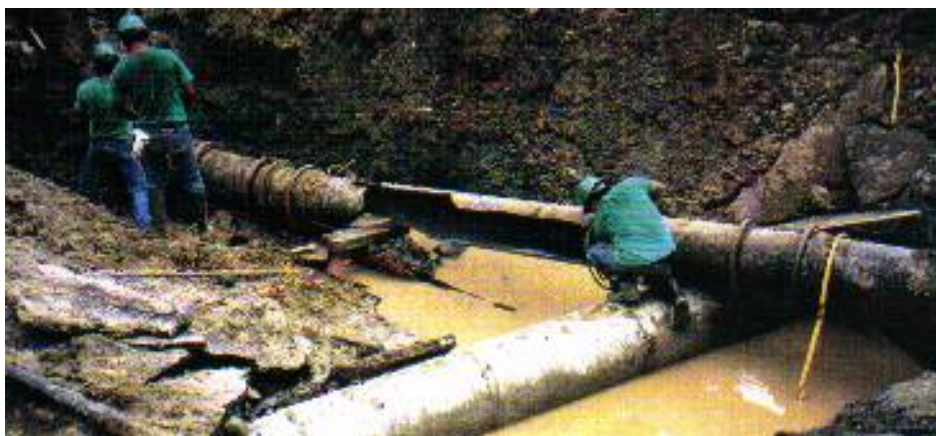
Figure 9
Catastrophic-Type Break Hawaii 34-Year-Old Cast Iron Main Break (14.5 Points)

Although cast or ductile iron pipe corrode at the same rate as steel, they do not usually fail as rapidly as steel pipe.²¹ This is partly a result of the wall thickness, but also because of the ability of the iron pipe graphitization to withstand some pressure if undisturbed and not subjected to external or internal stresses until the corrosion damage becomes too large. But the cost and damage caused by these types of graphitized iron pipe failures may be more severe when they do occur, as shown in Figures 9, 10, and 11. As mentioned earlier cast iron is more brittle than ductile iron, which results in more catastrophic-type failures than for ductile iron, as shown by this failure in a major road intersection in Hawaii.

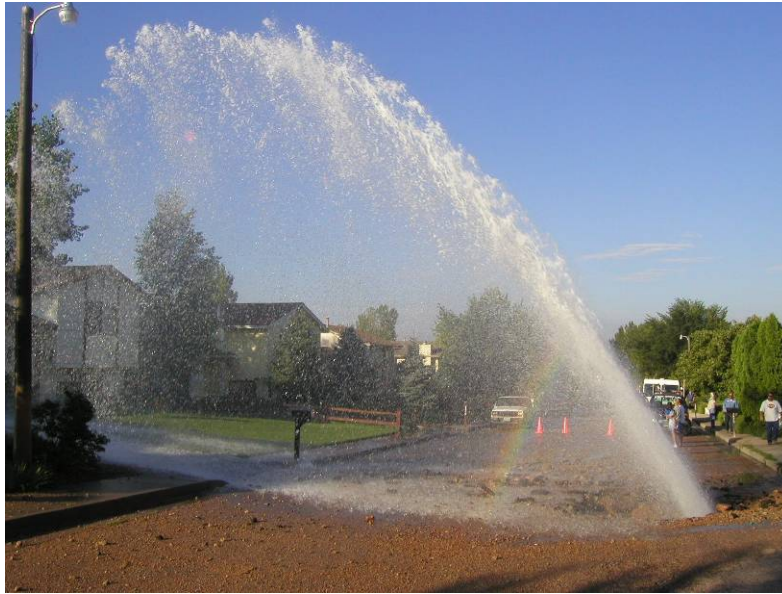
Figure 10
Major Leak on 24-Inch Polyethylene-encased Ductile Iron Line in Colorado

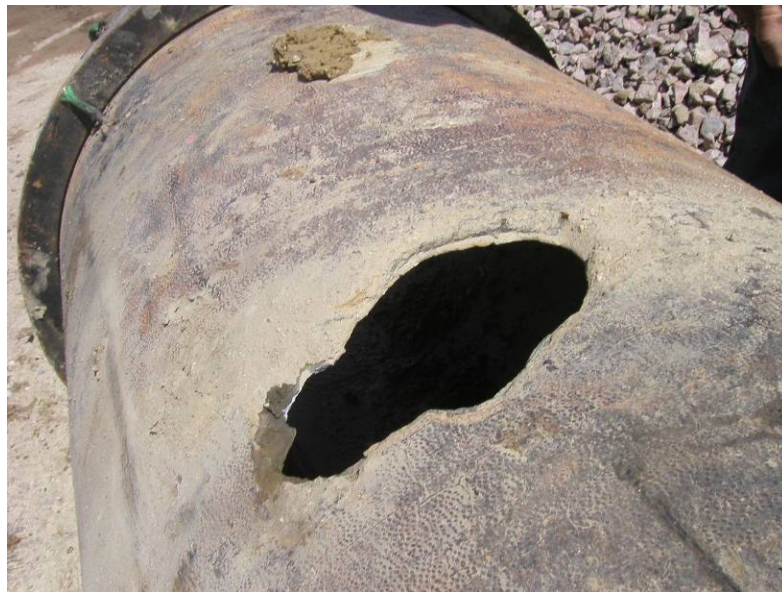
Figure 11
Colorado Corrosion Damage Repair Required Removal of Five-Foot Section of Polyethylene-encased Ductile Iron and Replacement with New Pipe with Galvanic Anodes

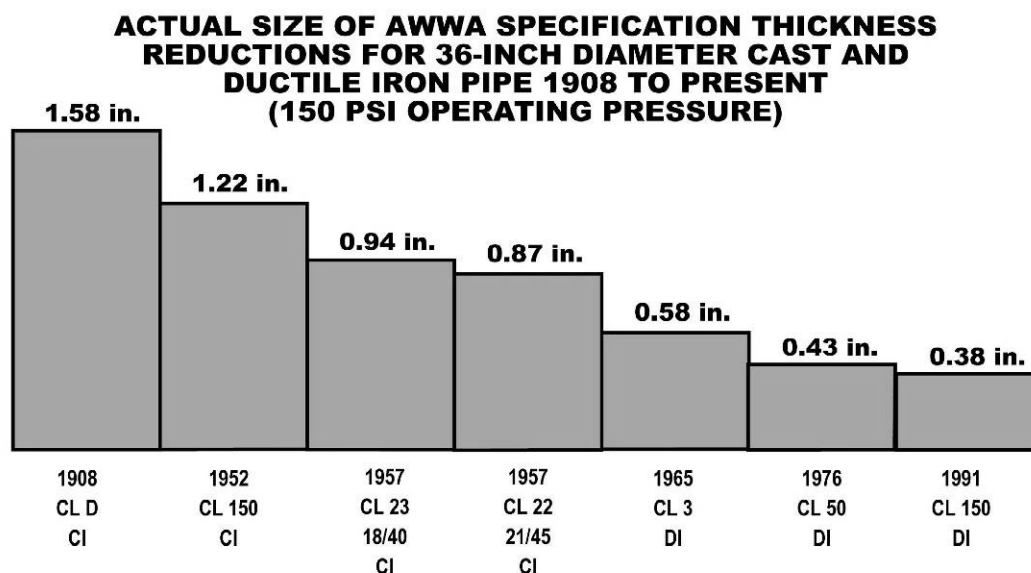
**Figure 13
Historical Iron Pipe Wall Thickness Reductions**

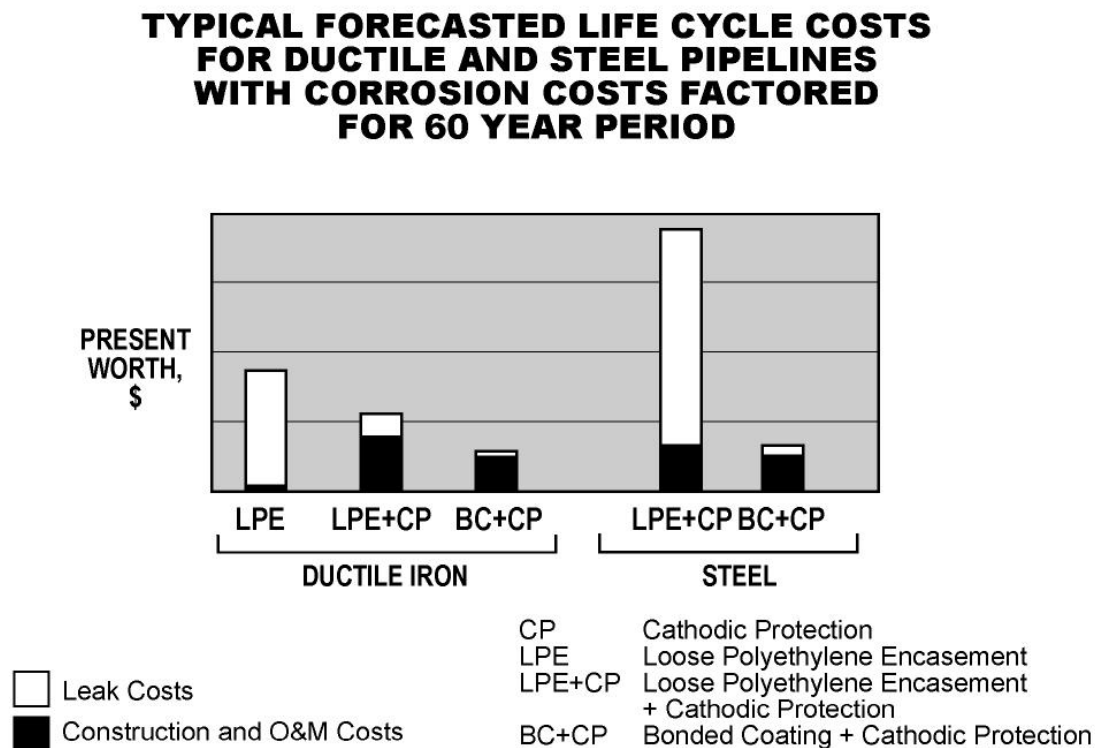
Figure 14
Comparison of Life-cycle Costs for South Dakota 24-Inch Pipelines

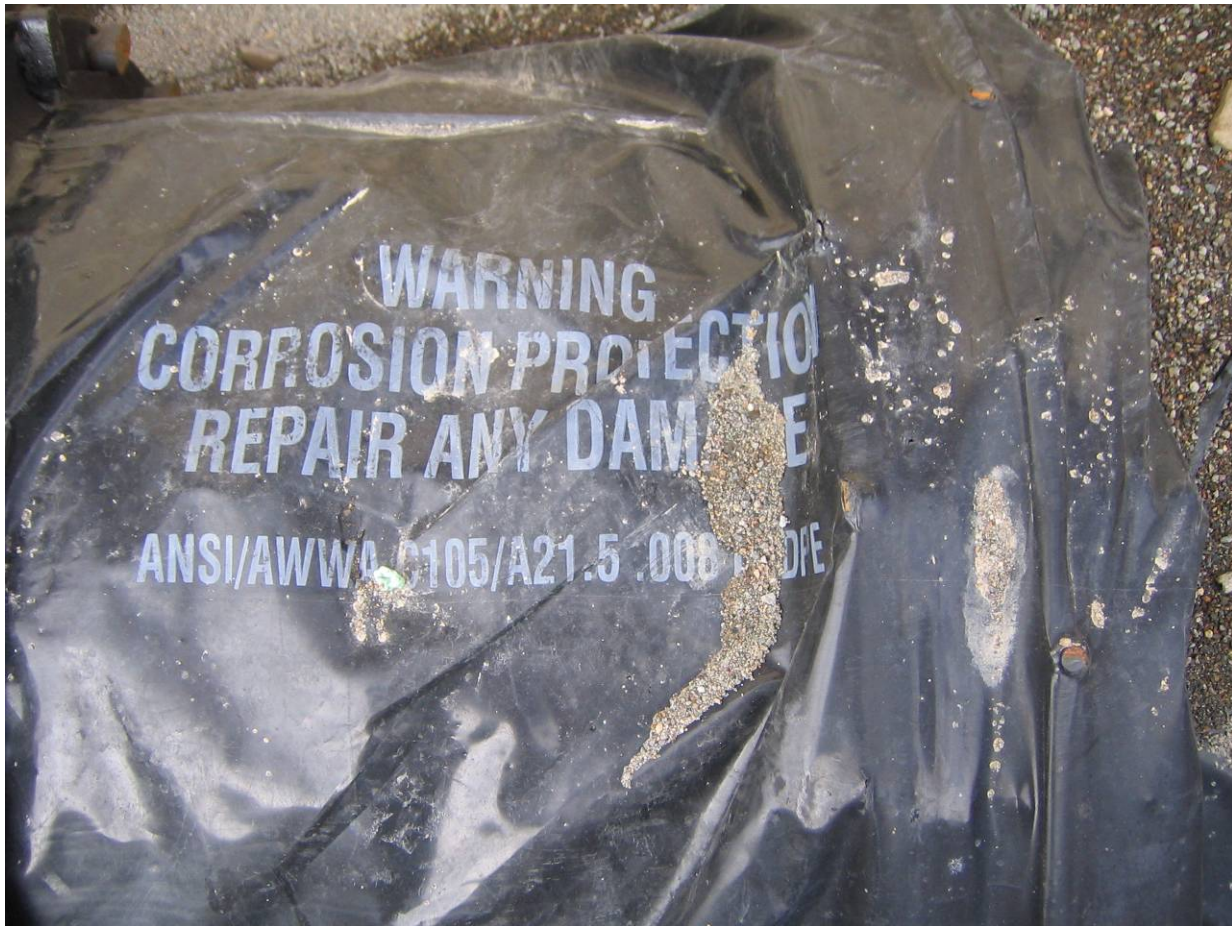
Figure 16
Printed Warning on Polyethylene Encasement

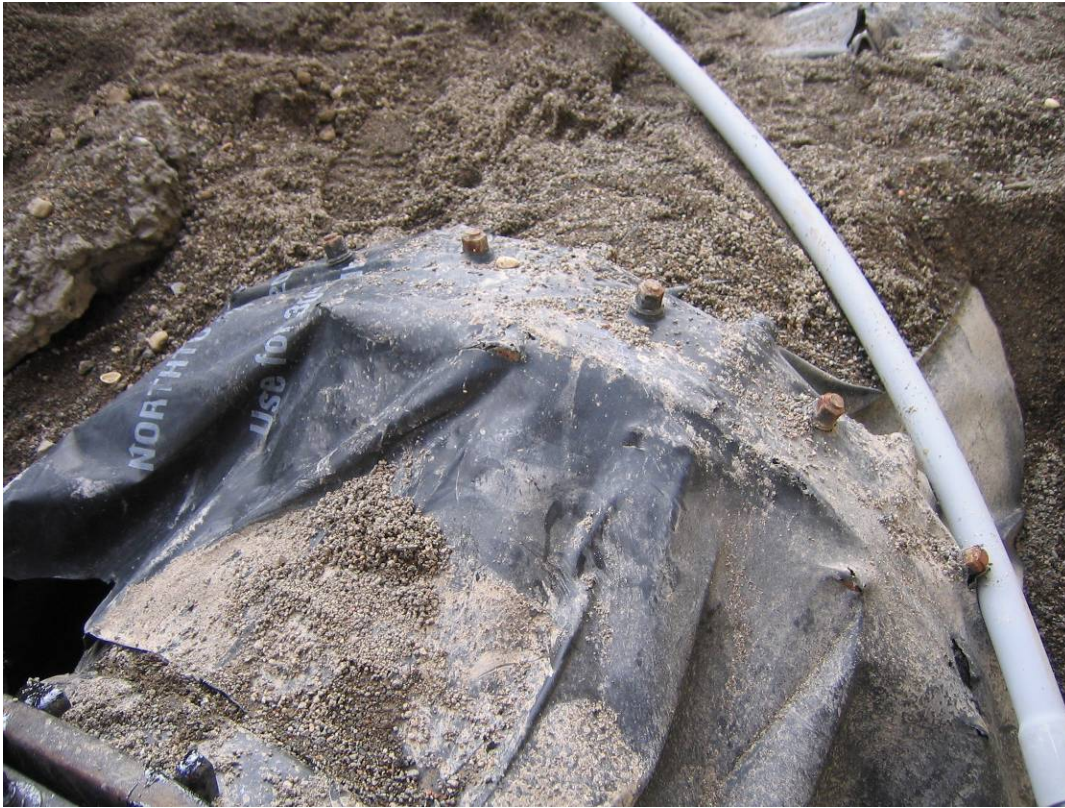
Figure 17
Damage to Polyethylene Encasement at Bolted Fittings

However, there is still difficulty and problems with possible damage to the polyethylene encasement at bolted type fittings, if not carefully installed so as to not damage the polyethylene encasement as shown below. This is the reason that some recommend use of petrolatum wax tape at these types of locations or use of the multiple layers of polyethylene encasement.

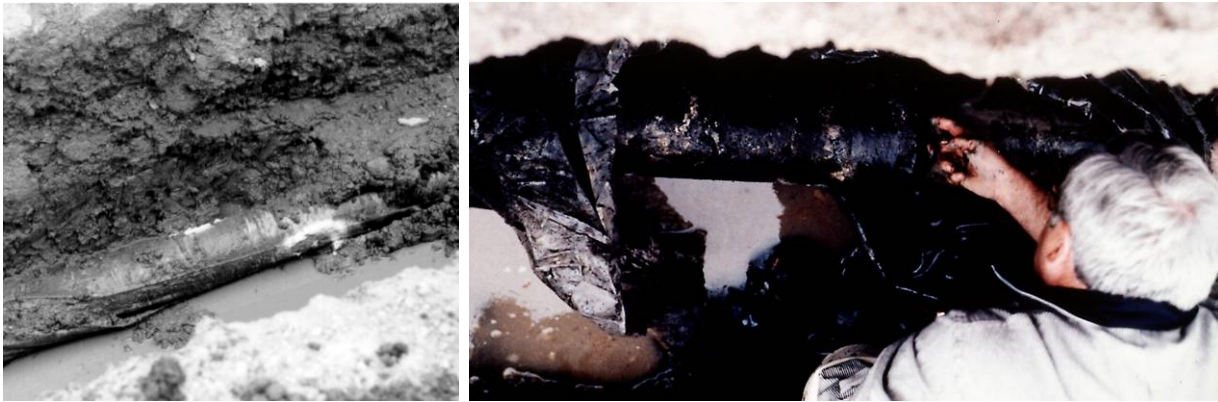
Figure 18
1986 Vancouver Polyethylene-encased Ductile Iron Pipe Evaluation Three Locations

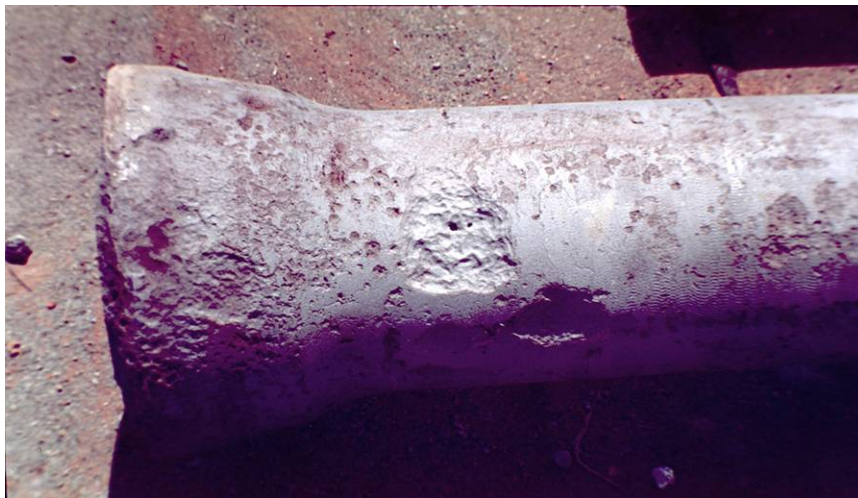
Figure 19
**Vancouver, BC, 445 Feet Removed and Examined in Three Sections, Replaced with
Tape Coated DIP with Cathodic Protection**

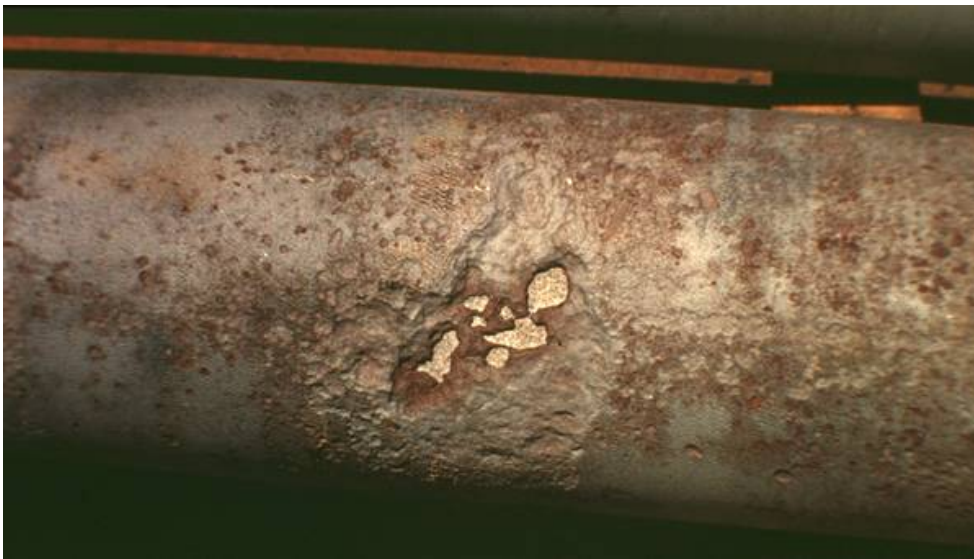
Figure 20
Vancouver, BC, Polyethylene-encased Ductile Iron Pipe After
Sandblasting Where Graphitization and Cement Mortar Lining Previously Held 650-
PSI Water Pressure

The most amazing thing that this study indicated was the ability of the cement mortar lining and the graphitized corroded ductile iron to still hold the 650-psi pressure, as shown on the following three Figures. This may be a major reason why we have not yet seen an appalling number of failures in distribution pipe pressures. It appears that although some polyethylene-encased ductile iron pipelines may actually be corroding, a significant number of leaks may not have appeared yet because of the ability of the cement mortar lining and/or graphitization to hold normal water or sewage liquid pressures. However, it is our experience, as shown by the examples in this paper, that the number of failures for both transmission-type bare and polyethylene-encased iron piping has been increasing as the lines grow older and the size of the corrosion-damaged areas become larger.

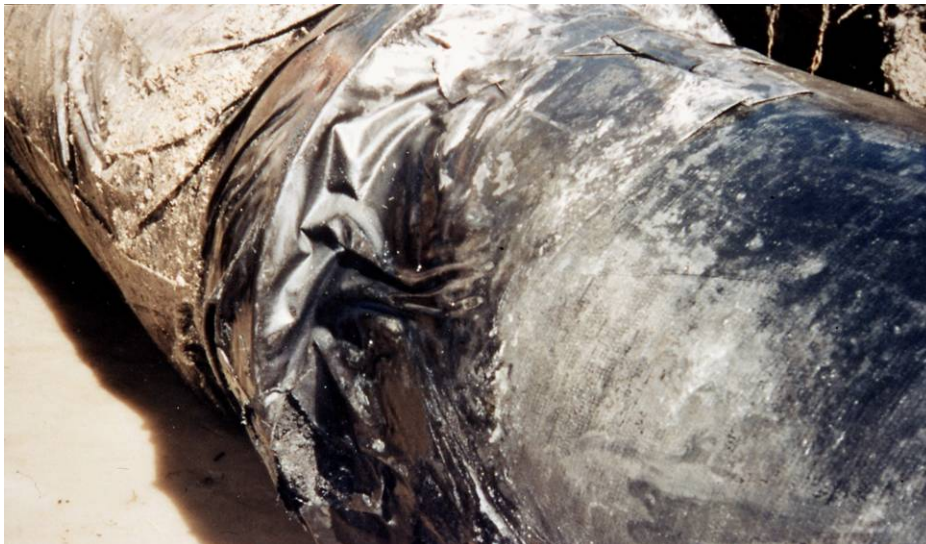
Figure 21
Sheridan, Wyoming, Ductile Iron Polyethylene Encasement Folded and Taped In Place,
With No Encasement Damage Visible

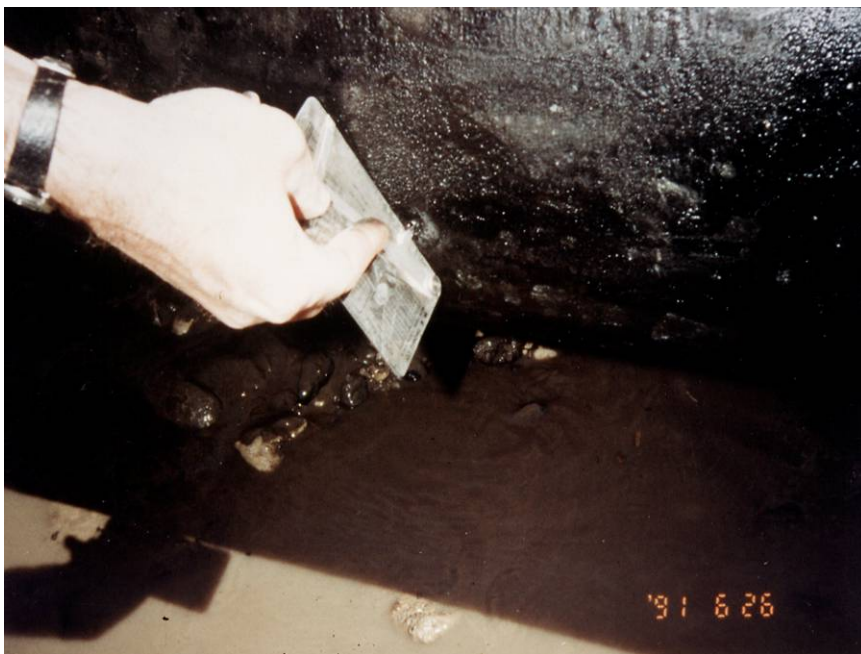
Figure 22
Sheridan, Wyoming, Polyethylene-encased Ductile Iron Pipe With Major Pit at 3
O' Clock, 180 Mils in 340 Mil-Thick-Pipe Wall 14-Year Burial

Although no major tears were found, we observed corrosion under undamaged polyethylene encasement. The pit was located at 3 o'clock on the pipe and was approximately 3/16-inch (180 mil-depth) in the Class 50 (340 mil) DIP, as shown in Figure 22. However, we could not correlate the presence of soil or contamination inside the polyethylene encasement or a polyethylene defect at the pipe pit location, see Figure 23. Testing indicated that the polyethylene-encasement material met AWWA standards.

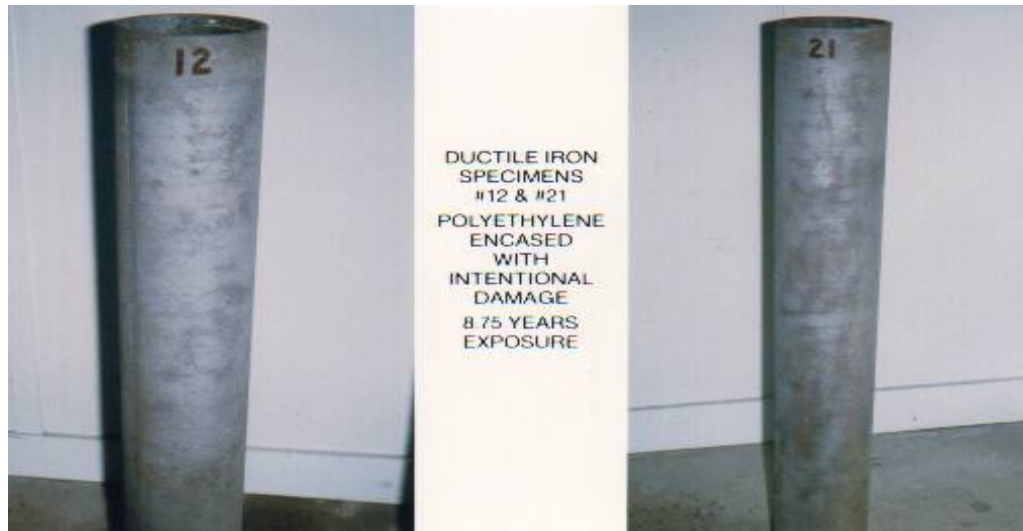
Figure 24
Marston Lake (Denver) Site 68-Mil Pit Under Undamaged Polyethylene Encasement in 8.75 Years

A review of data also confirms that corrosion can occur under undamaged polyethylene encasement. At the Marston Lake-test location in Denver, Colorado, DIPRA conducted testing in moist to wet soils in the 1,350 ohm-cm range. The polyethylene encasement was intentionally damaged on the samples to determine the amount of protection under damaged and undamaged polyethylene encasement. In 1983, after 8.75 years of exposure, the last six samples were excavated and examined. After blast cleaning, several pipe samples displayed corrosion pitting under undamaged polyethylene encasement. One sample indicated that the pit depth was 43 mils at the polyethylene encasement-damaged location. However, there was deeper pitting damage (68 mils, 150 percent of original) on the opposite side of the pipe under undamaged polyethylene encasement.⁶¹

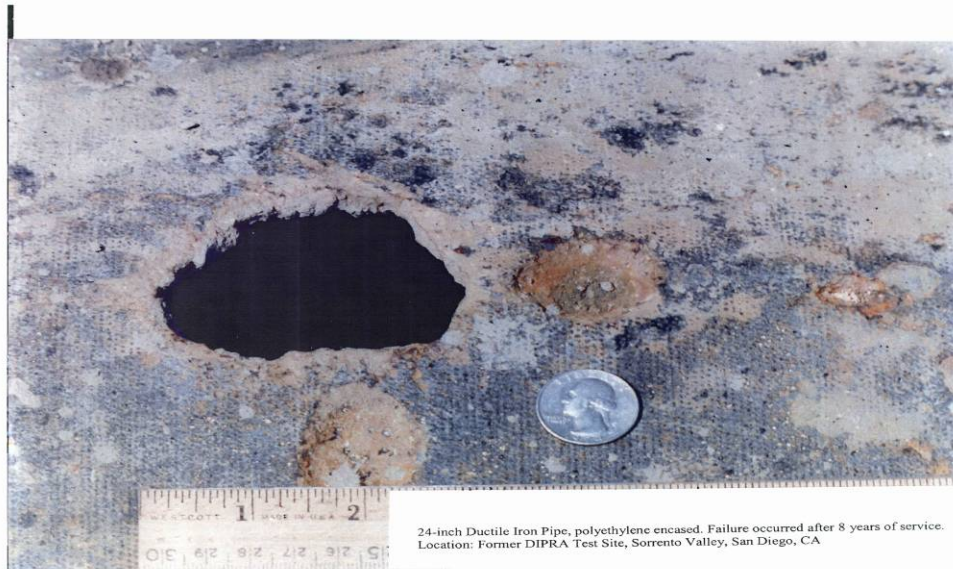
Figure 25
San Diego, CA, 8-Year-Old 24" Polyethylene-encased Ductile Iron Pipe at Former DIPRA Test Site

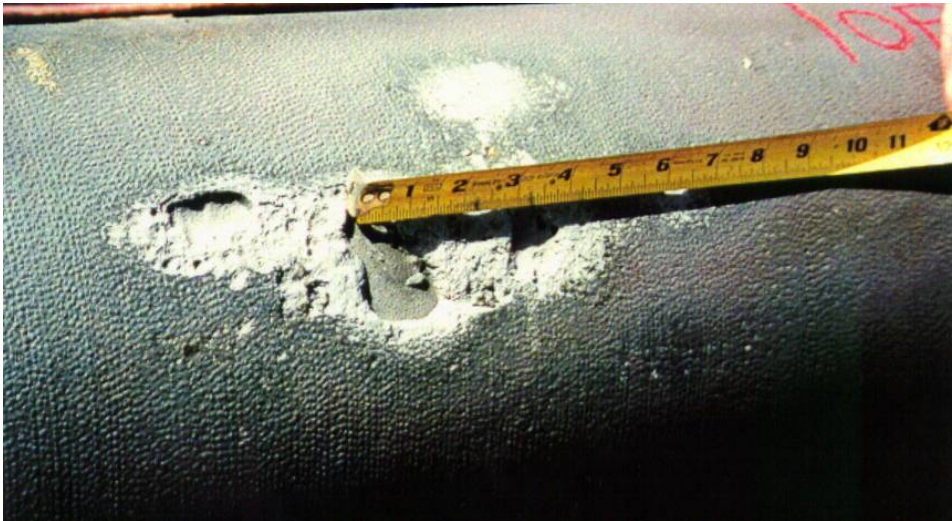
Figure 27
Colorado Springs, Colorado, Force Main Corrosion Where Only Polyethylene
Lining Was Holding Sewage Pressure

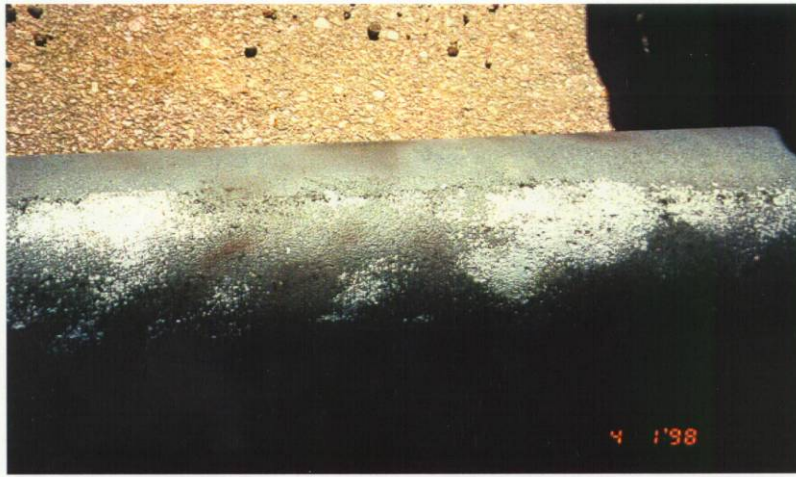
Figure 28
Colorado Springs, Colorado, Sewer Force Main With Uniform Pitting on Pipe
Bottom from MIC Corrosion

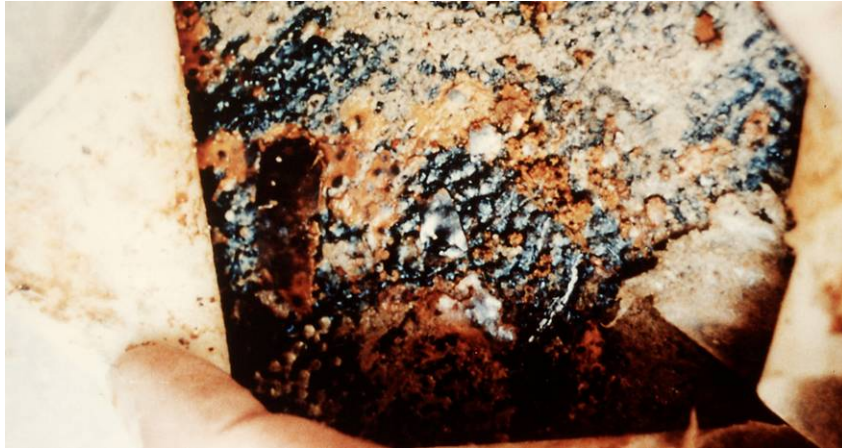
Figure 30
Vernal, Utah, Electrical Shielding Of 10-Year Old Cathodic Protected Pipeline With 30- to 60-mil Deep Pipe Under Intact Polyethylene Encasement

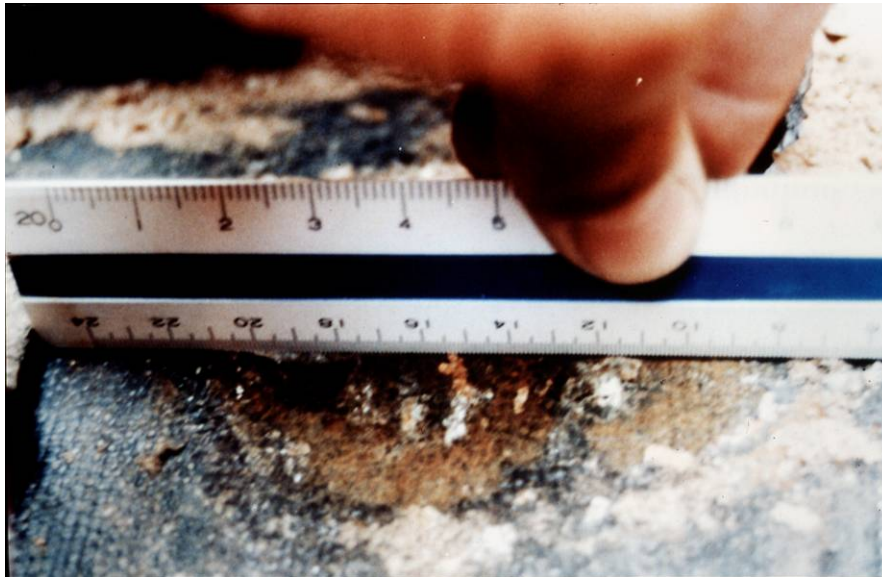
Figure 31
Vernal, Utah, 125-Mil, (0.3175 cm)-Deep Corrosion on CP Polyethylene-Encased DIP

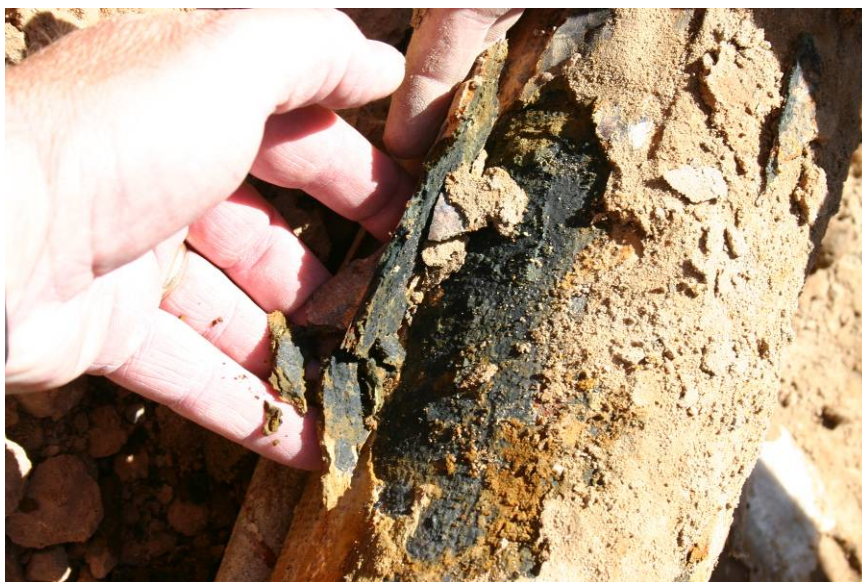
Figure 32
Vernal, Utah, CP Polyethylene-Encased DIP with Black Layer and Graphitization
Under Polyethylene Encasement

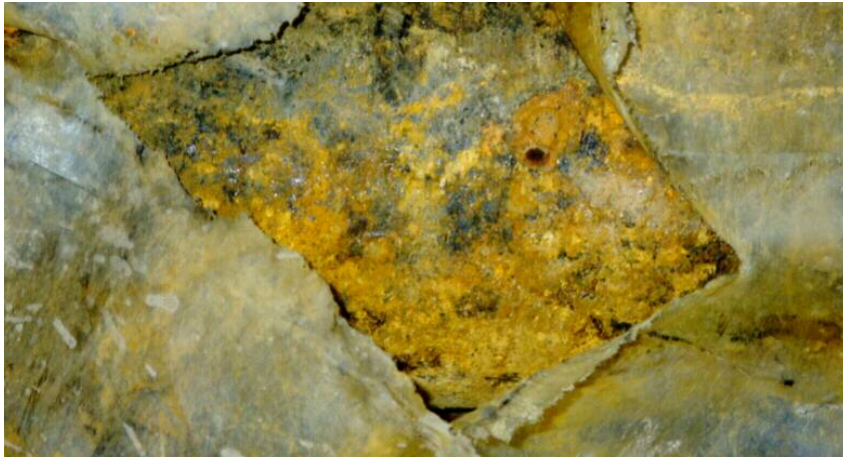
Figure 33
Sheridan, Wyoming, Surface Corrosion Indicating Possible Electrical Shielding Of
Cathodic Protection With Loose-Bonded Polyethylene Encasement

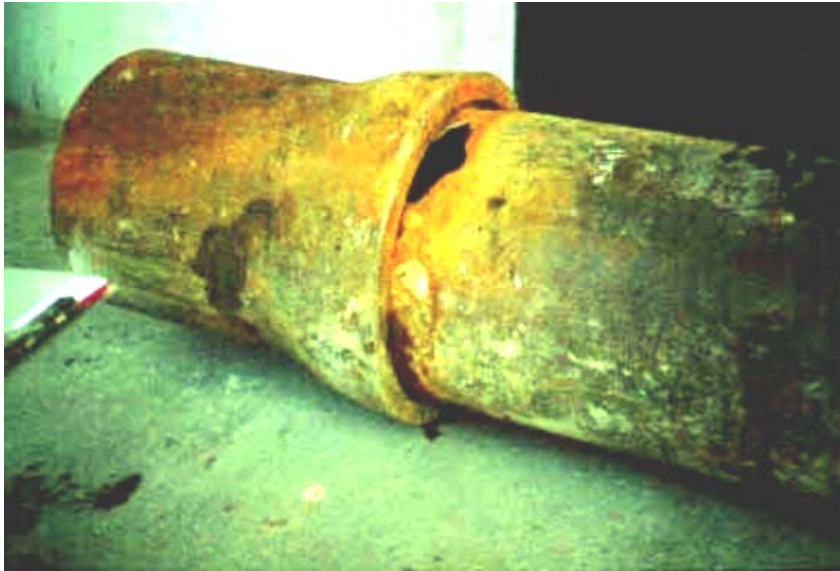
Figure 34
California City, California Corrosion Leak on Cathodic Protected Polyethylene
Encased 14-inch Ductile Iron Pipeline

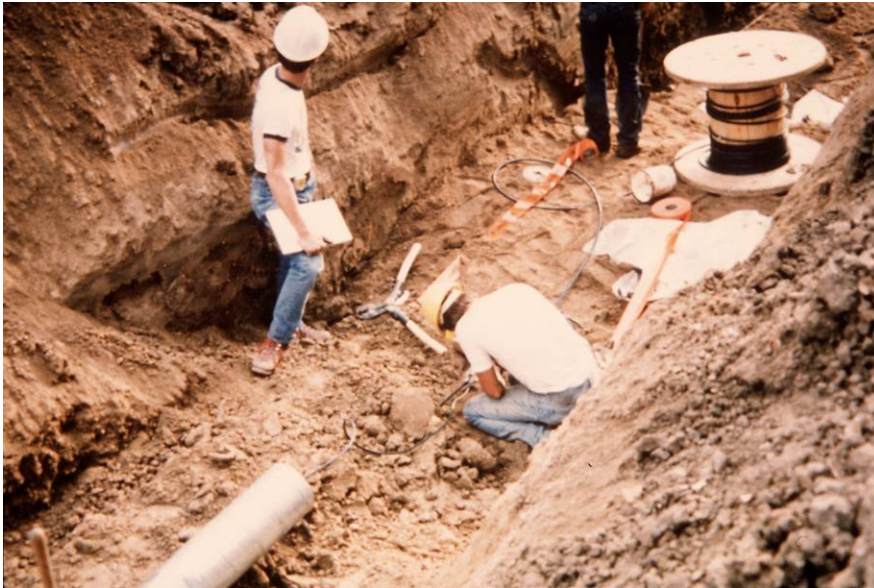
Figure 35
Denver, Colorado, Distributed Impressed Current Anode System for Dual Force Mains
(103 to 137 Micro-Amps/Square Foot Current Requirement)

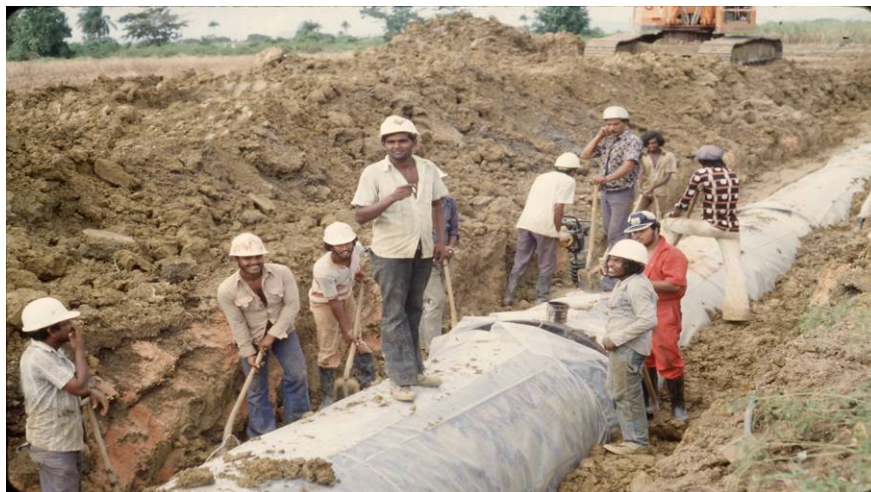
Figure 36
Trinidad-Tobago Polyethylene-encased Ductile Iron Pipe High Current Requirement in
Low Resistivity Salt Contaminated Soils (>700 Micro-Amps/Square Foot)

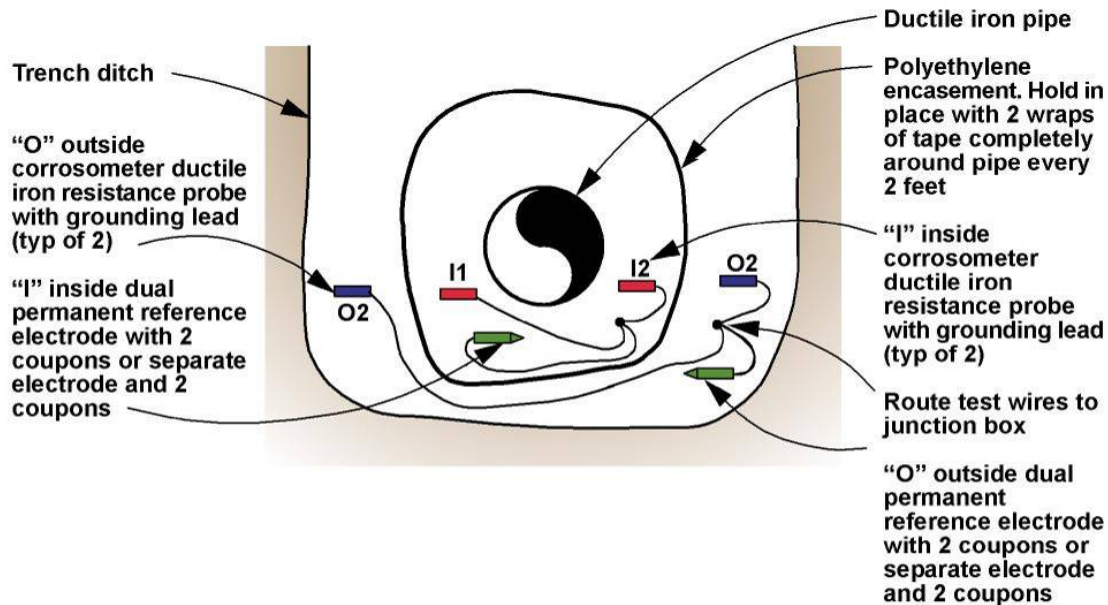
Figure 42
Ductile Iron Type PDI-M
Corrosion Monitoring System

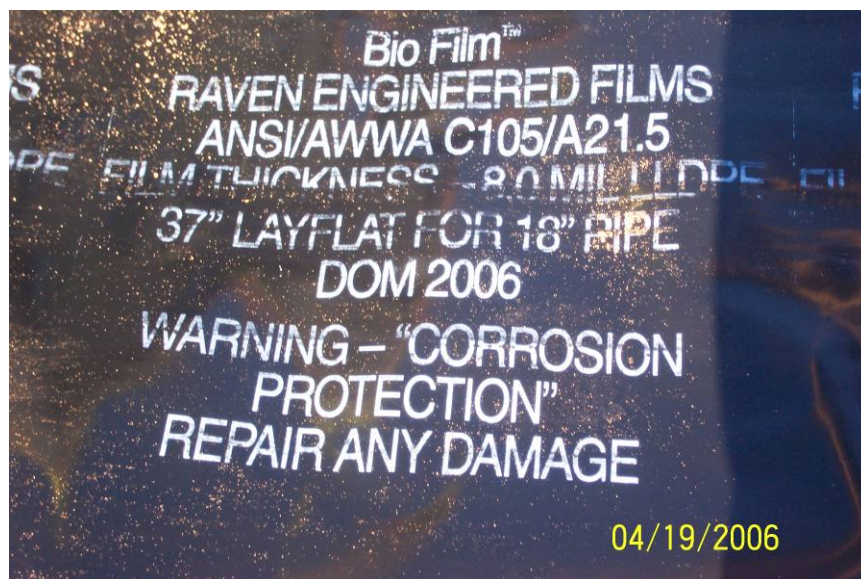
Figure 43
2006 Minnesota Forcemain Project Anti-MIC 8-mil Linear Low Density Polyethylene Encasement With Warning

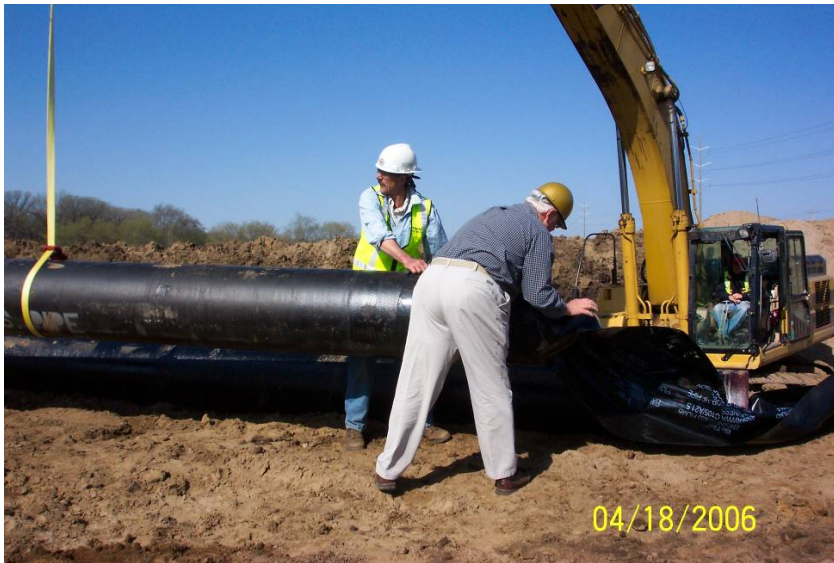
Figure 44
Inner Layer of 8-mil Anti-MIC Polyethylene Encasement

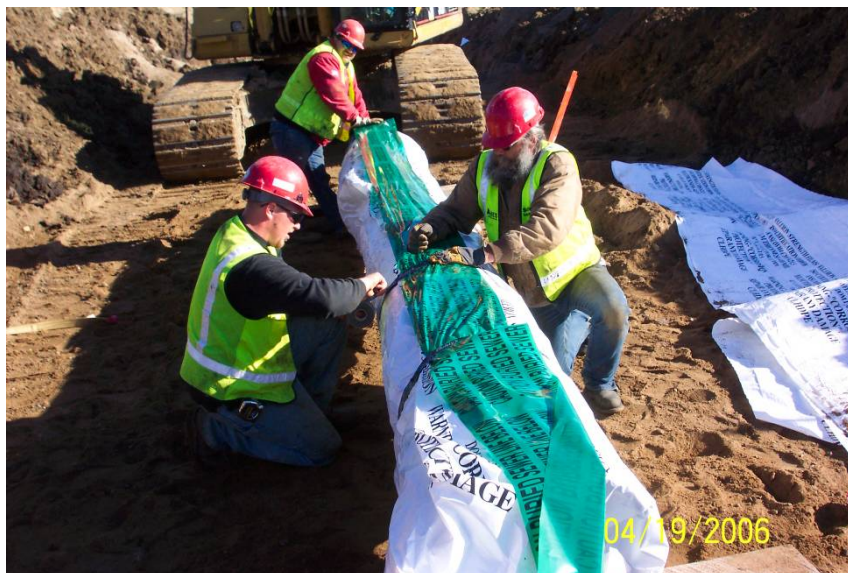
Figure 45
Folding Over of 4-mil Outer Wrap of High-Density Cross-Laminated Polyethylene Encasement and Taping In Place With Identification Tape

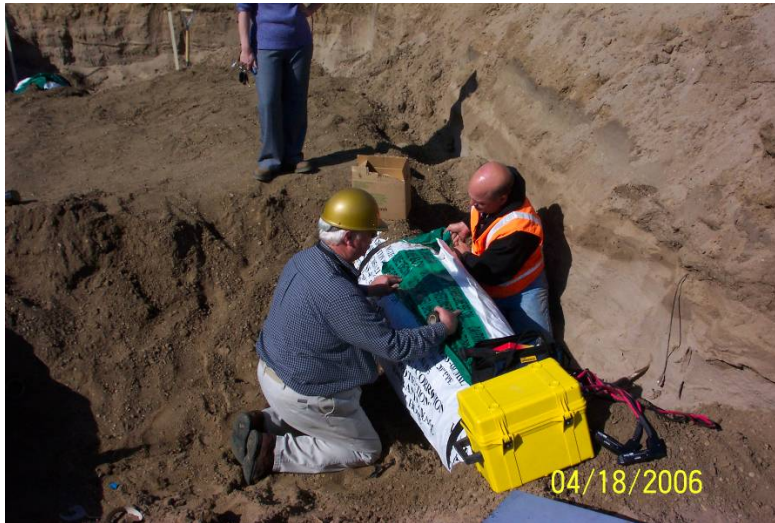
Figure 46
Joint Bonded and Polyethylene Encasement Overlap at Joint

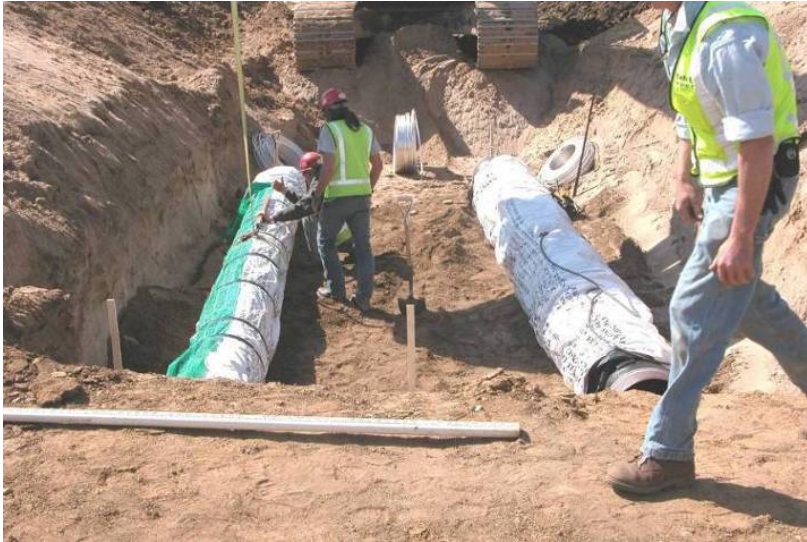
Figure 47
Polyethylene-encased Ductile Iron Ribbon Anode Cathodic Protection System

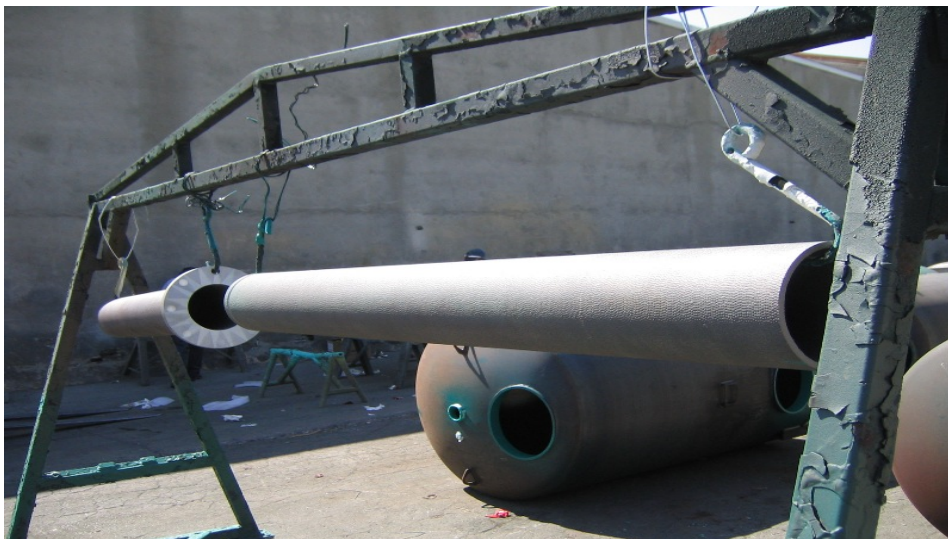
Figure 48
Successful Surface Preparation of Ductile Iron Pipe

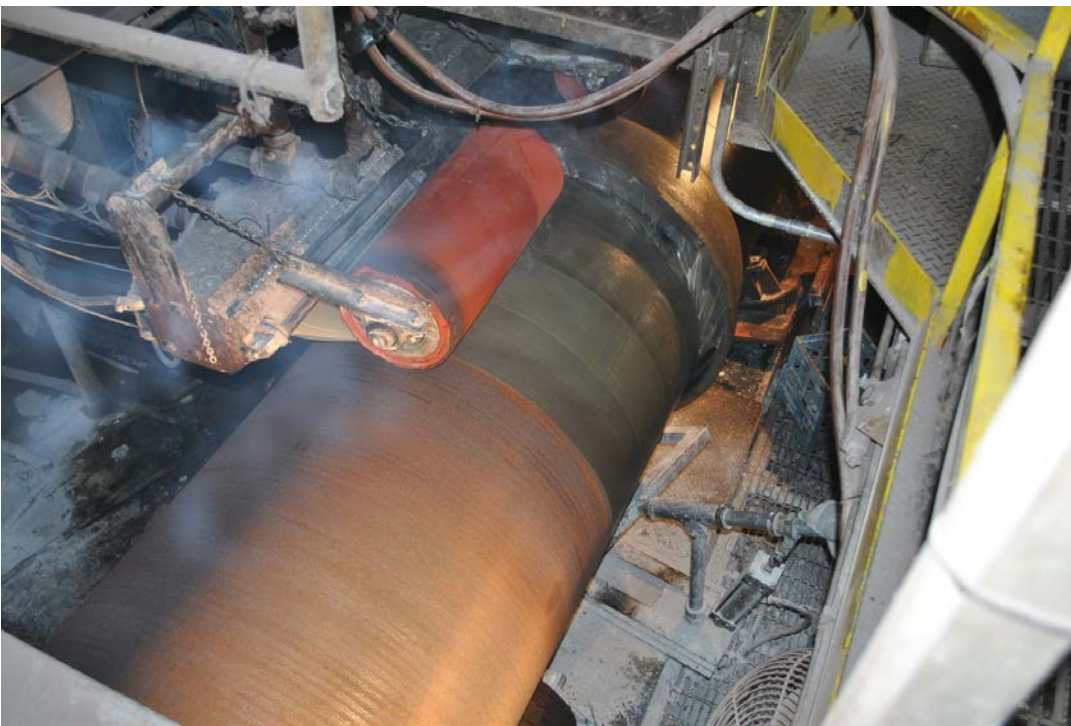
Figure 50
Extruded Polyethylene (Pritec) Ductile Iron Coating Application

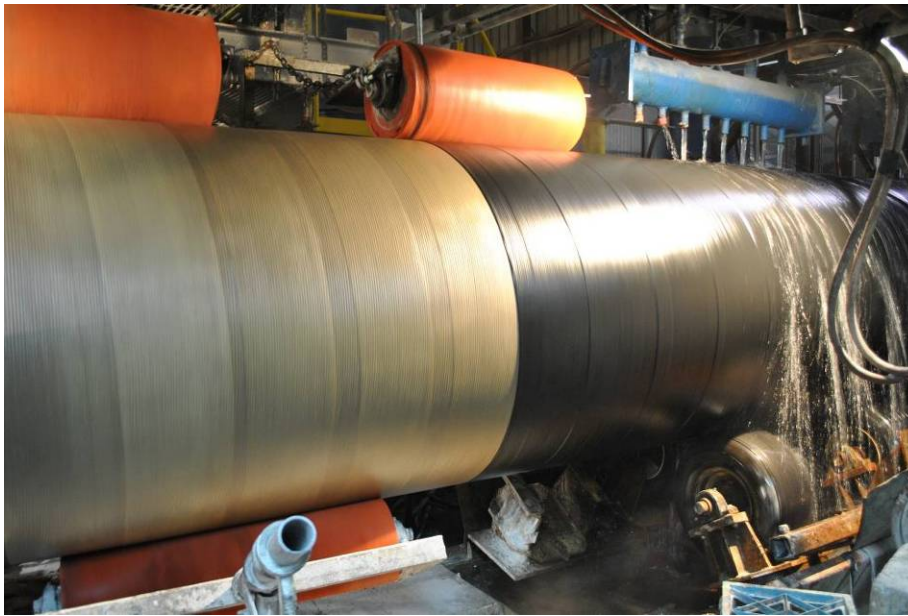
Figure 51
External Polyethylene Ductile Iron Coating Internal and External Coating with Water Quench
