NACE International
57th Annual
Appalachian Underground Corrosion Short Course
May 15, 2012
Morgantown, West Virginia

**CORROSION CONTROL CONSIDERATIONS FOR
DUCTILE IRON PIPE – A CONSULTANT’S PERSPECTIVE**

William S. Spickelmire
RUSTNOT Corrosion Control Services, Inc.
325 Chester Drive
Boise, Idaho 83706
208-384-9752
bspickelmire@rustnotconsulting.com

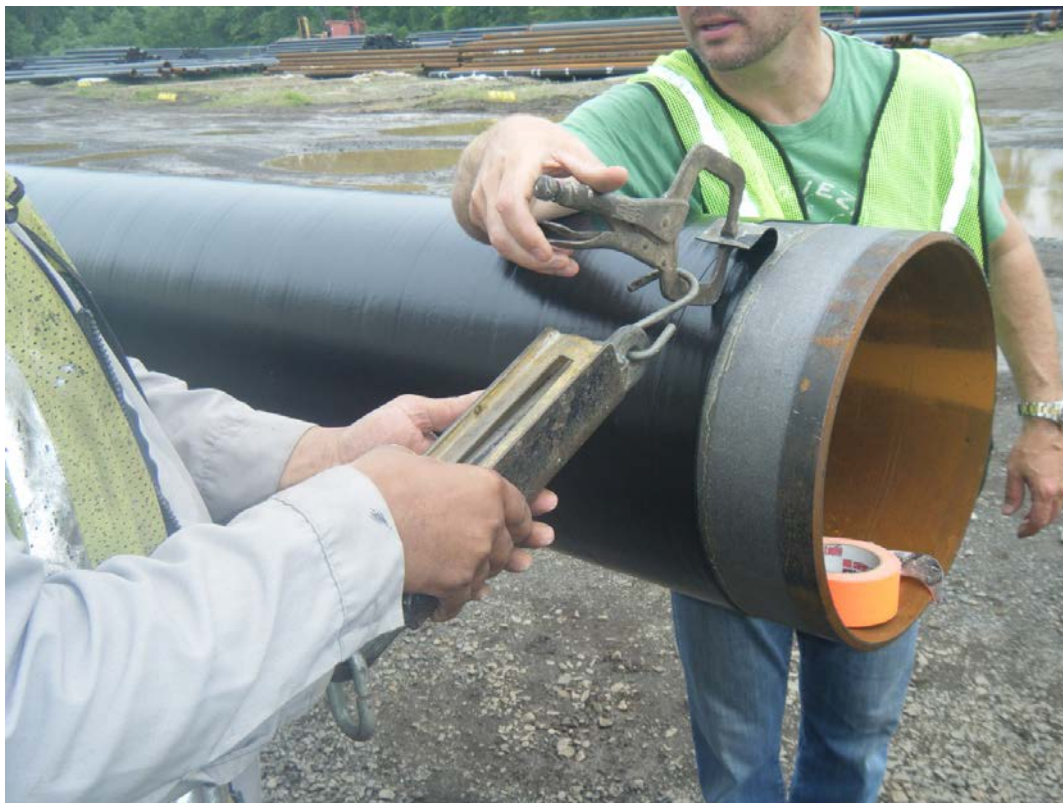
Figure 52
Adhesion Testing of Extruded Polyethylene Coating at Ductile Iron End Cut Back

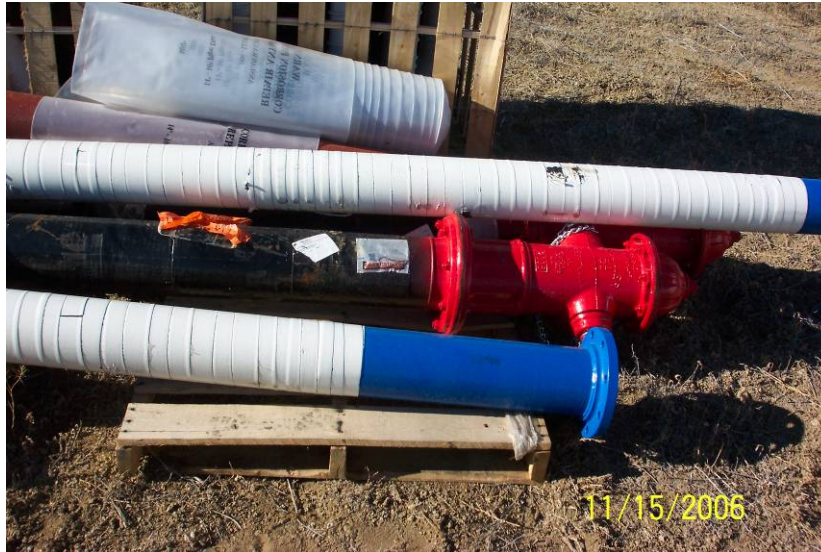
Figure 54
2006 Hand Taping of Ductile Iron Stub Pieces with FBE Fittings

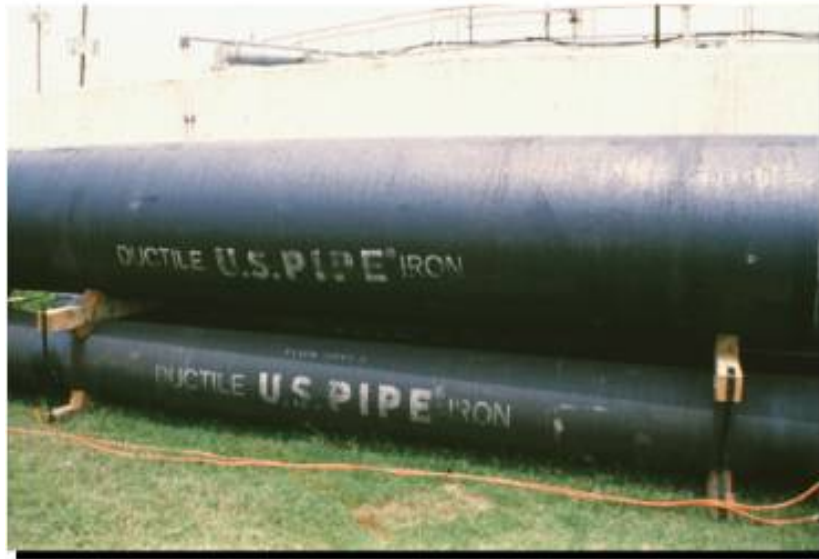
Figure 55
Polyurethane-Coated Ductile Iron Pipe

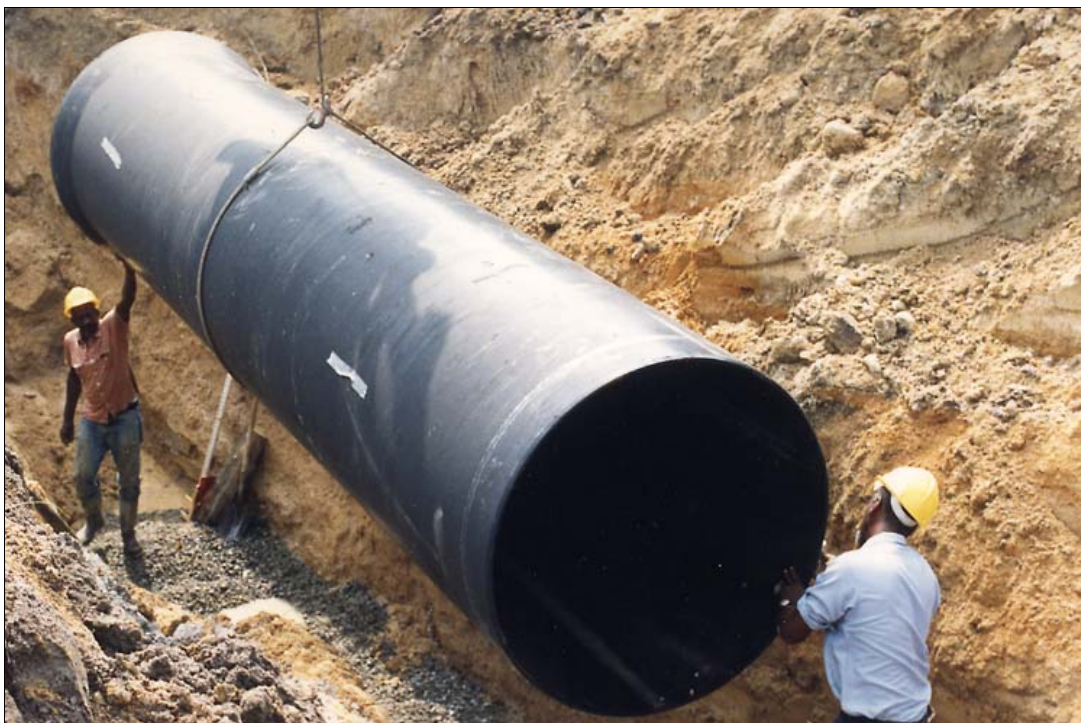
Figure 56
San Diego Polyurethane and Lined Wastewater Force Main

San Diego and numerous other utilities have reported good success with the use of polyurethane coatings and linings.

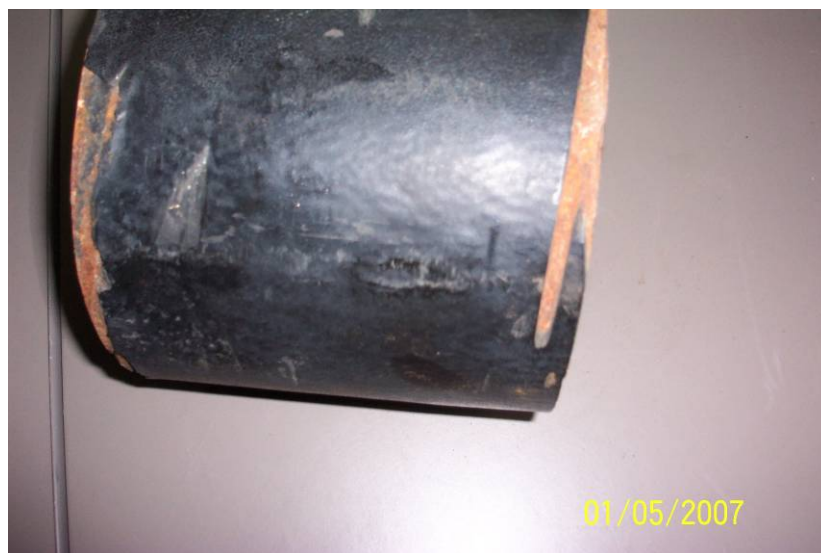
Figure 57
2003 Polyurethane-Coated Ductile Iron Stub Pipe

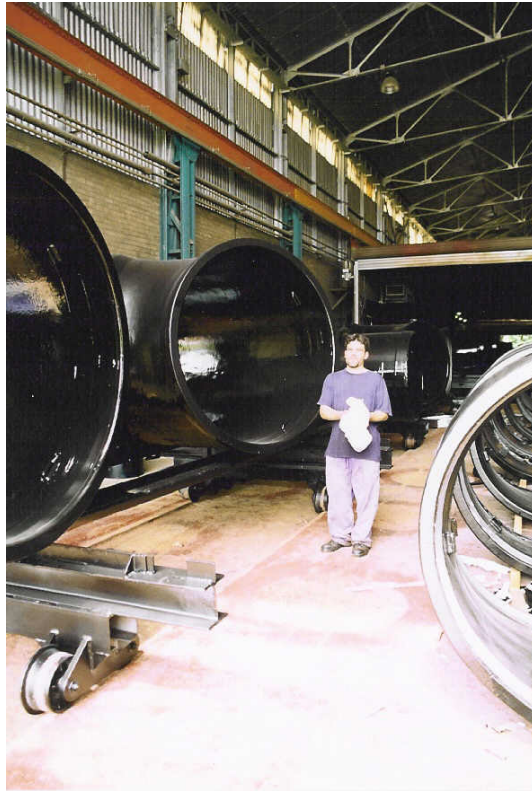
Figure 58
European Polyurethane Coated and Lined Ductile Iron Pipe

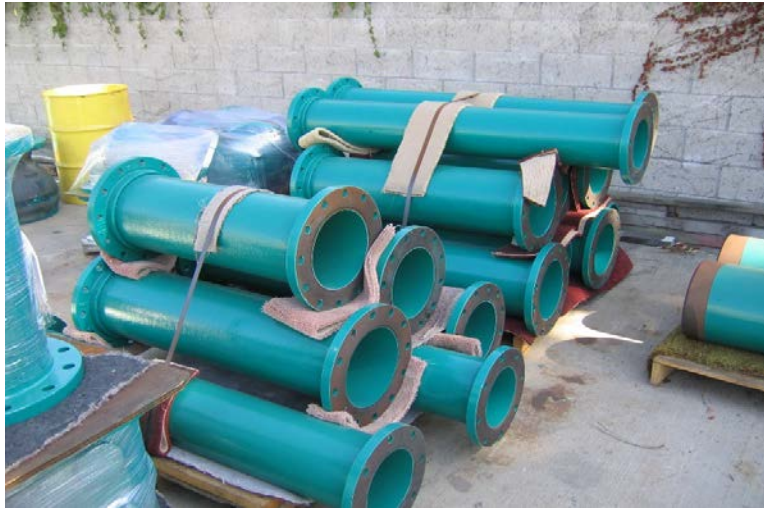
Figure 59
Fusion-Bonded Coated and Lined Ductile Iron Pipe and Fittings

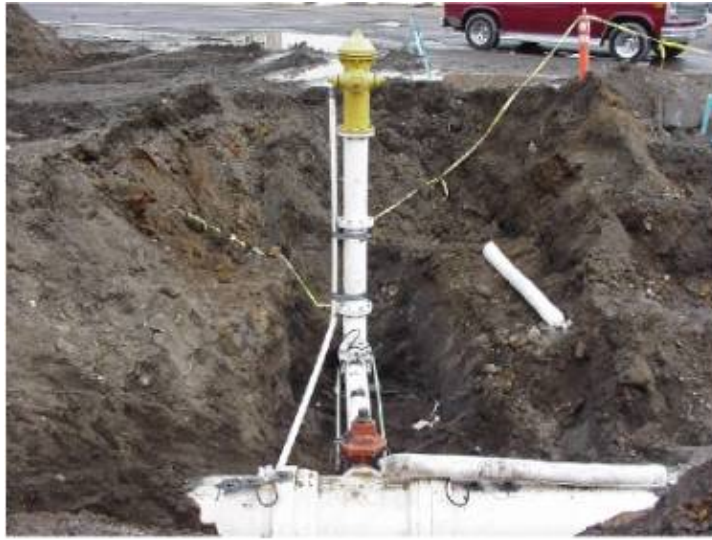
Figure 60
Seattle Thermoplastic Coated Cathodic Protected Ductile Iron Pipe With Fusion-Bonded Coated Fittings

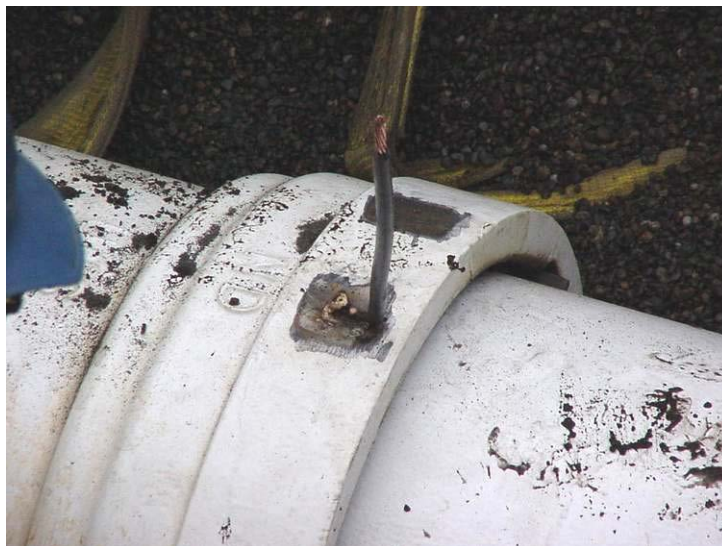
Figure 61
2000 Seattle Thermoplastic Pipe Coating Allows Engagement of Spigot Directly into Bell

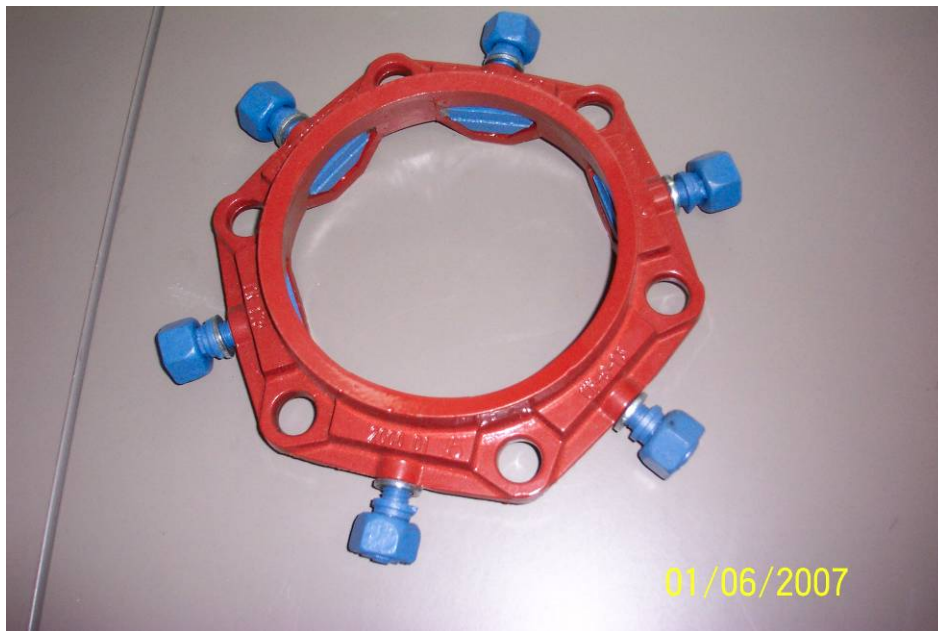
Figure 62
Tight-bonded Coated Restraints Now Available

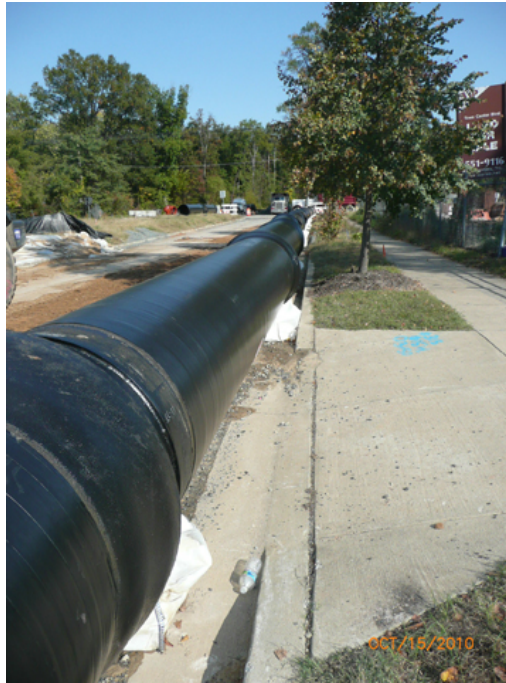
Figure 63
Tight-Bonded Ductile Iron Pipe Project October 2010 East Coast

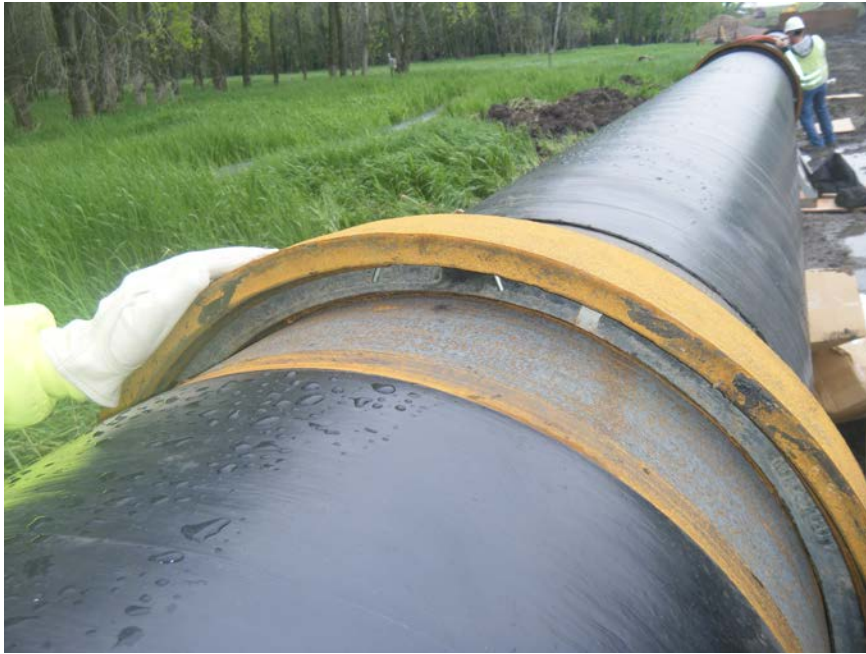
Figure 64
Tight-Bonded Coated Internally Restrained Ductile Iron Bore Pipe 2011

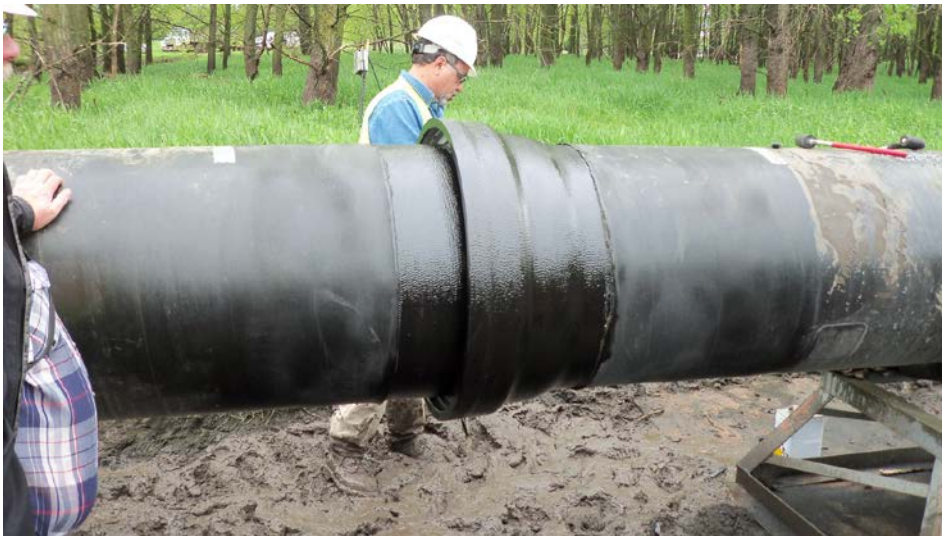
Figure 65
Heat Cured Epoxy Primed Ductile Iron Joint

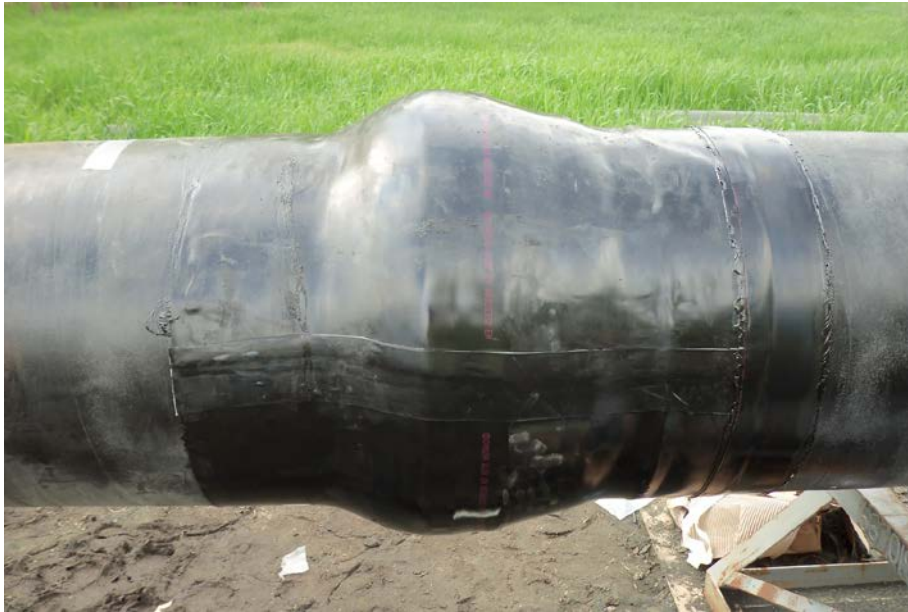
Figure 66
High Recovery Heat Shrink Bore Kit Sleeve

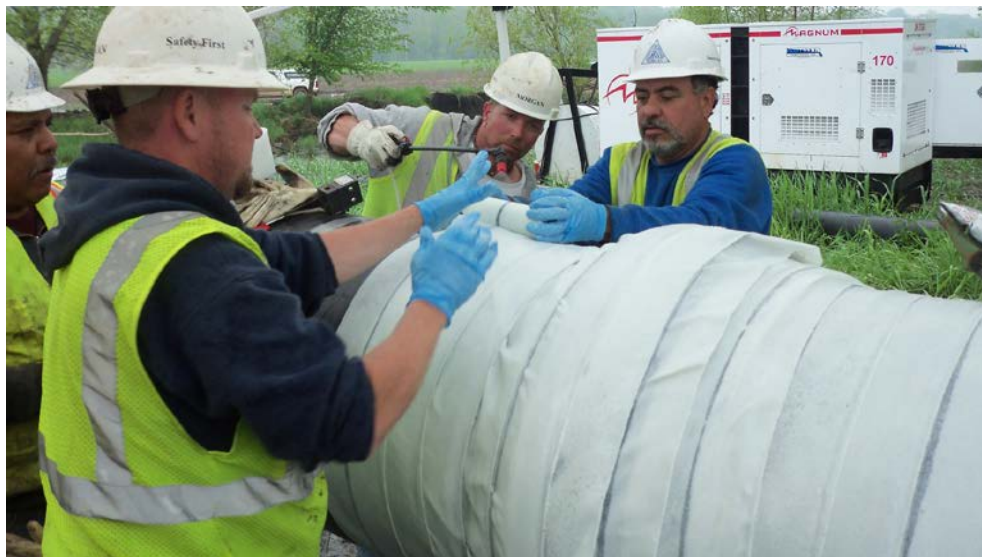
Figure 67
Water Activated Glass Impregnated Protective Sleeve at 50% Overlap 6 to 8 Layers

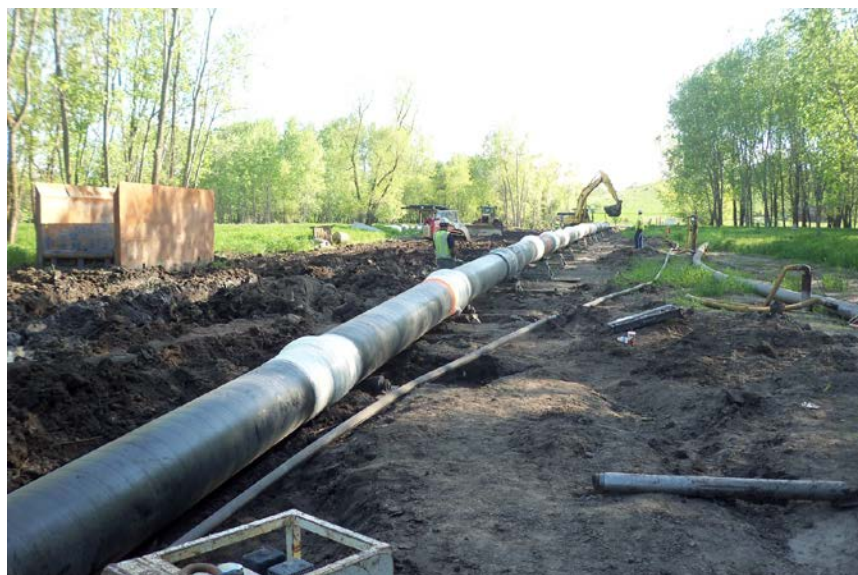
Figure 68
Tight-Bonded Coated Ductile Iron Bore Pipe Ready to be Pulled Under River
