## Cathodic Protection for AST's

*Presented by:*  
**James T. Lary**  
**Corrpro Companies, inc.**  
**1055 West Smith Road**  
**Medina, Ohio 44256**  
**[jlary@corrpro.com](mailto:jlary@corrpro.com)**  
**330-241-6615**

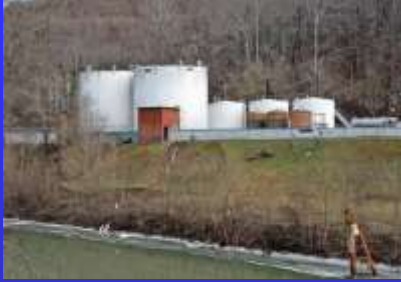
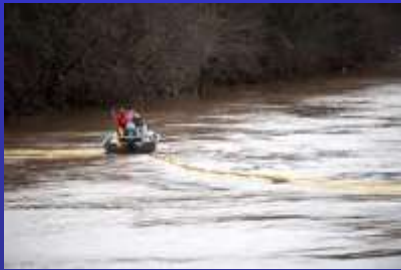
# Charleston, WV Spill

The investigation found that two small holes ranging in size from about 0.4-inch to 0.75-inch in the bottom of the 48,000-gallon tank 396 were caused by corrosion, likely resulting from water leaking through holes in the roof and settling on the tank floor. Furthermore, the CSB inspection found a similar hole penetrating the bottom of nearby tank 397, containing the same chemical at the facility, located in Charleston. Other tanks also showed multiple signs of pitting and metallurgical damage, investigators said. The growing corrosion in these tanks went unnoticed until the bottom of 396 was breached and up to an estimated 10,000 gallons of product made their way through the underlying mixture of soil and gravel under the facility and into the Elk River on January 9, 2014.

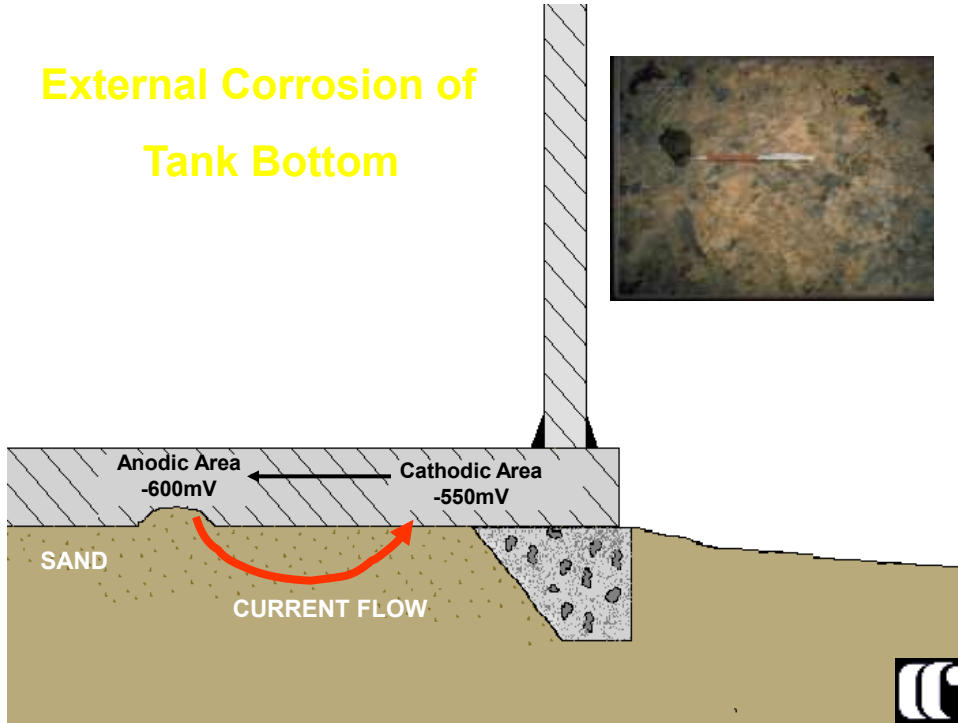
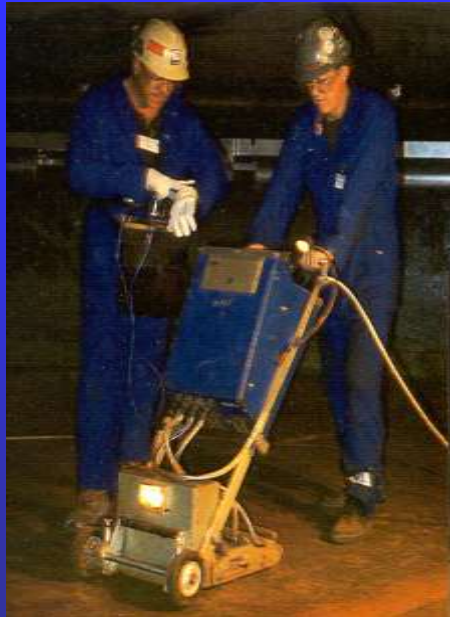
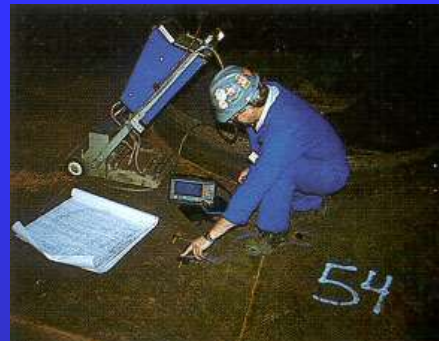
## External Corrosion of Tank Bottom

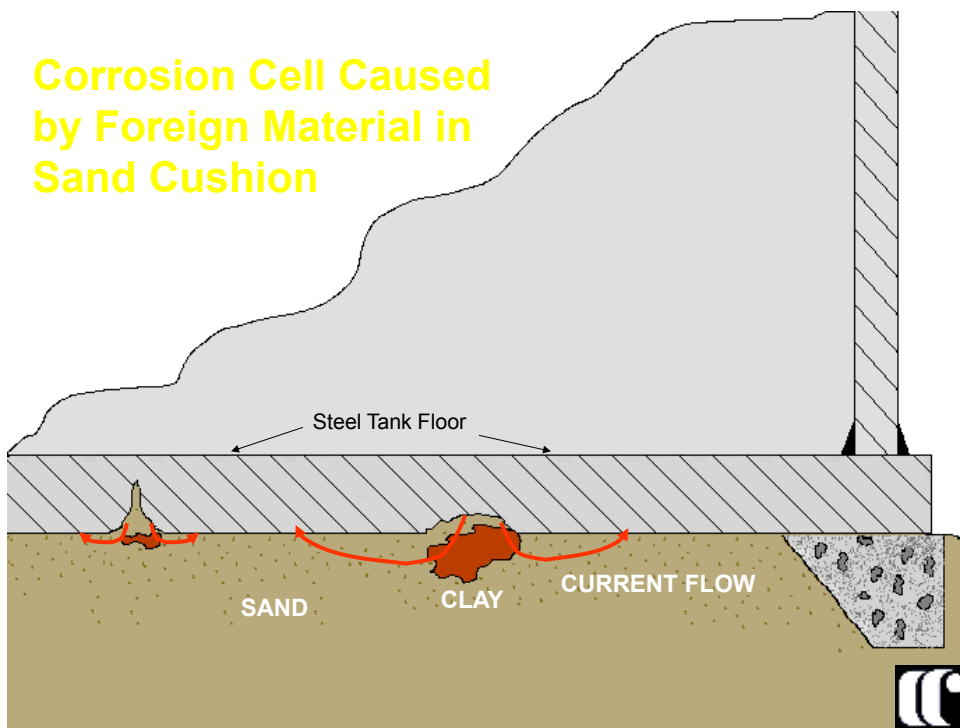
## Corrosion Cell Caused by Foreign Material in Sand Cushion

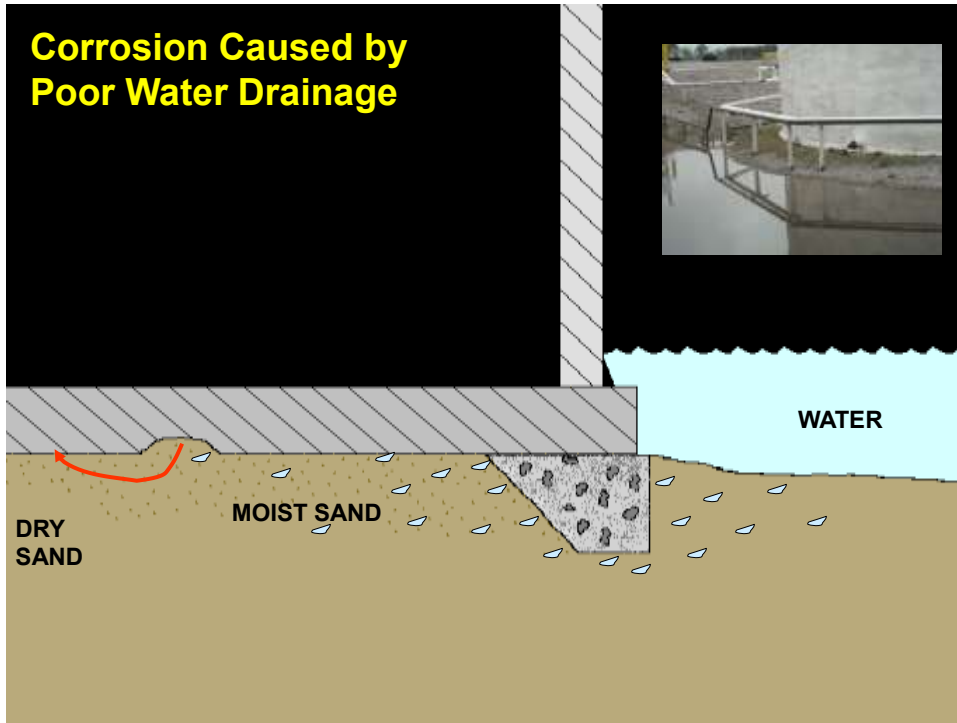
## Corrosion Caused by Poor Water Drainage

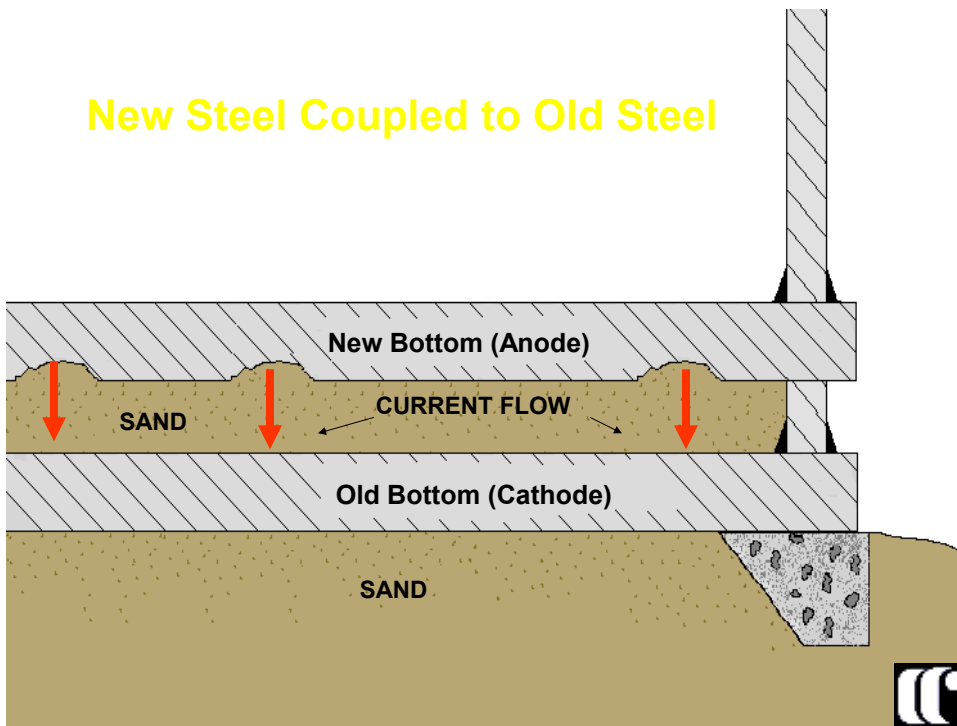
## New Steel Coupled to Old Steel

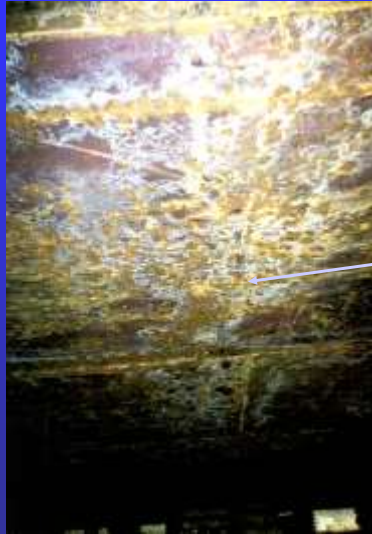
## Concrete Slab

Leak detection groove  
under under bottom

Tank bottom required  
30% floor  
replacement  
after 5 years in  
service

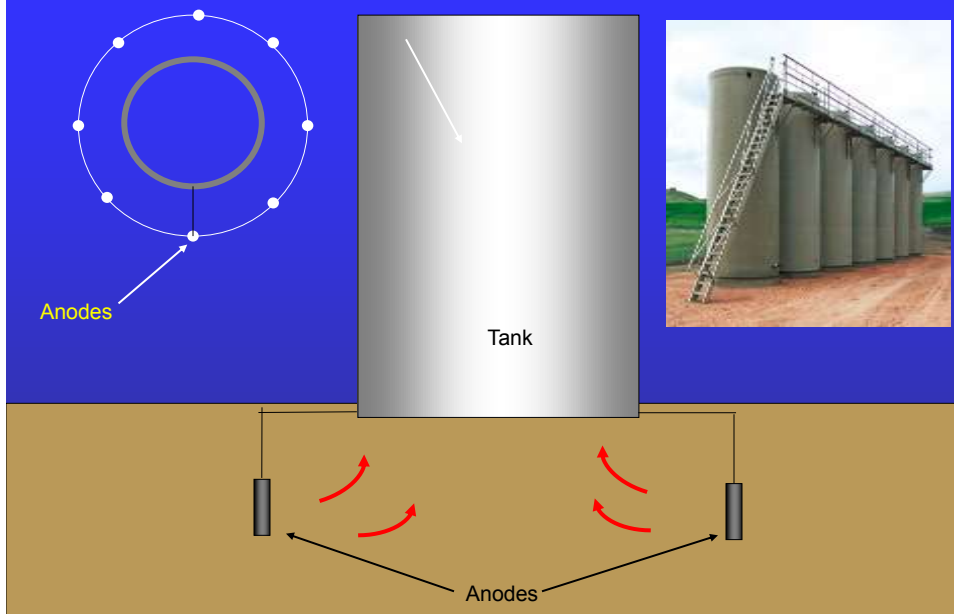
## Above Ground Storage Tank With Galvanic Anodes

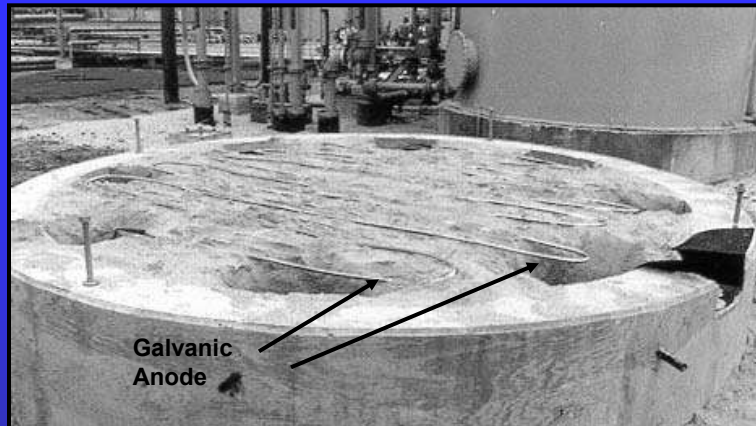
**Galvanic Anode Installation on AST. Note that anode life and current output are dependent upon sand / backfill conditions. Reference cells were rarely installed to monitor performance.**

**(Many galvanic systems installed by tank contractor)**

- With the advent of secondary containment liners for AST's, some oil companies initially installed galvanic (zinc or magnesium) anode cathodic protection systems. Many of these same companies have now abandoned this approach due to the inability to obtain effective levels of cathodic protection or limited system design life.
- The industry preference for cathodic protection for large AST's is now impressed current.

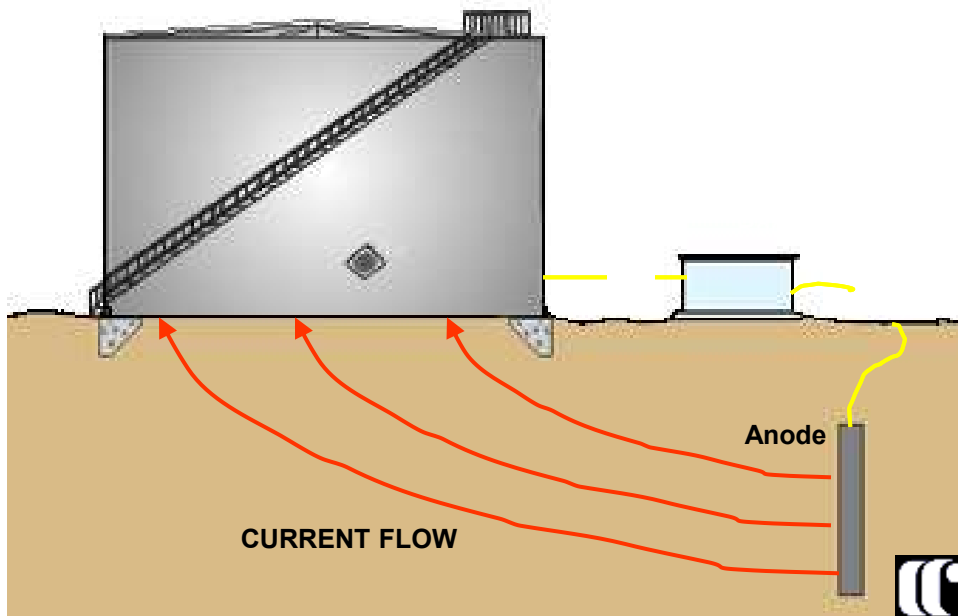
## Impressed Current Cathodic Protection

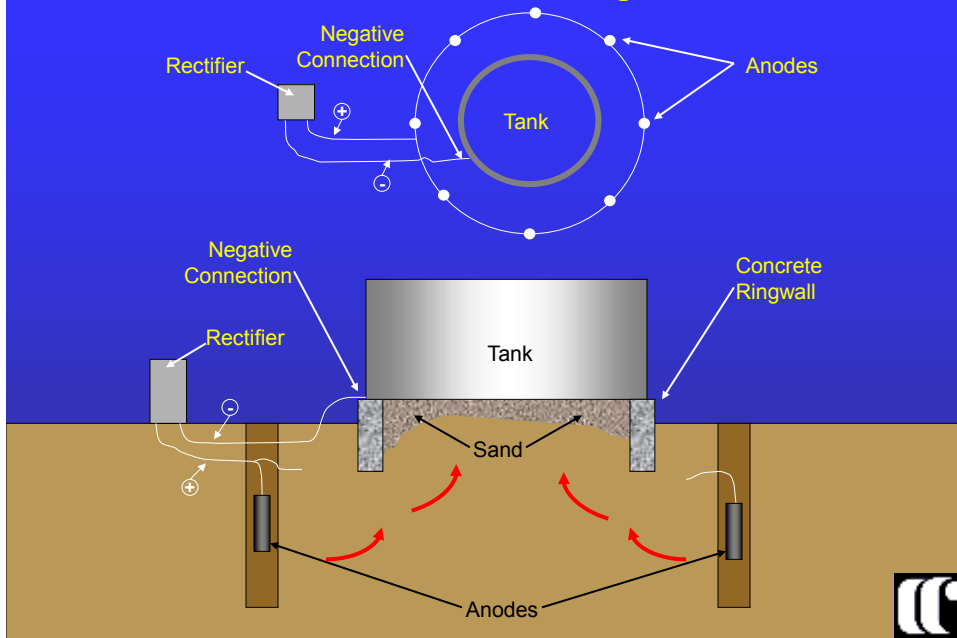
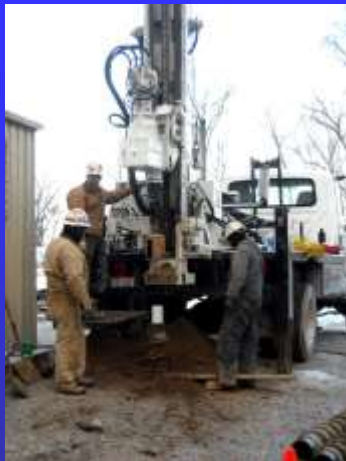
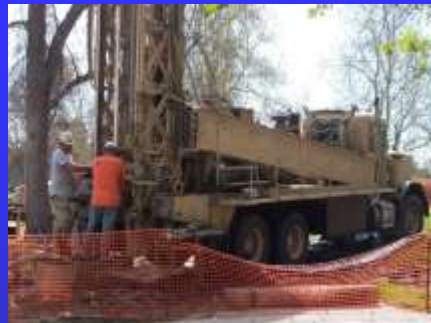
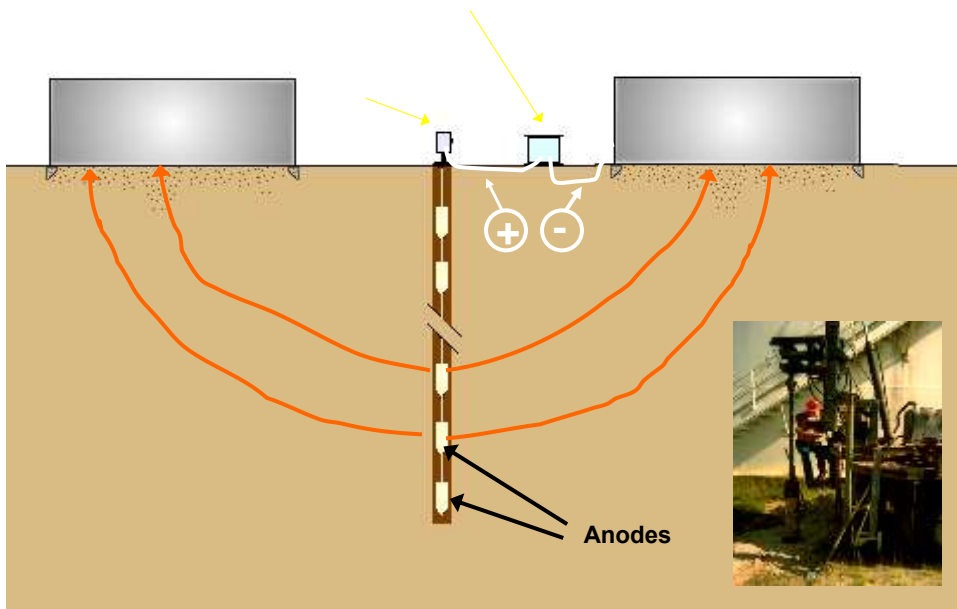
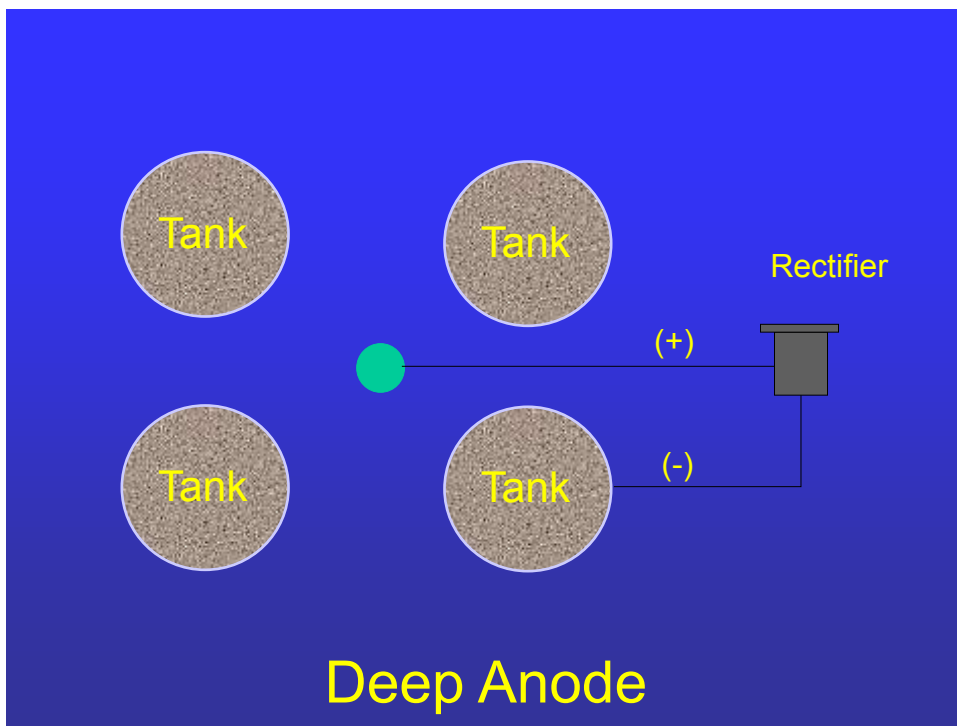
## Above Ground Storage Tank Vertical Impressed Current Anodes - Existing Tanks

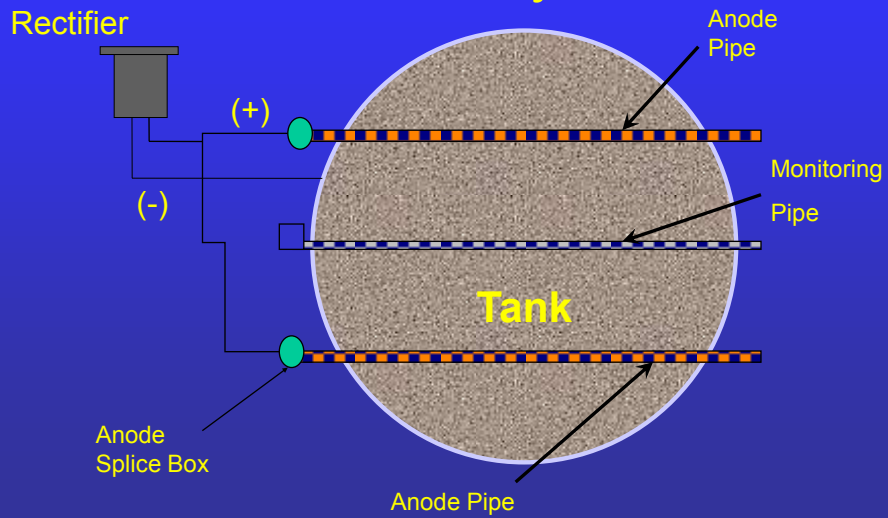
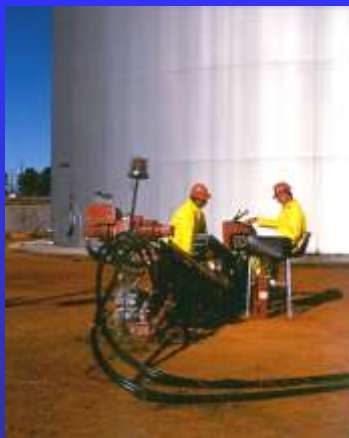
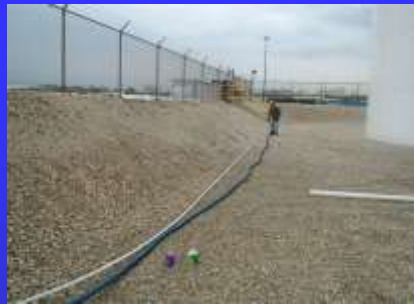
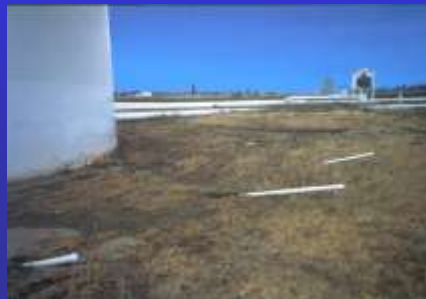
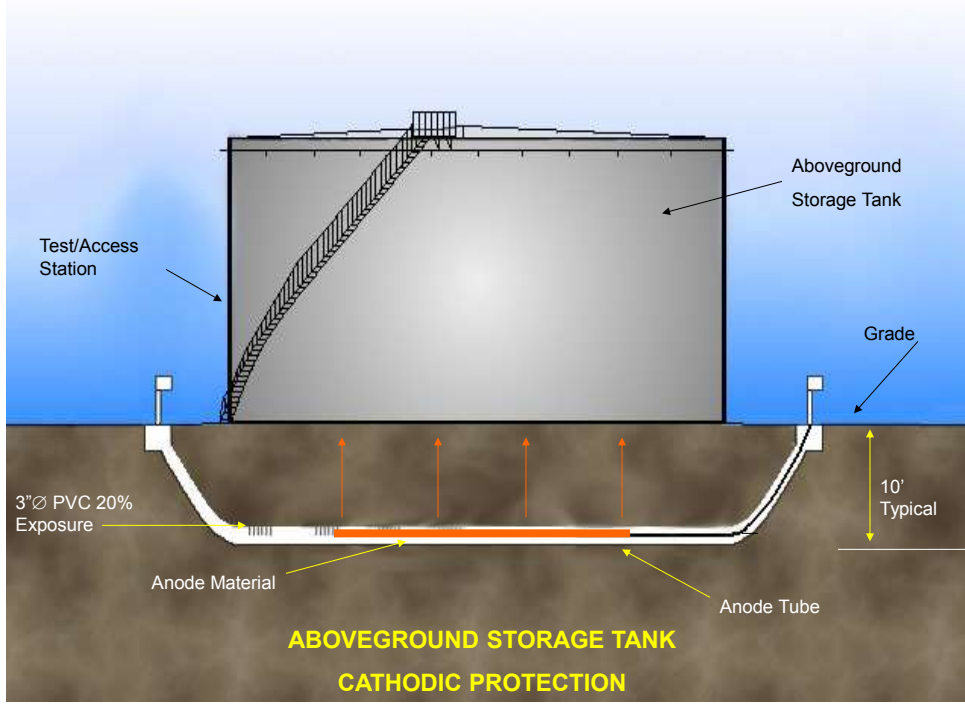
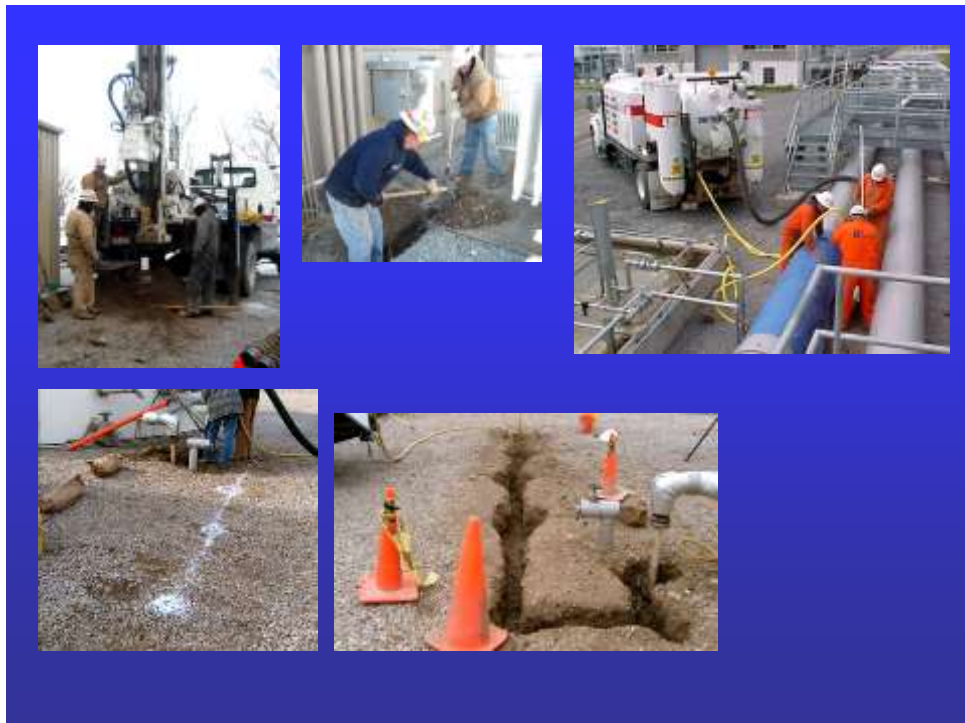
# Computer Guided Horizontally Bored Anode System

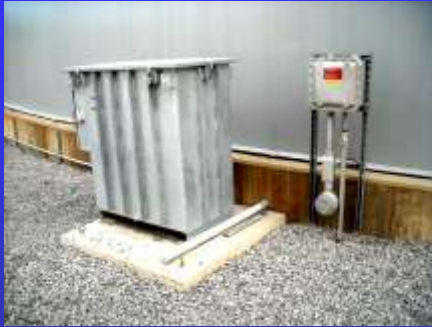
## *Rectifier Units*

Explosion or Non Explosion Proof ?  
AC Input ?  
AC Availability ?

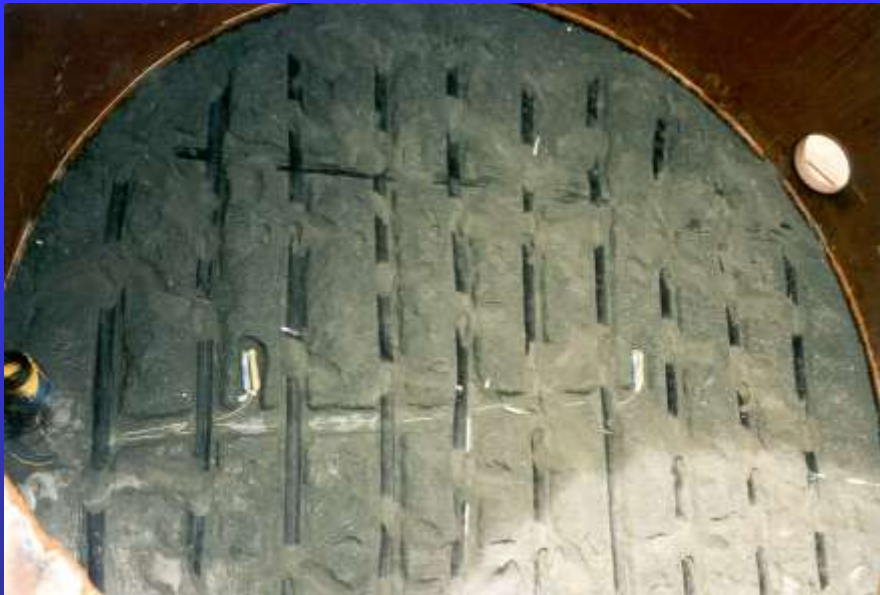
**CP Installation on Rebottomed Tank**

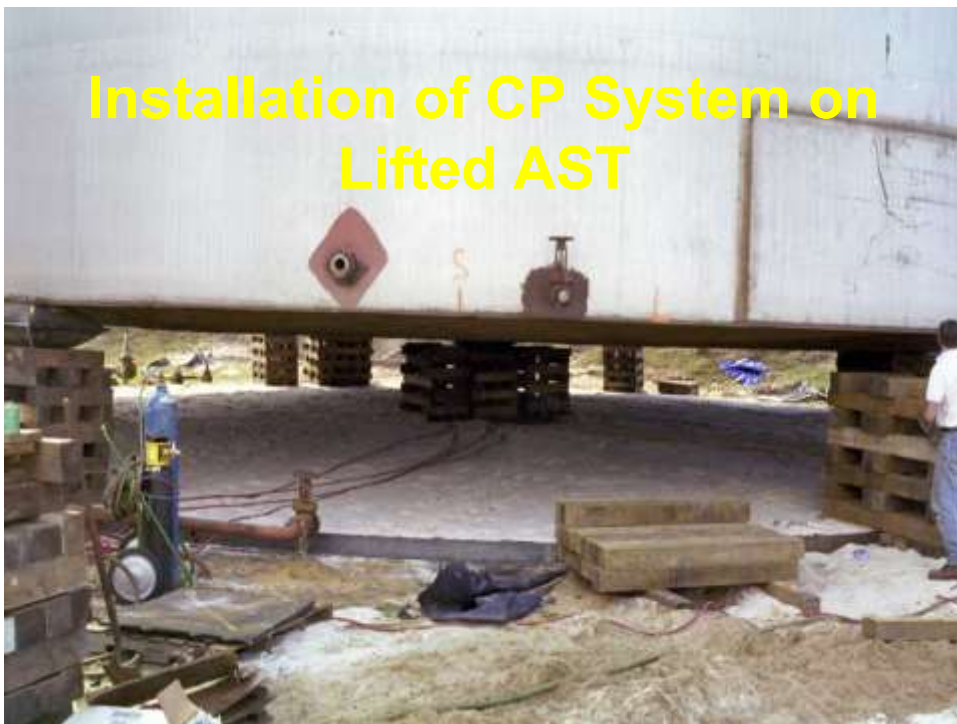
## Installation of CP System on Lifted AST

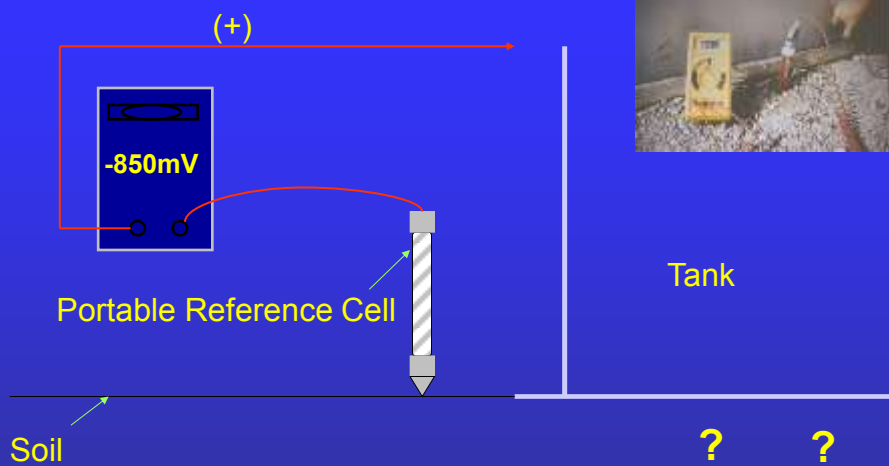
**Cathodic Protection Survey (When Tank is Full)**

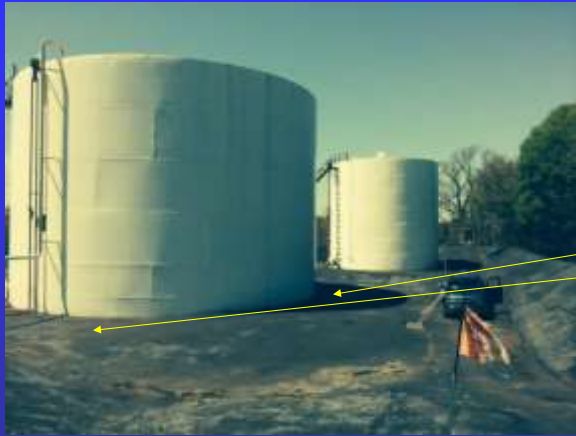
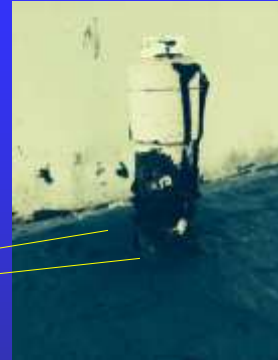
**Rim Potential Measurements**

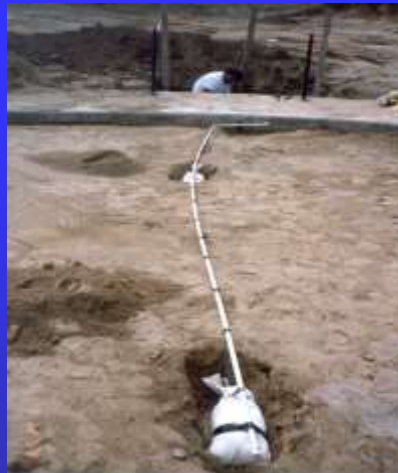
**Soil Access Station (Thru Liner or Asphalt)**

**Reference Cell Placement Under Tank Bottom  
(Note obtain and store native readings)**

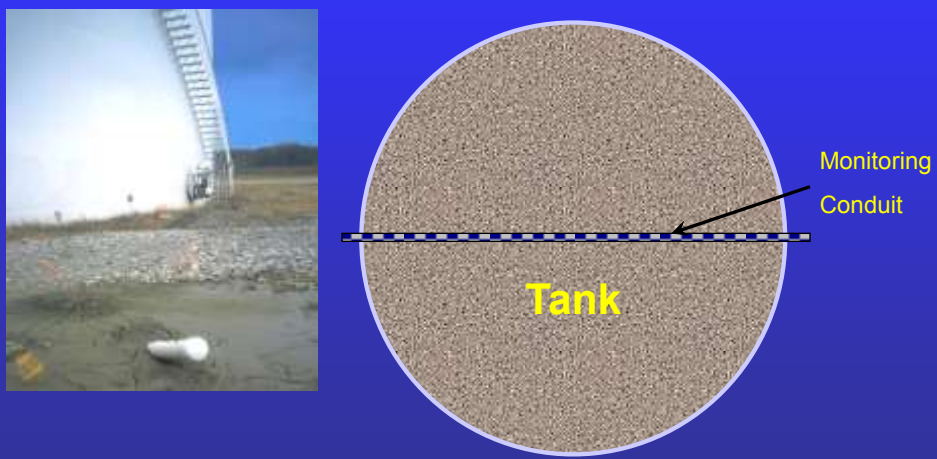
## Reference Cell Monitoring Conduit

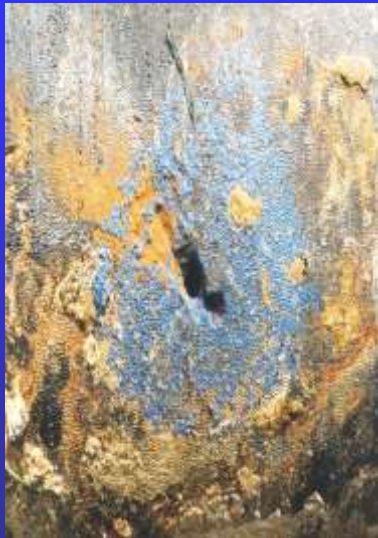
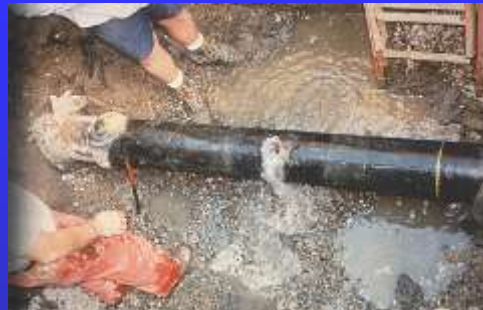
Pitting (concentrated) corrosion attack on ductile iron pipe.
