Pipeline Coating Failures

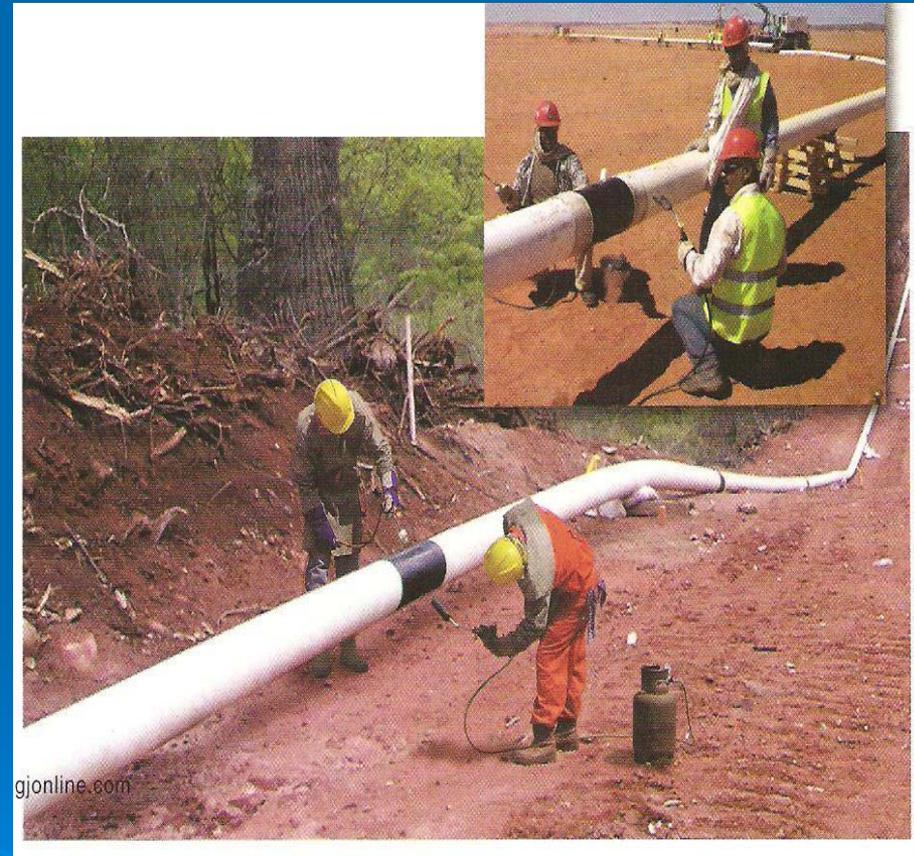
Construction (HSS)

18 in Oil Pipeline

- 3 layer Polyethylene
- In Line Inspection (ILI)
 - Corrosion 1st 15 km
- 131F Operating Temp
- Service- 15 yrs
- Wet, compacted sand pH 5.4
- HSS
 - Hot melt type / Epoxy Primer
 - Surface Prep Power tool

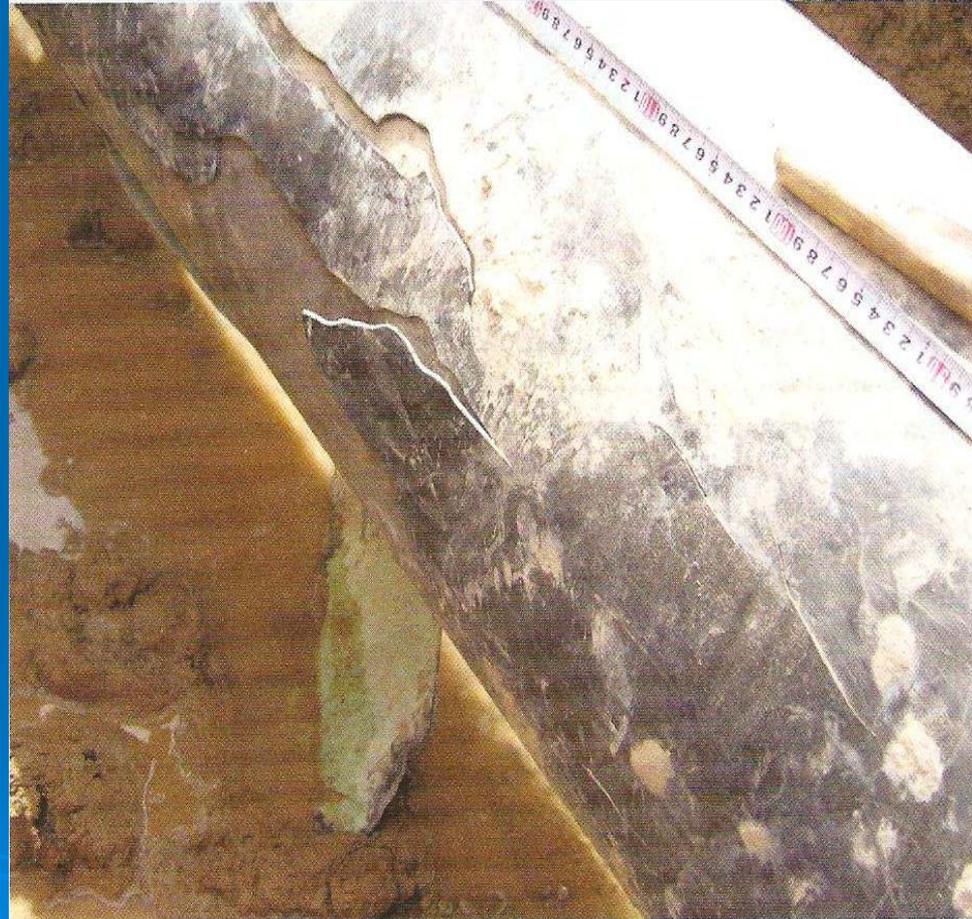
Construction (HSS)

16 in Oil Pipeline

- 3 layer Polyethylene
- In Line Inspection (ILI)
 - Severe external corrosion
 - Pitting- “Craters” at field joints
- 122F Operating Temp
- Service- 12 yrs
- Brackish w/ 2g/liter chlorides
- HSS
 - Hot melt type / Epoxy Primer
 - Surface Prep- Wire brush
 - Millscale on surface
 - Overlap 1 cm (~ 1.2 in)

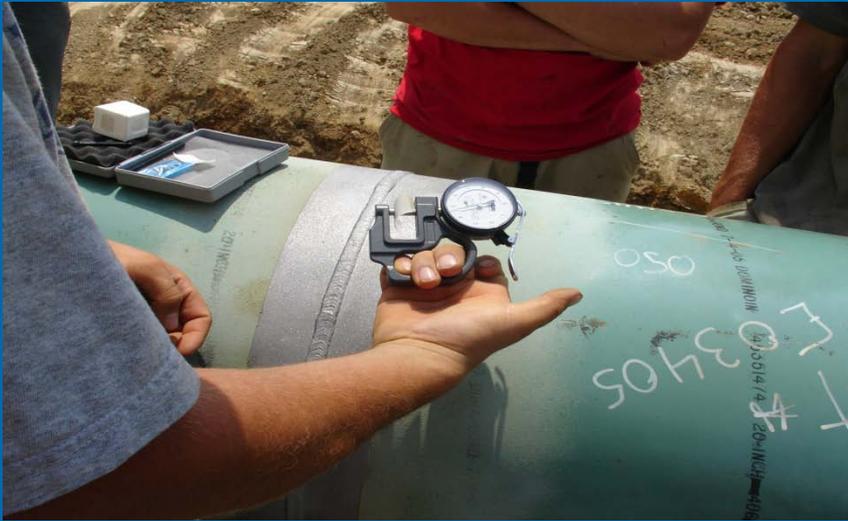
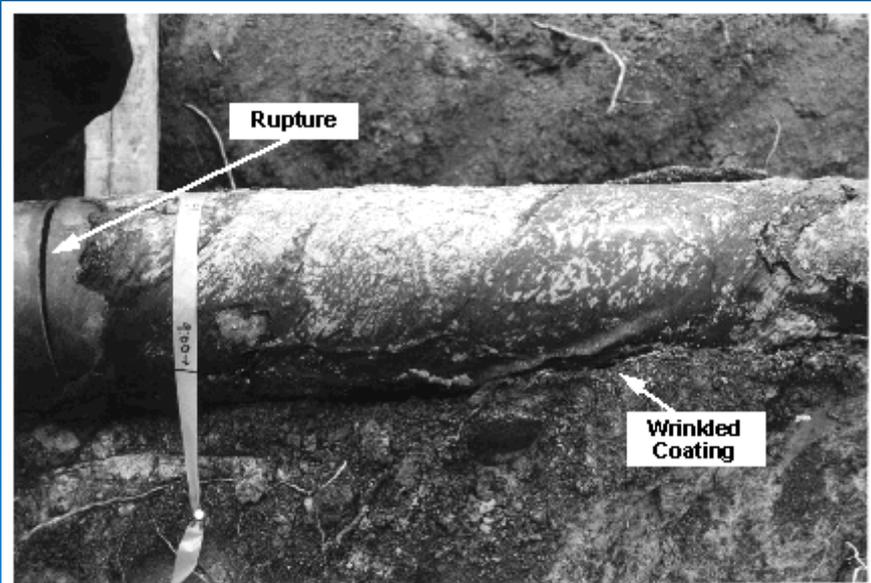
Construction (HSS)

Causes of Disbondment

- Surface preparation
 - Minimum Near white blast
- Application
 - Fish mouths
 - Overlaps
- Service Conditions
 - Operating temperature
 - Soil conditions
- UV Degradation during storage.

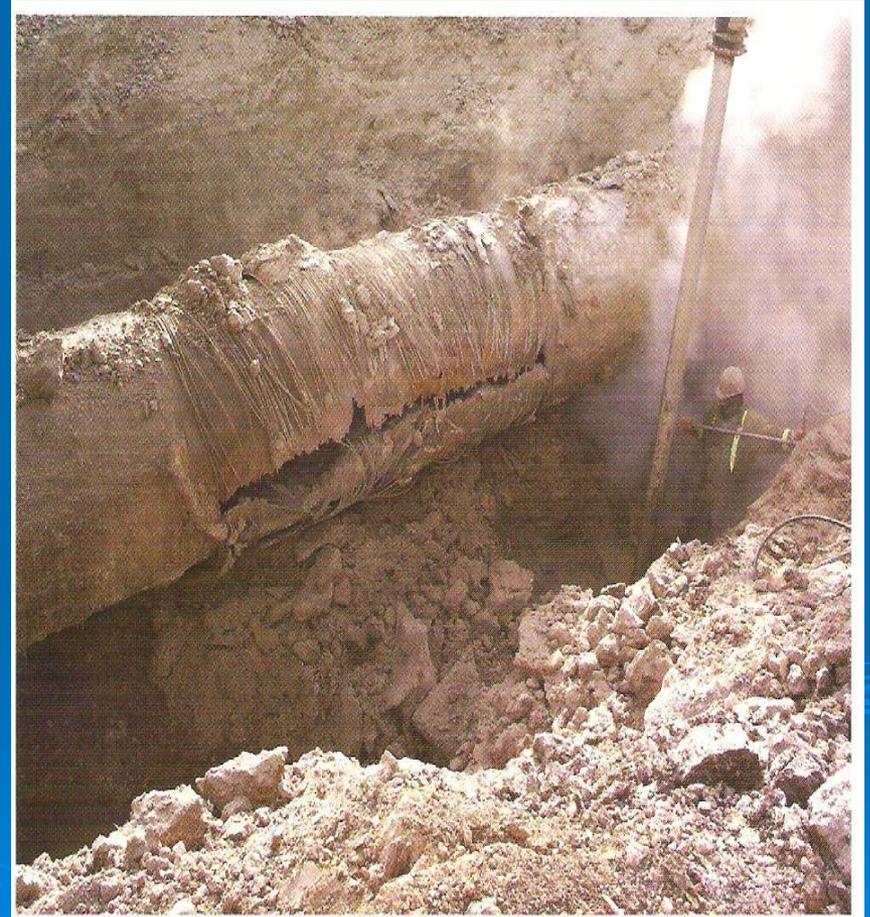
Case History

- Water main 48 in.
 - Failure location
 - 10 ft long
 - Along pipe wall
 - Concrete coating deteriorated and spalled
 - Reinforcement wires broke
 - Exposed steel substrate to soil conditions
