Pipe Coating Failures

Gregory C Hardig,
Senior Certified Coatings Inspector Cert N-3494
CPR Corrosion Protection Resources LLC

Appalachian Underground Corrosion Short Course

Pipeline Coating Failures

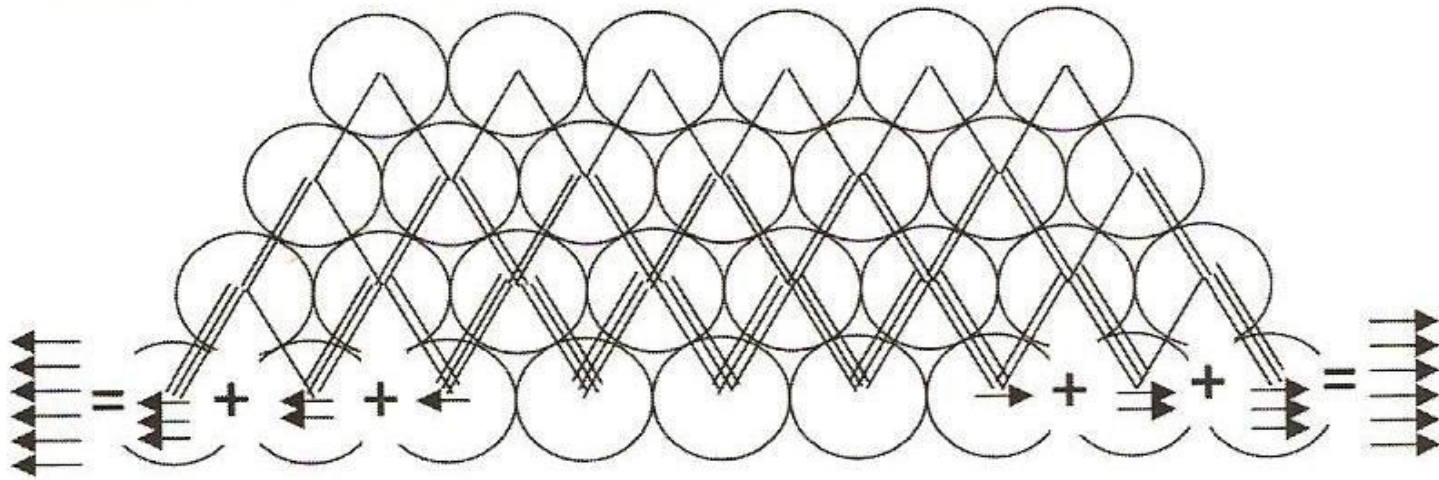
- Causes stresses on the piping.
- Deforming the diameter of the pipe.
- Stress is increased at every level

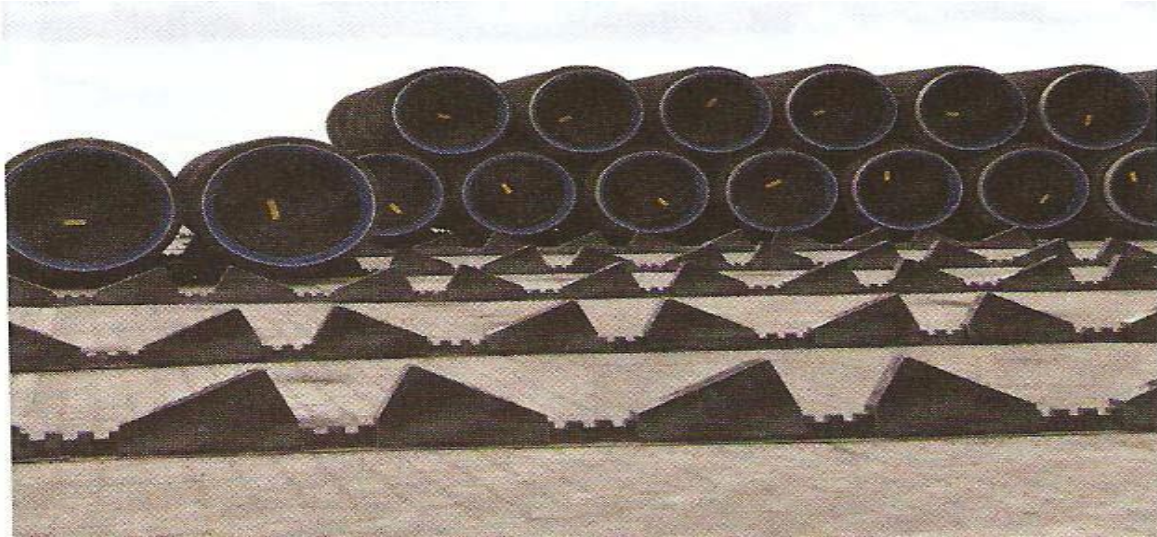
- Causes stresses on the coating.
- Stacking- Abrasion and Impact damage where the pipes touch. (3 & 9 o'clock positions)
 - Pipe stacks should be blocked to prevent rolling.

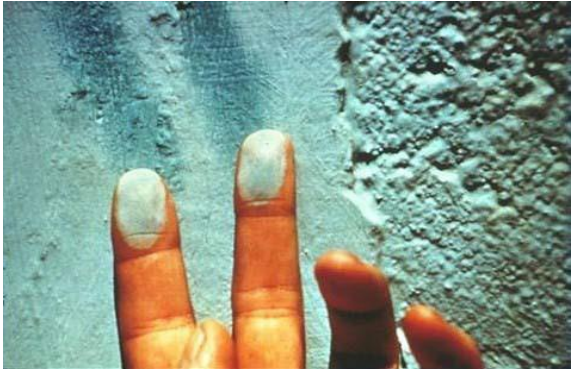
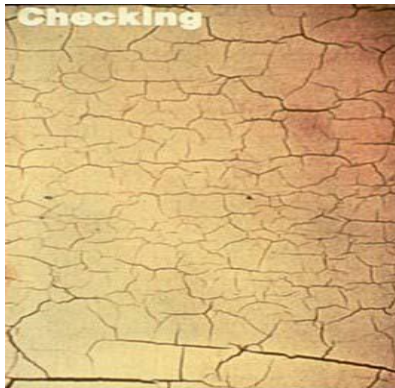
- UV Degradation
- Chalking: Deterioration of the resin / binder because of UV exposure.

Loss of plasticizers will make the coating brittle and eventually checking in the coating.

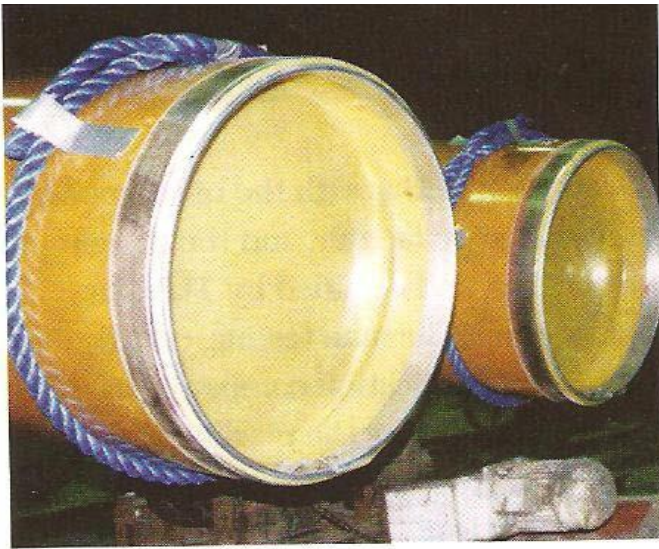
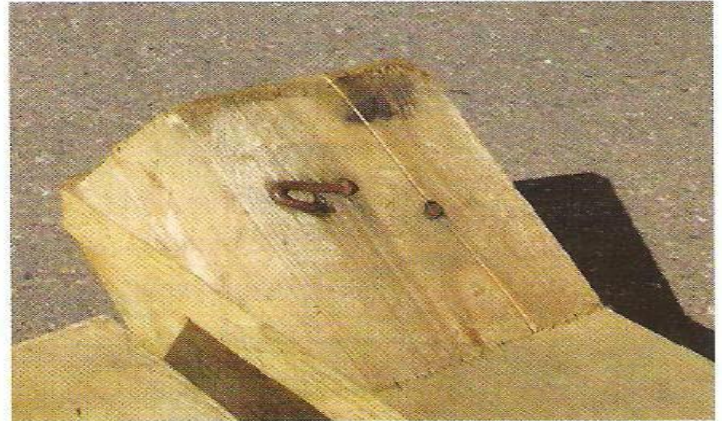
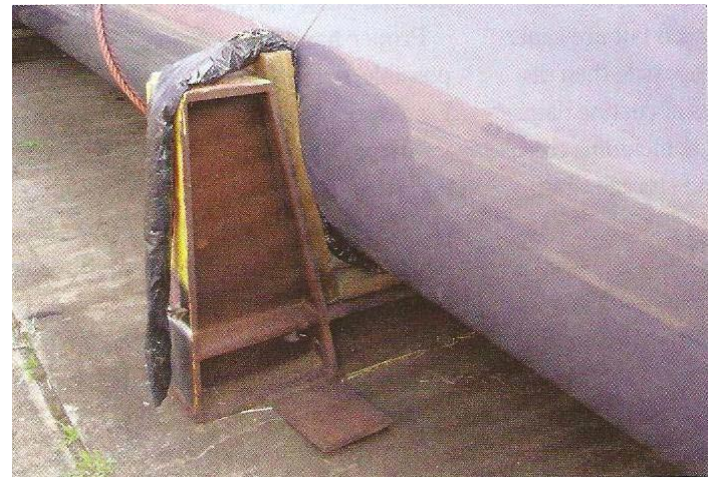
- Supports and Stops
 - Abrasion and Impact

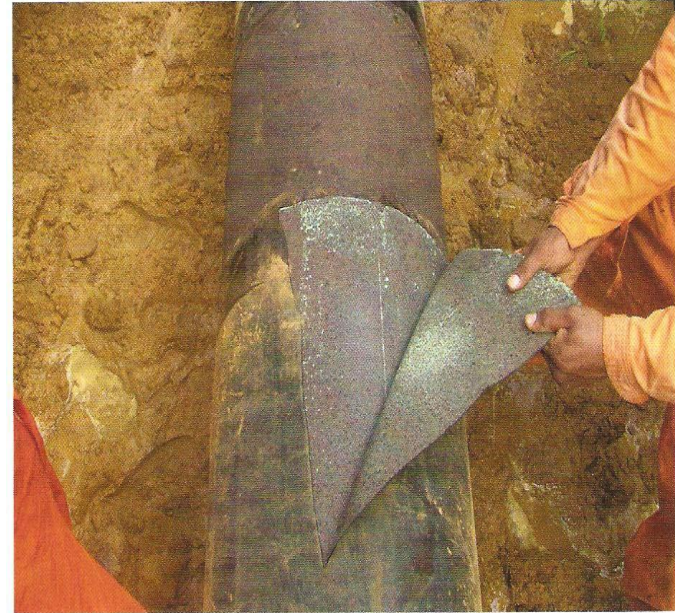
16 in Oil Pipeline

- Disbonding of HSS
 - Steel surface
 - 3LPE coating system
- Significant corrosion
 - Field joint
 - Steel surface
 - Salt crystals under HSS
- Disbondment of coating system

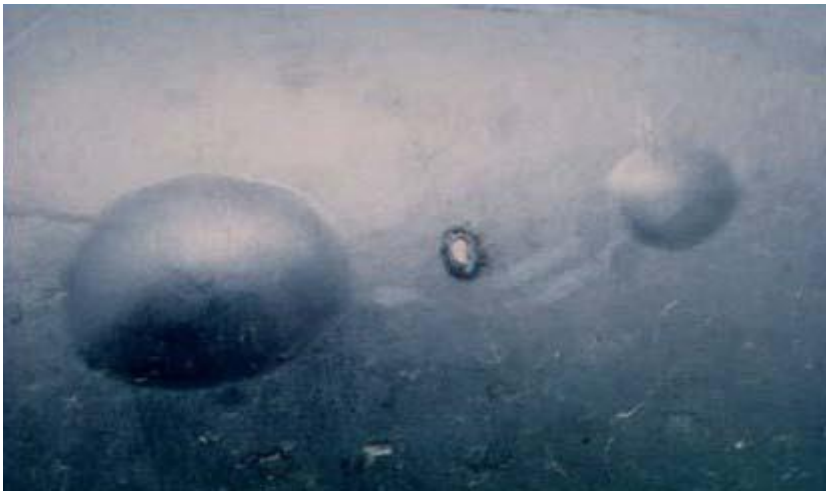
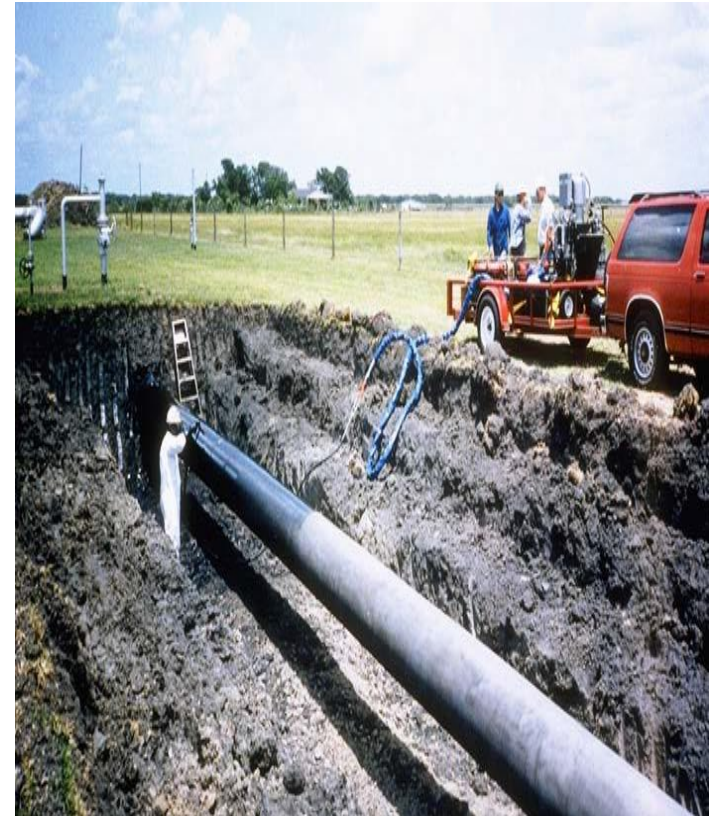
➤ Field Welds- PUR

- Liquid applied Polyurethane
- Epoxy modified
- Operating temperature 176 F

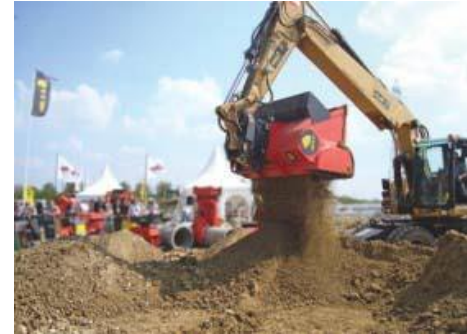
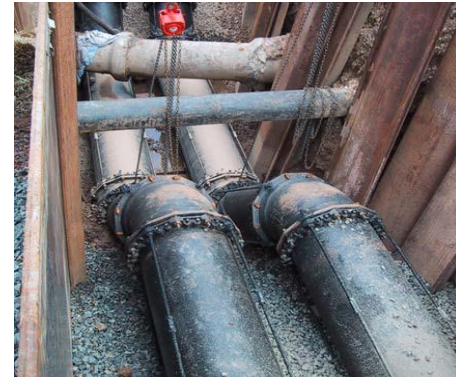
➤ Backfill Materials

- Select according to coating type
- Pipeline Research Council International Catalogue
 - No. L52208 July 2005
 - Smaller particles do less damage
 - Average 20 mm size produce the least amount of holidays

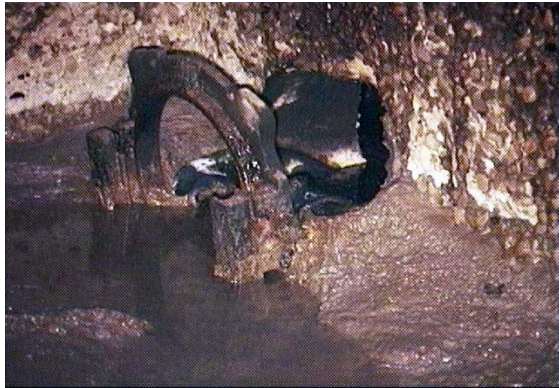
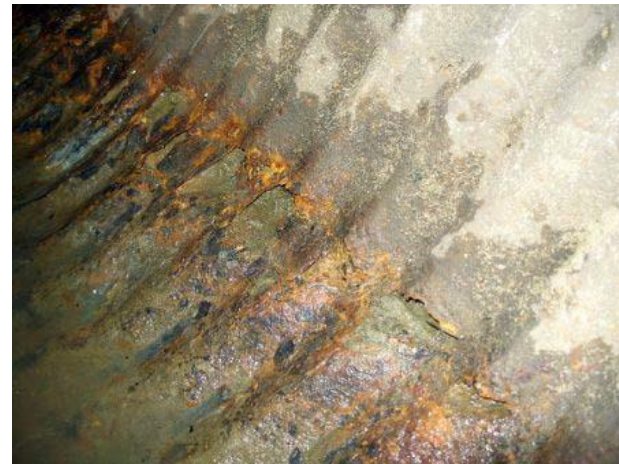
- Hydrogen Sulfide H_2S
 - Concrete and steel deterioration
