ENGINEERING &
TECHNICAL SERVICES, INC.

AC CORROSION ISSUES

By
Robert F. Allen

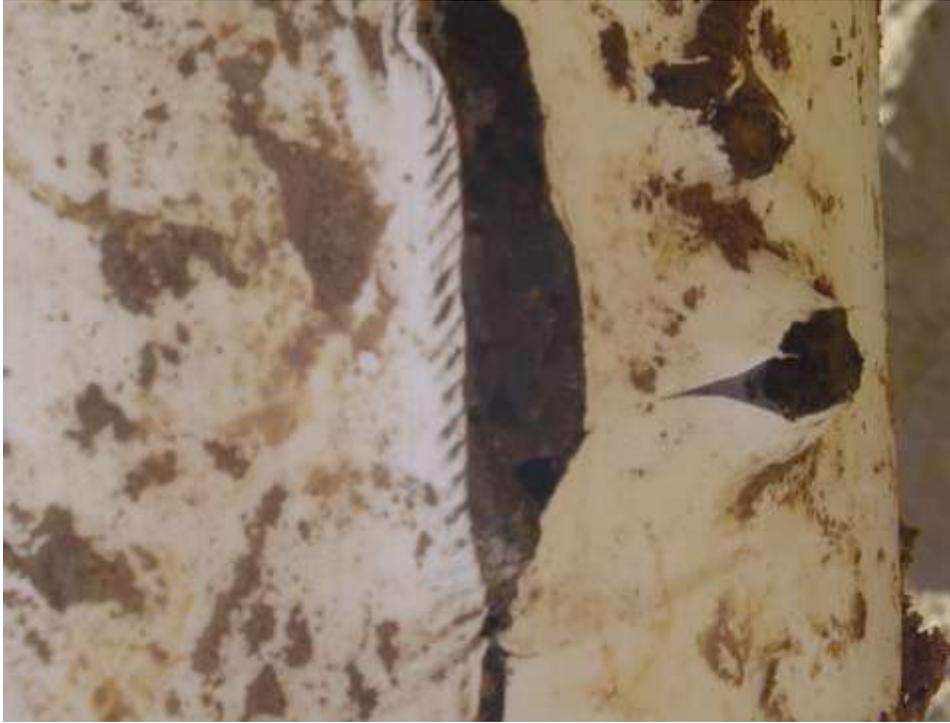
- Excavation revealed “crater-like” corrosion pits underneath corrosion product “bulges”.
- Low soil resistivity (1900 ohm-cm) was attributed to de-icing salt contamination.
- A steel rod coupon was installed and monitored for 220 days.

- The coupon had a holiday surface area of 1 cm^2
- Despite a CP current density of 1.5 to 2 A/m^2 and an “ON” potential of -1800 to $-2000 \text{ mV}_{\text{cse}}$, the coupon exhibited pitting corrosion at a rate of 210 mpy due to an AC current density which varied from 20 to 220 A/m^2

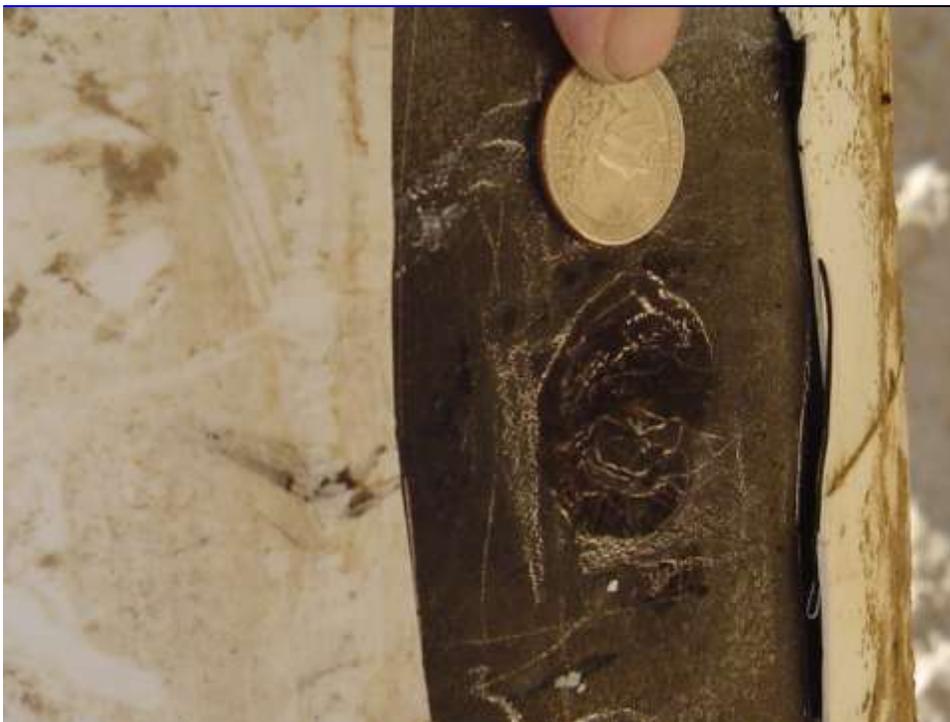
- 12" diameter, (0.25" w.t.), coated with extruded polyethylene with CP.
- 1" diameter smooth, round, dish shaped pit
- CP records indicate a well protected line
- Pipeline parallels 4-345 kV & 1-115 kV circuits for over 5 miles.
- Induced AC potentials of 50-80 V

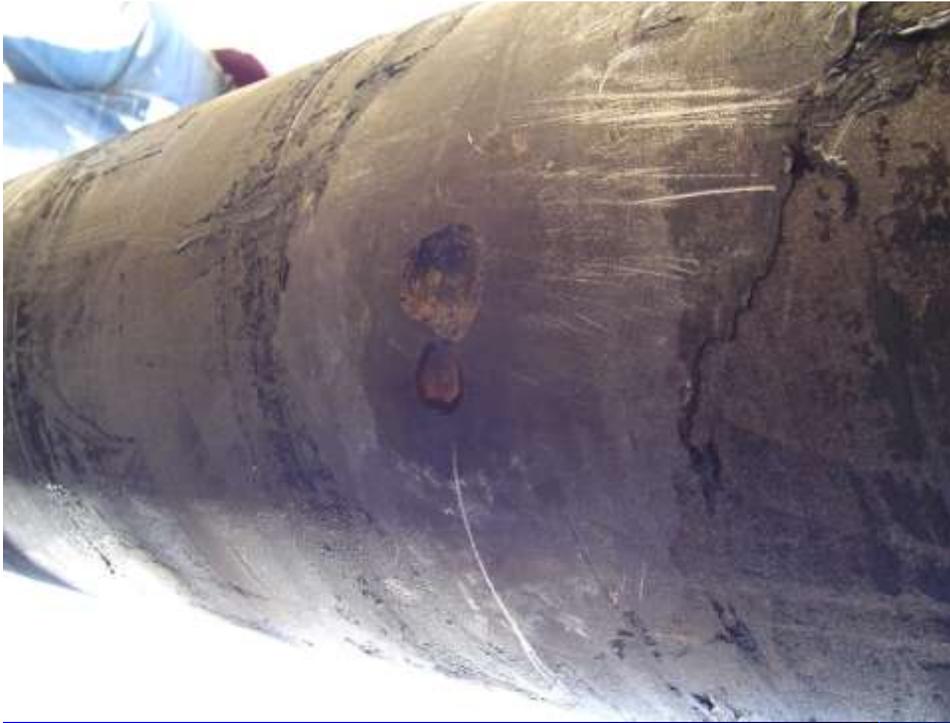
- Inspection of the defect revealed an isolated smooth round corrosion pit that was uncharacteristic of either microbial influenced corrosion or DC stray current corrosion
- A corrosion rate of 60 mpy was calculated
