# COMMON PIPELINE ANOMALIES

Henry S. Green Jr

Appalachian Underground Corrosion Short Course

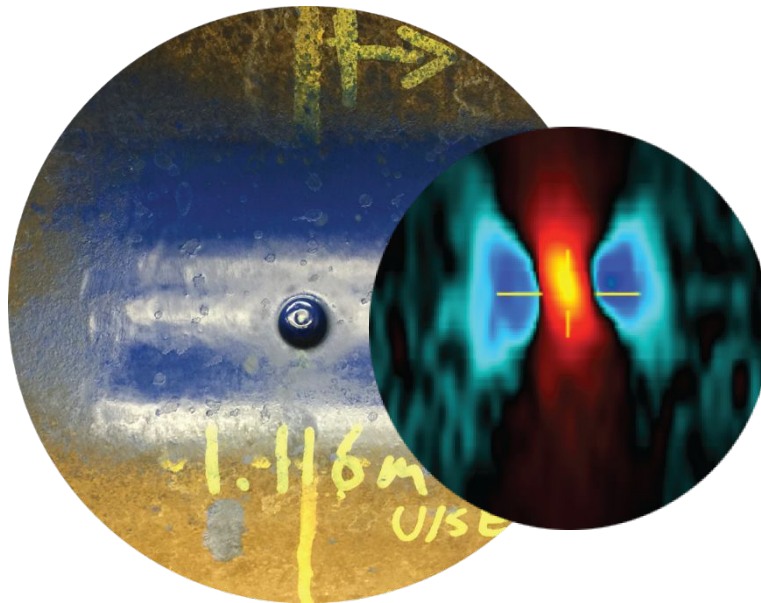
Calibrate and verify our sizing models

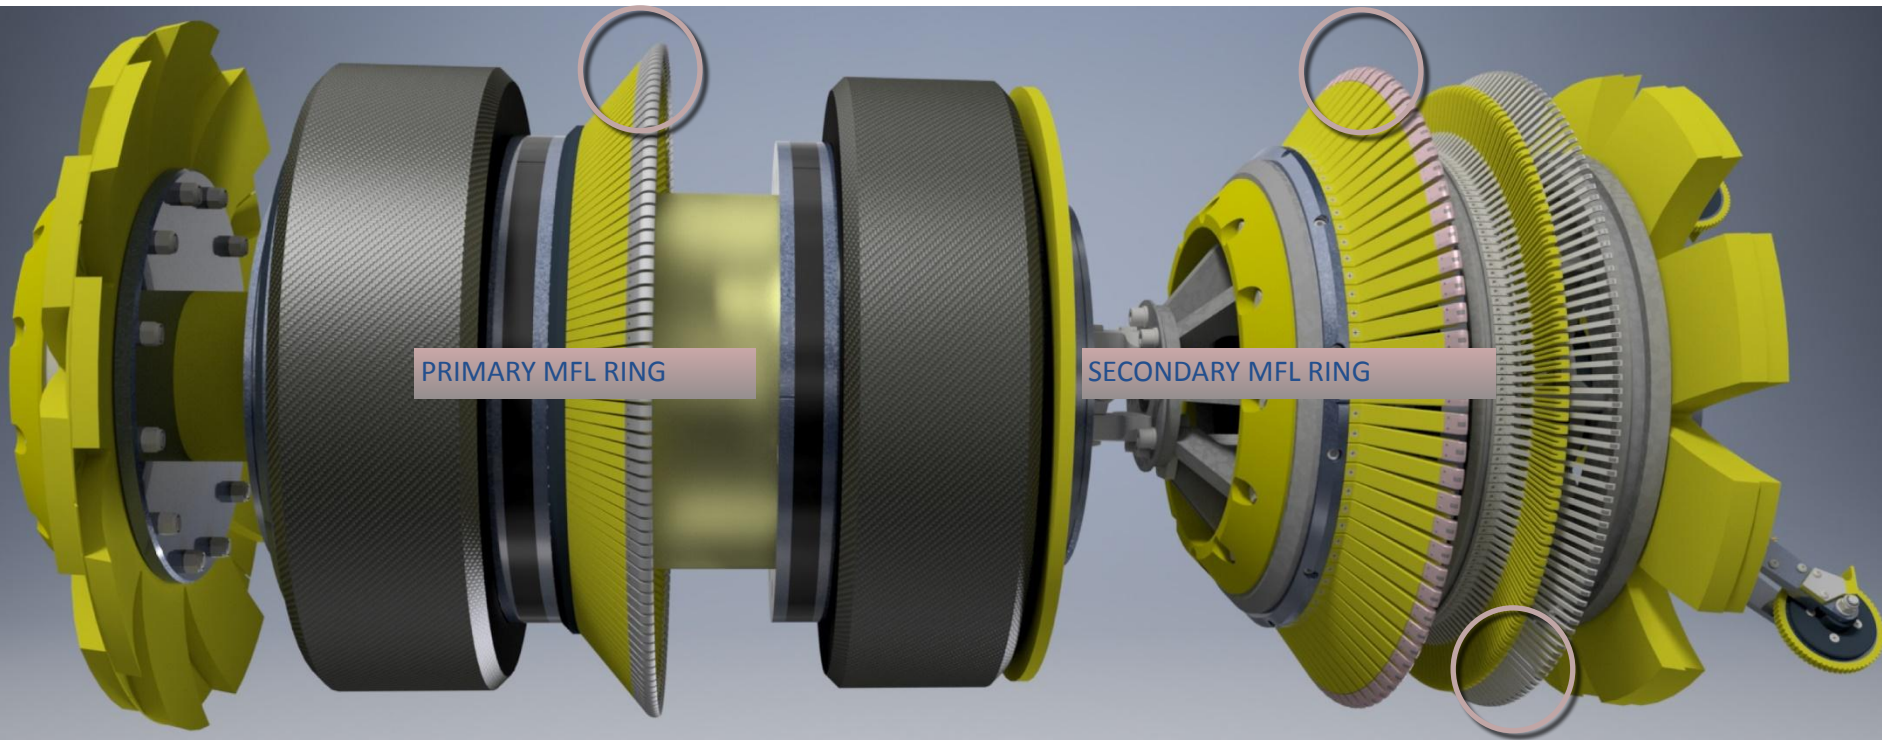
MFL SENSOR DENSITY

RESIDUAL SENSORS

PRIMARY MFL RING

SECONDARY MFL RING

CALIPER

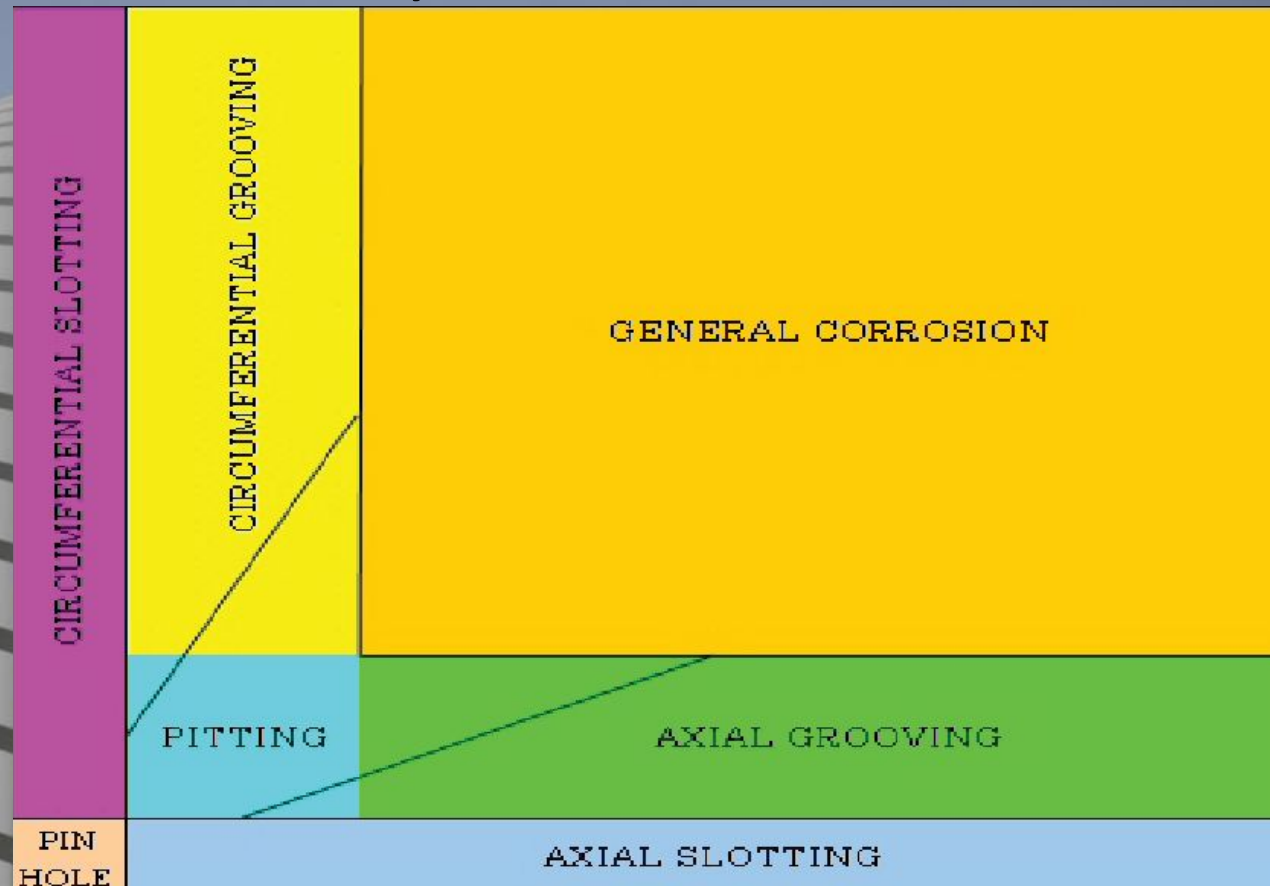
Defect Width

Defect Length

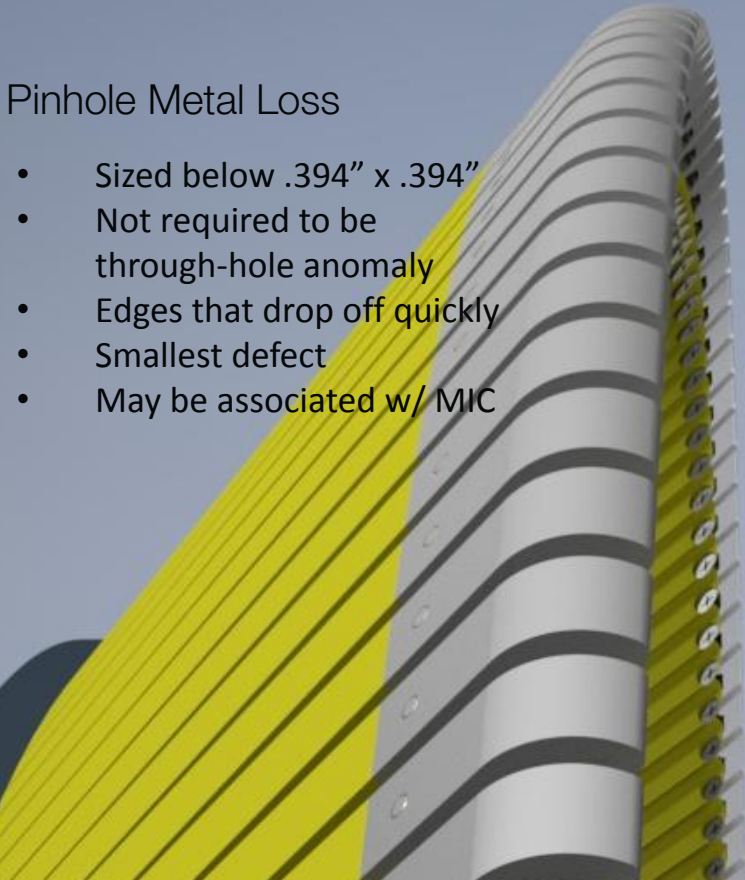
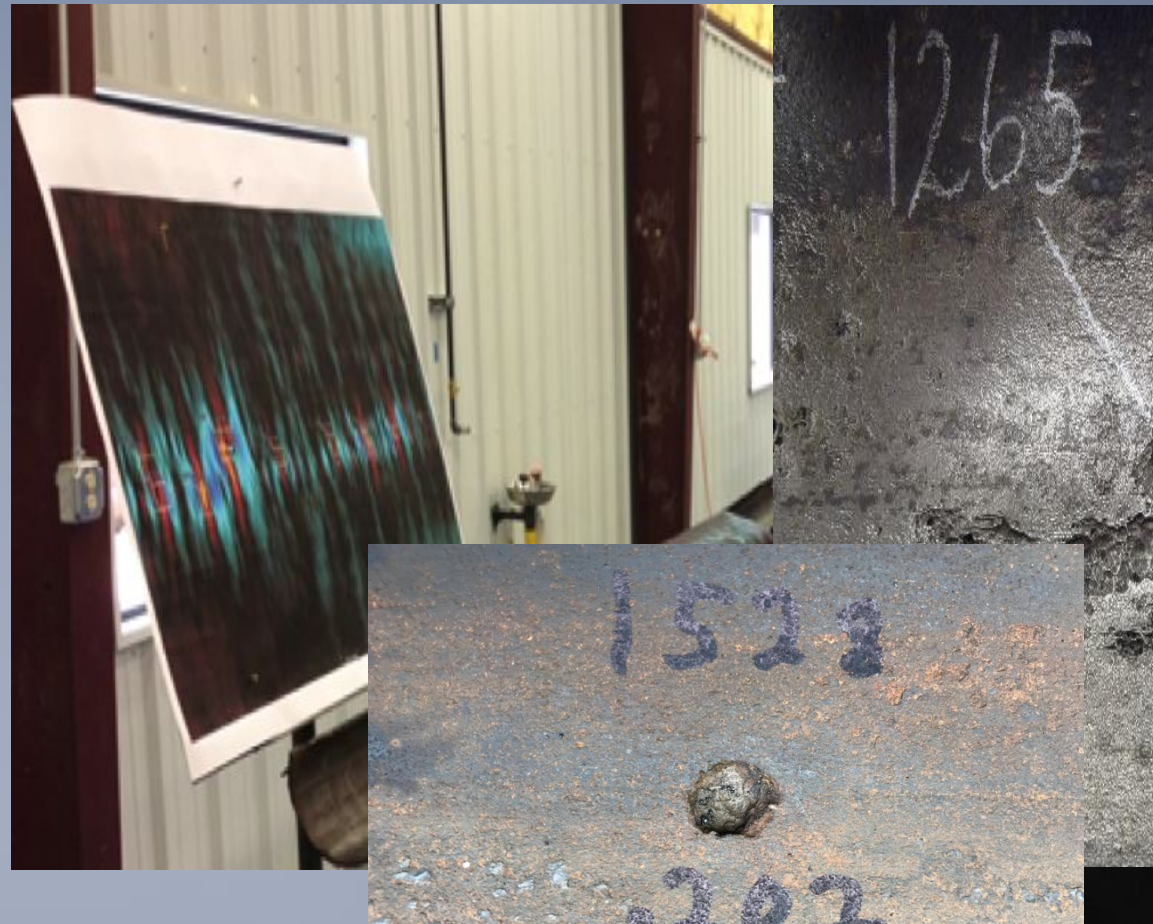
### Pinhole Metal Loss

- Sized below .394" x .394"
- Not required to be through-hole anomaly
- Edges that drop off quickly
- Smallest defect
- May be associated w/ MIC

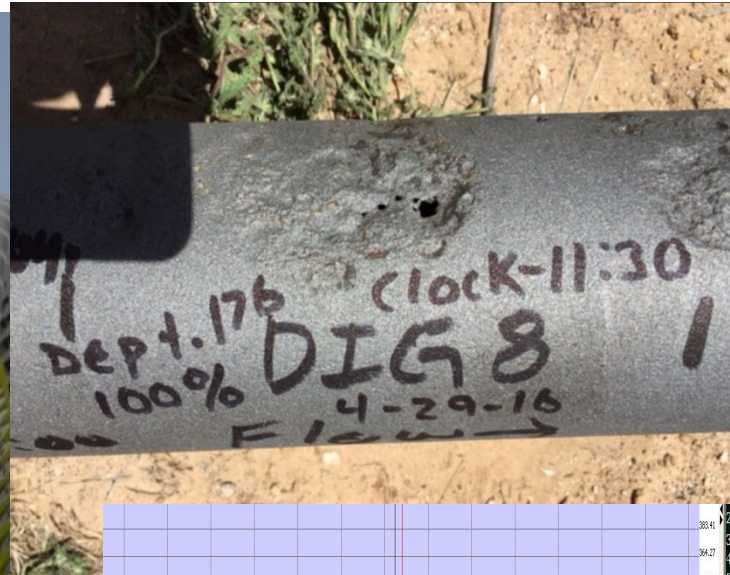
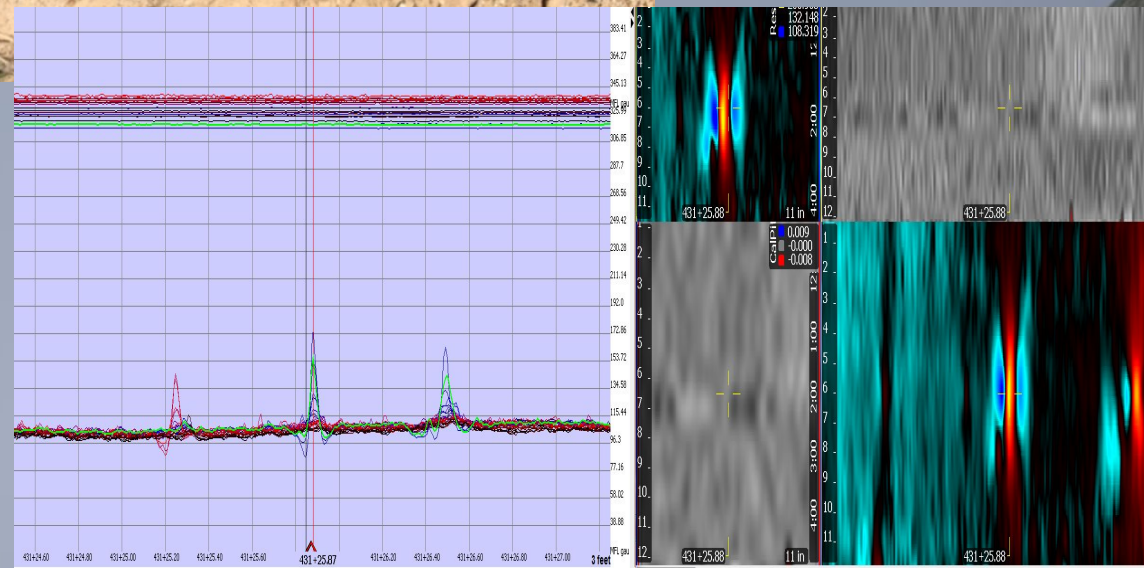
### External Metal Loss

- Metal Loss signature (peak) on MFL data set
- No internal surface change measured

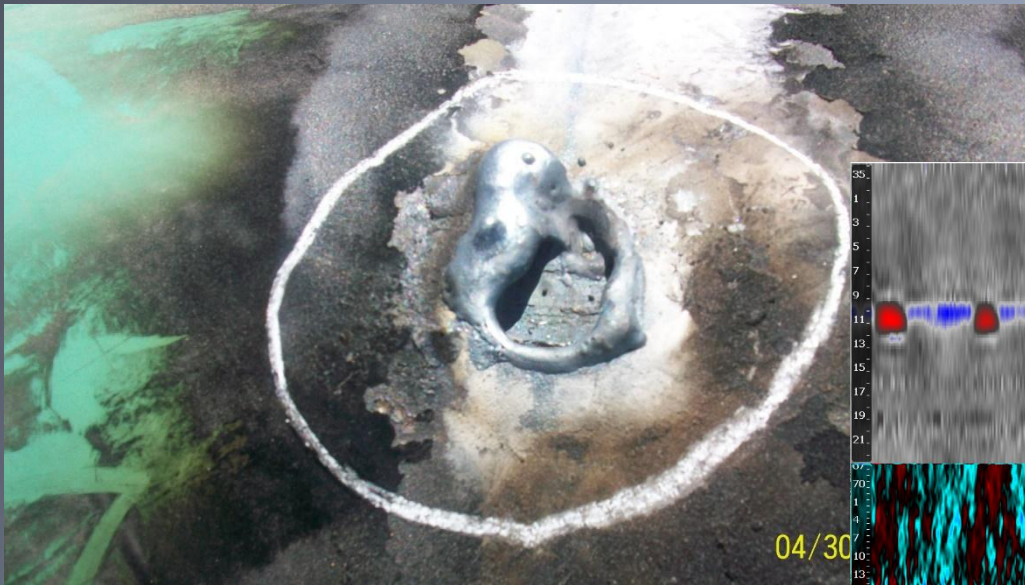
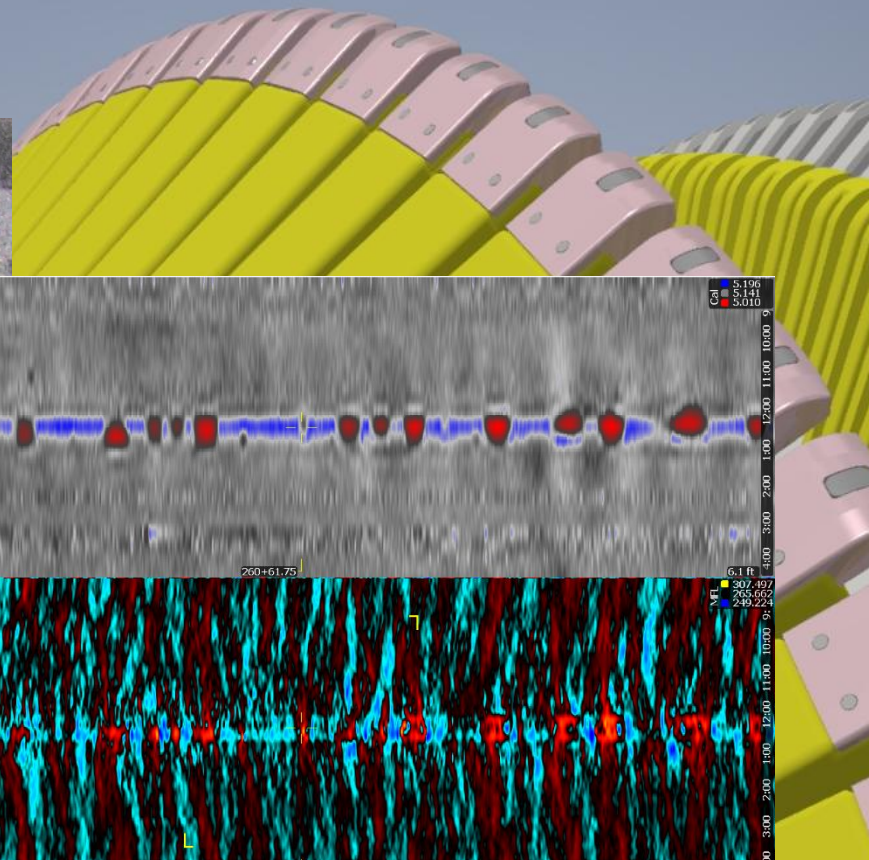
Lamination

- Mid-wall originated anomaly
- Requires internal surface break for classification (MfL technologies)

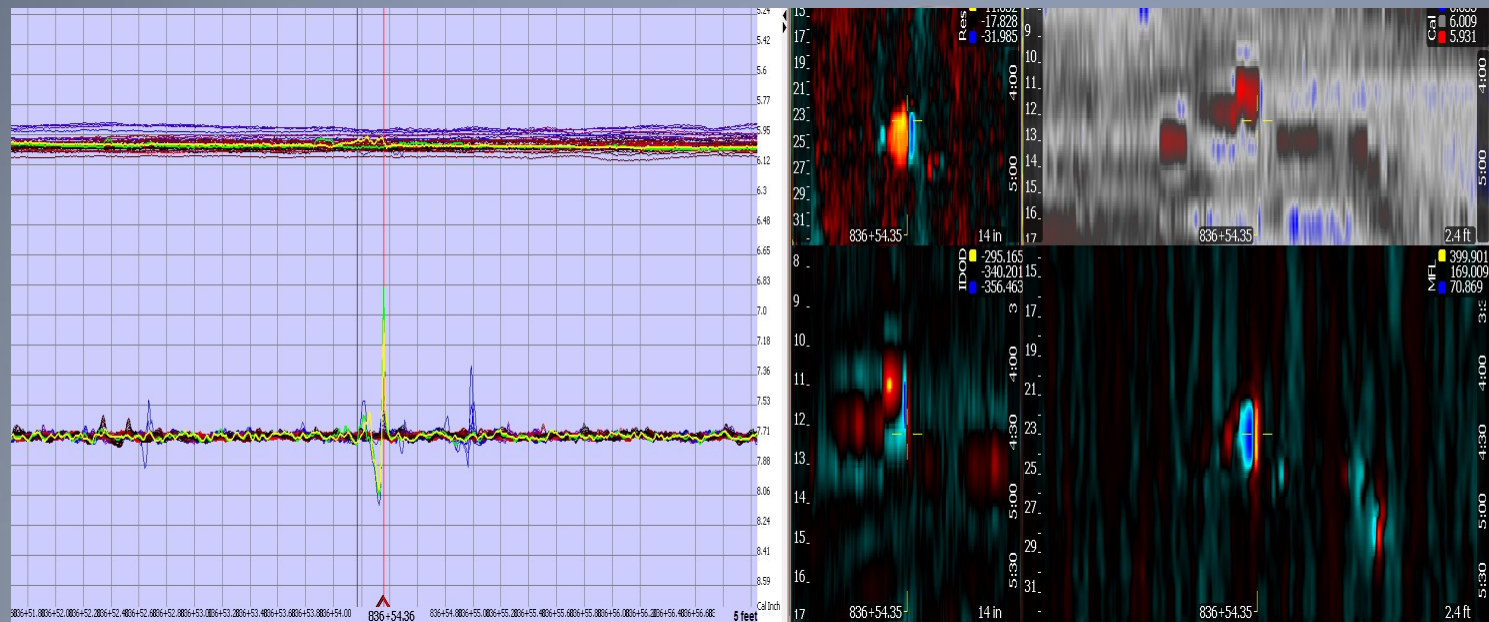
#### Mill Defects

- Sharp bipolar signal on the MfL and Residual data sets
- Internal surface change measured
- Non-typical Dent or Metal Loss signature

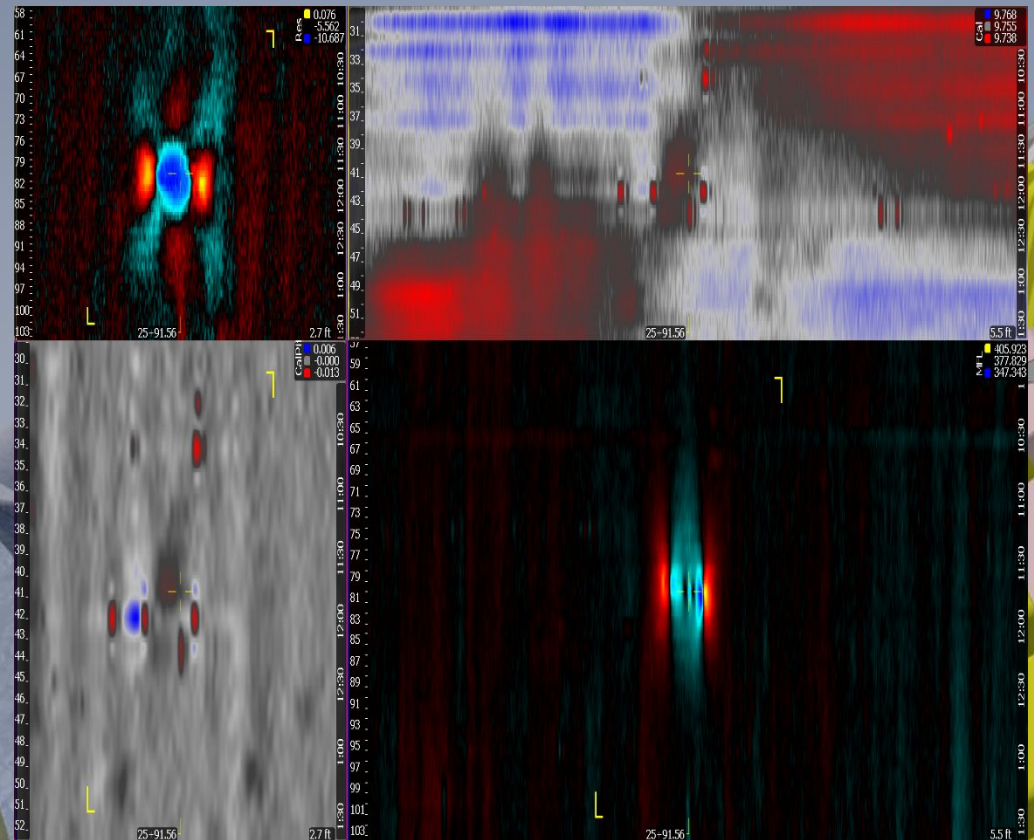
#### Heat Affected Zones (HAZ)

- Internal surface change measured
- Metals in close proximity (MfL)
- Can make determination between:
  - Type A Sleeves (Reinforcing)
  - Type B Sleeves (Pressure Containing)

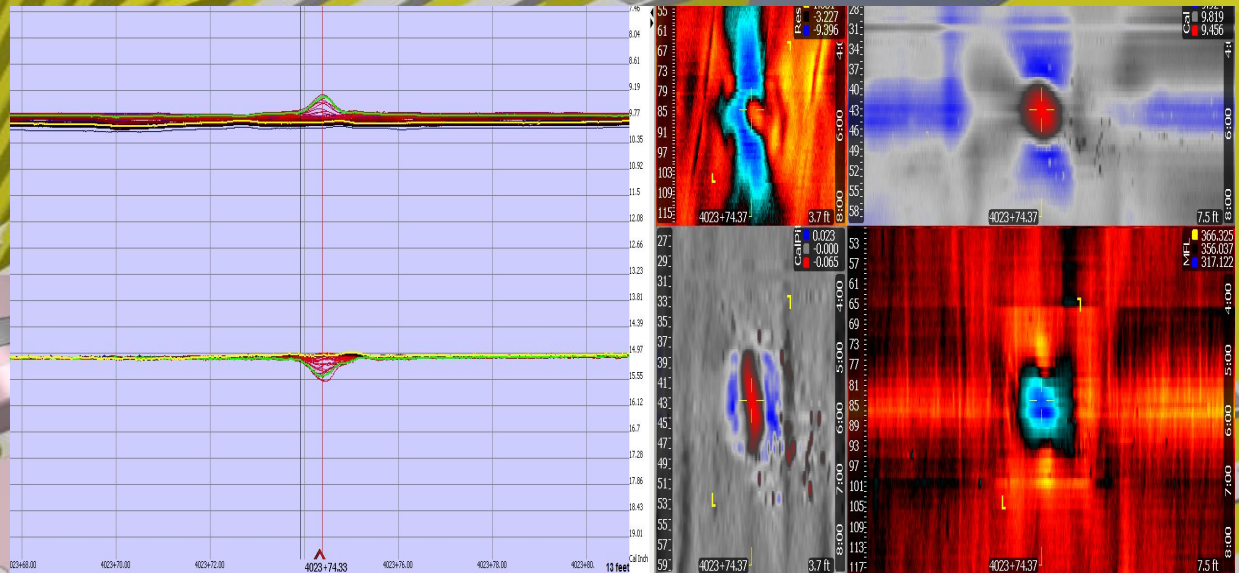
### Dents

- Dent signature (fairly smooth movement on Caliper and MfL sensors)
- Caliper Sensors show movement in the interior of the pipe

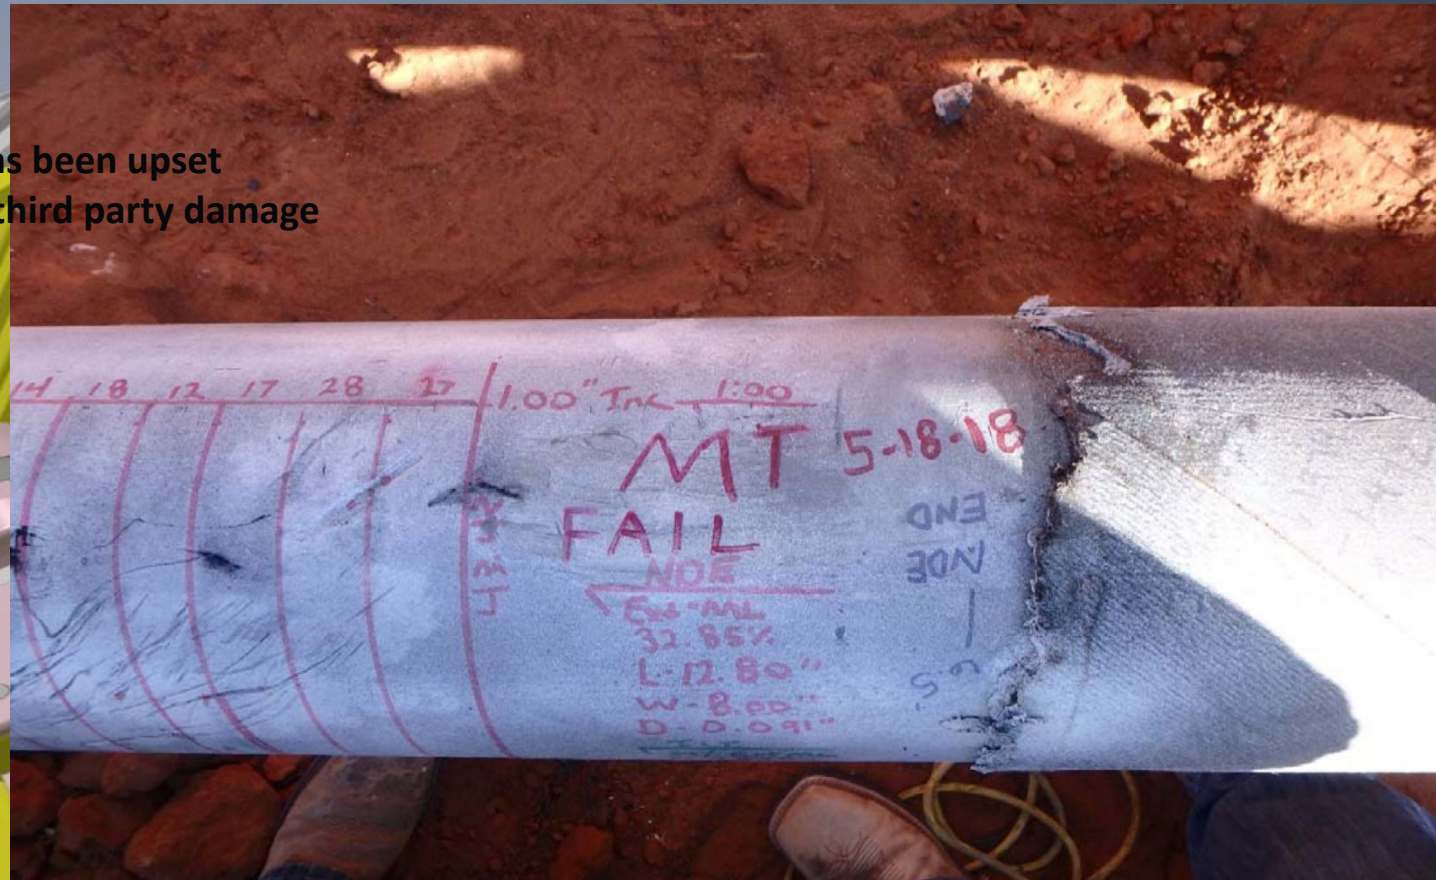
### Gauges

- Pipeline metal has been upset
- Identification of third party damage

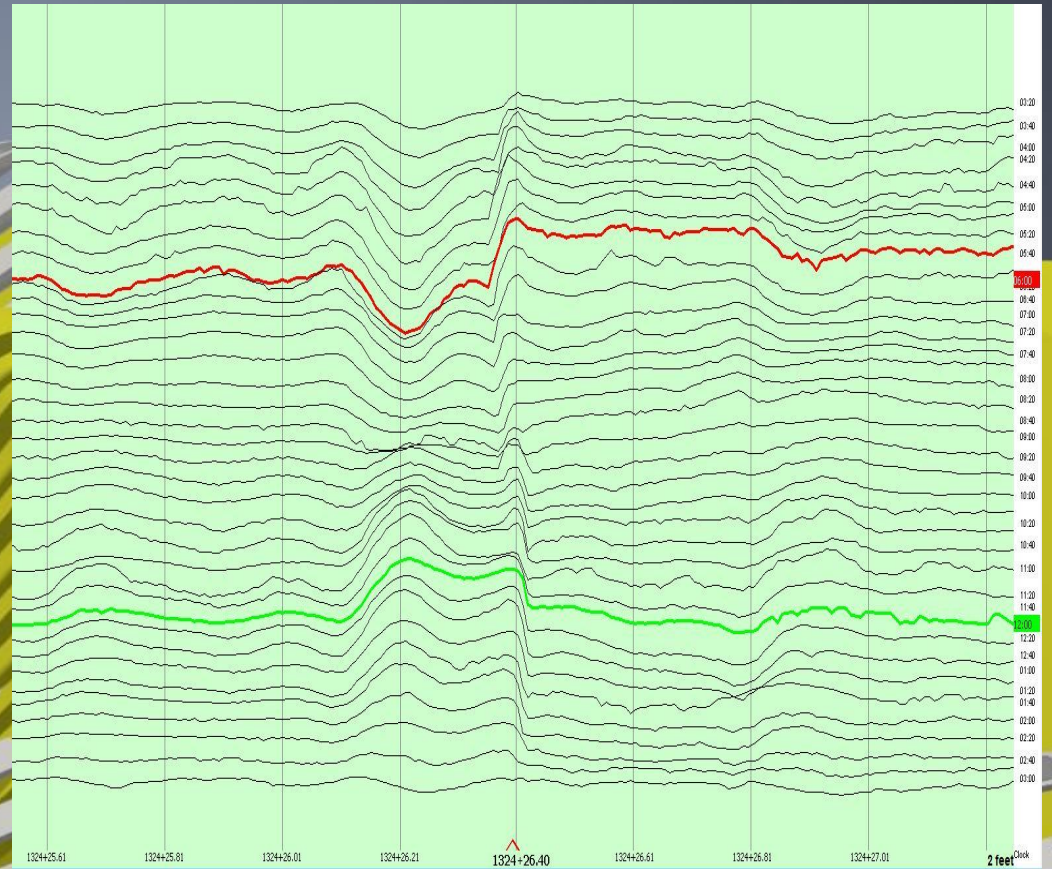
Misalignments (Hi-Low Welds)

- Offset girth welds

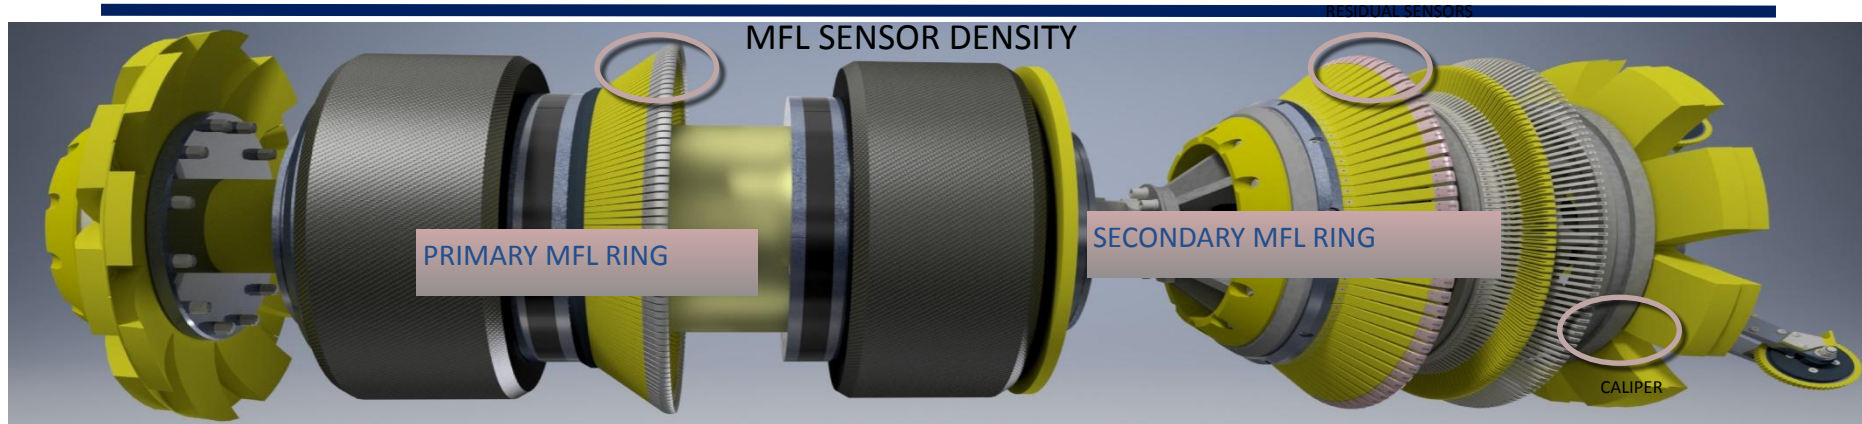
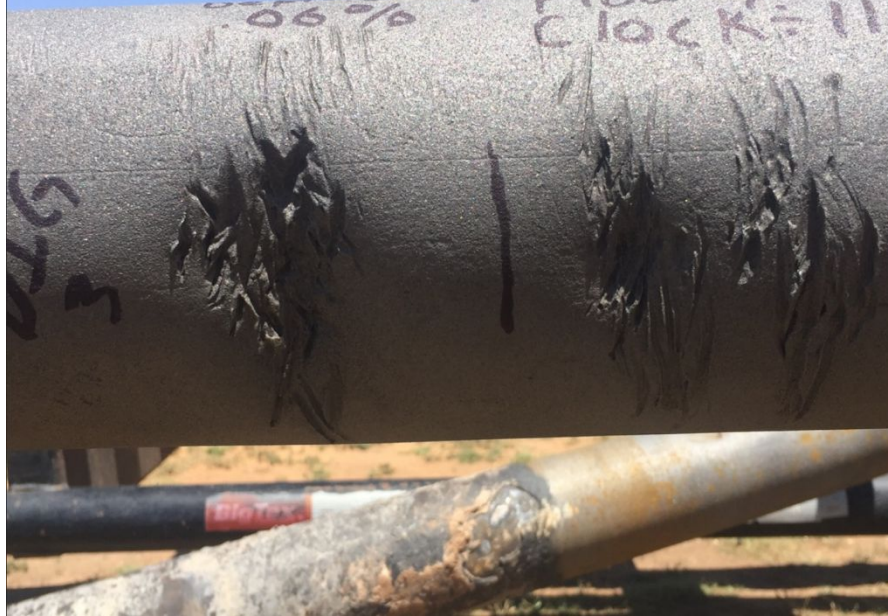
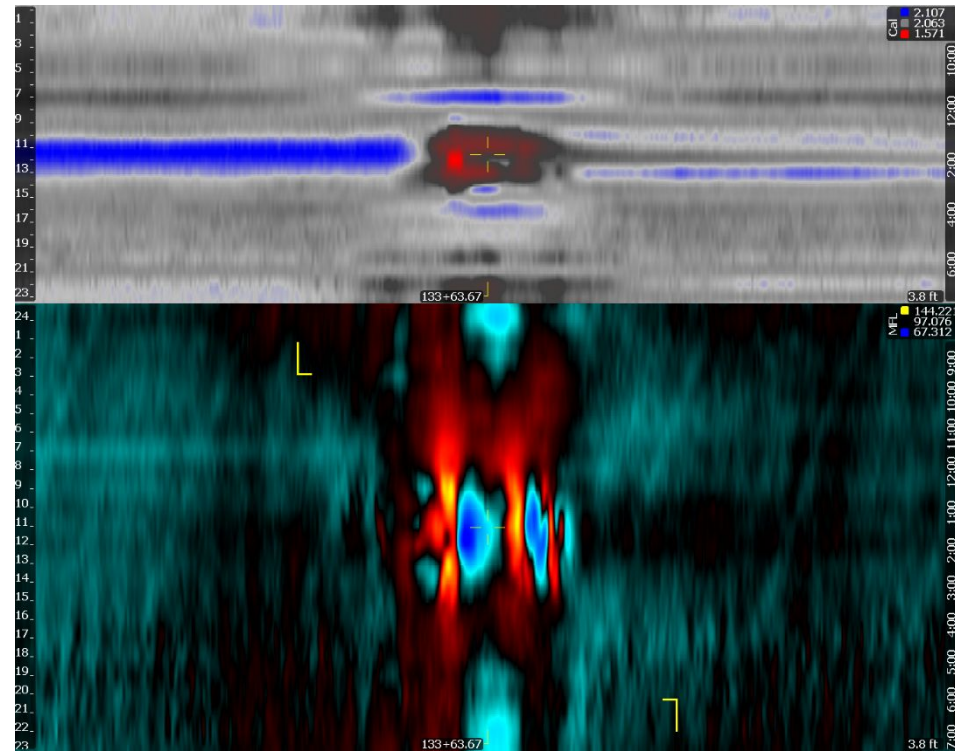
## Dent with Metal Loss

- Dent signature on Caliper data set
- External Metal Loss signature on MfL data set
- Metal Loss occurs at same position/orientation as Dent

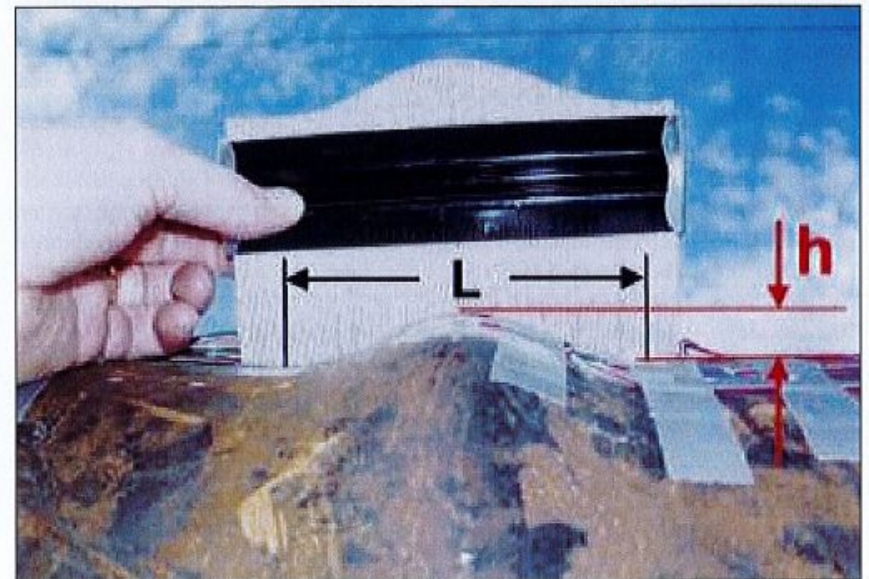
- May occur in complete pipe joint or the middle of a pipe section

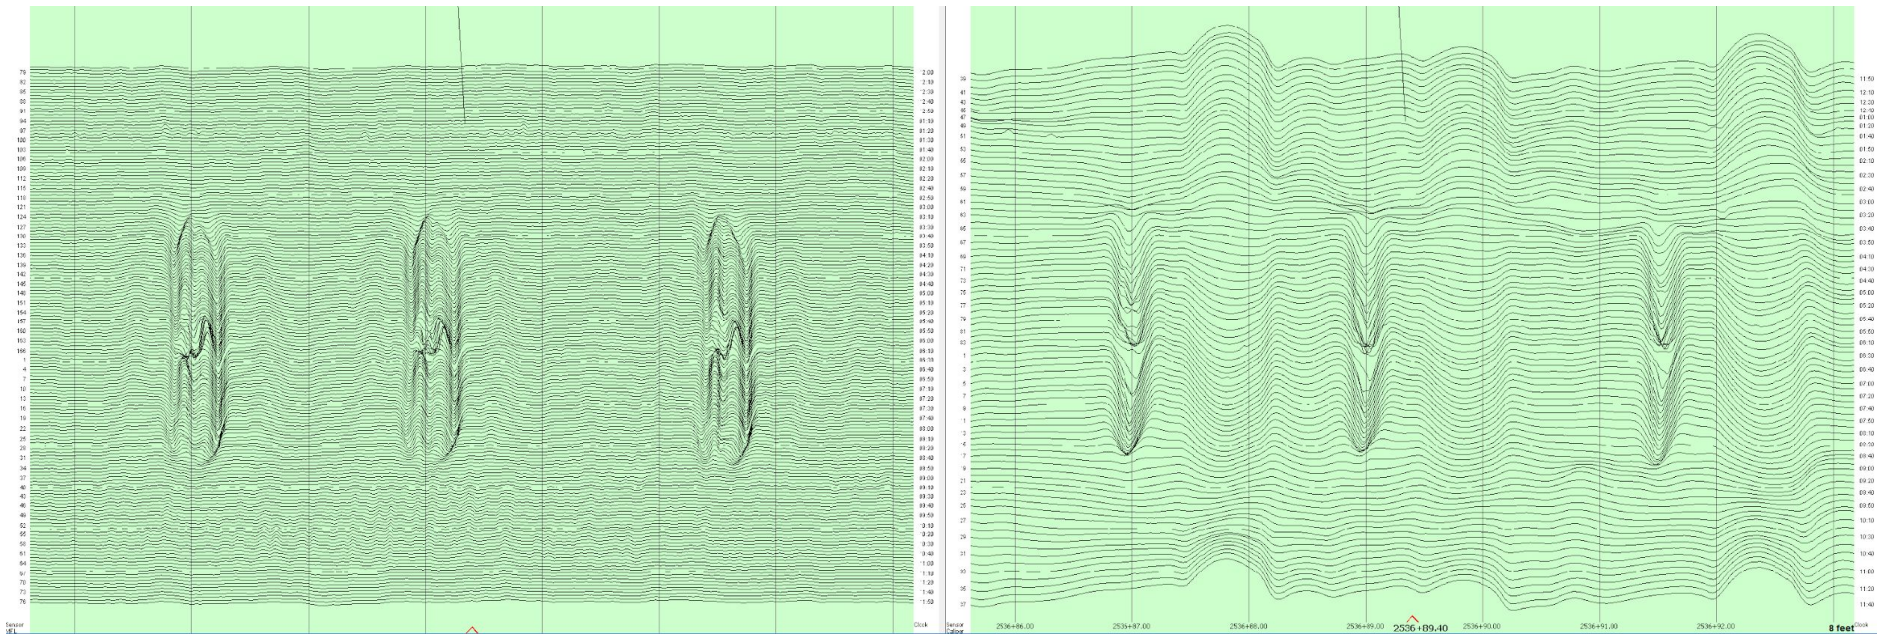
# MFL MULTI-TECH ILI TOOL Wrinkles

- All Caliper Sensors move from baseline

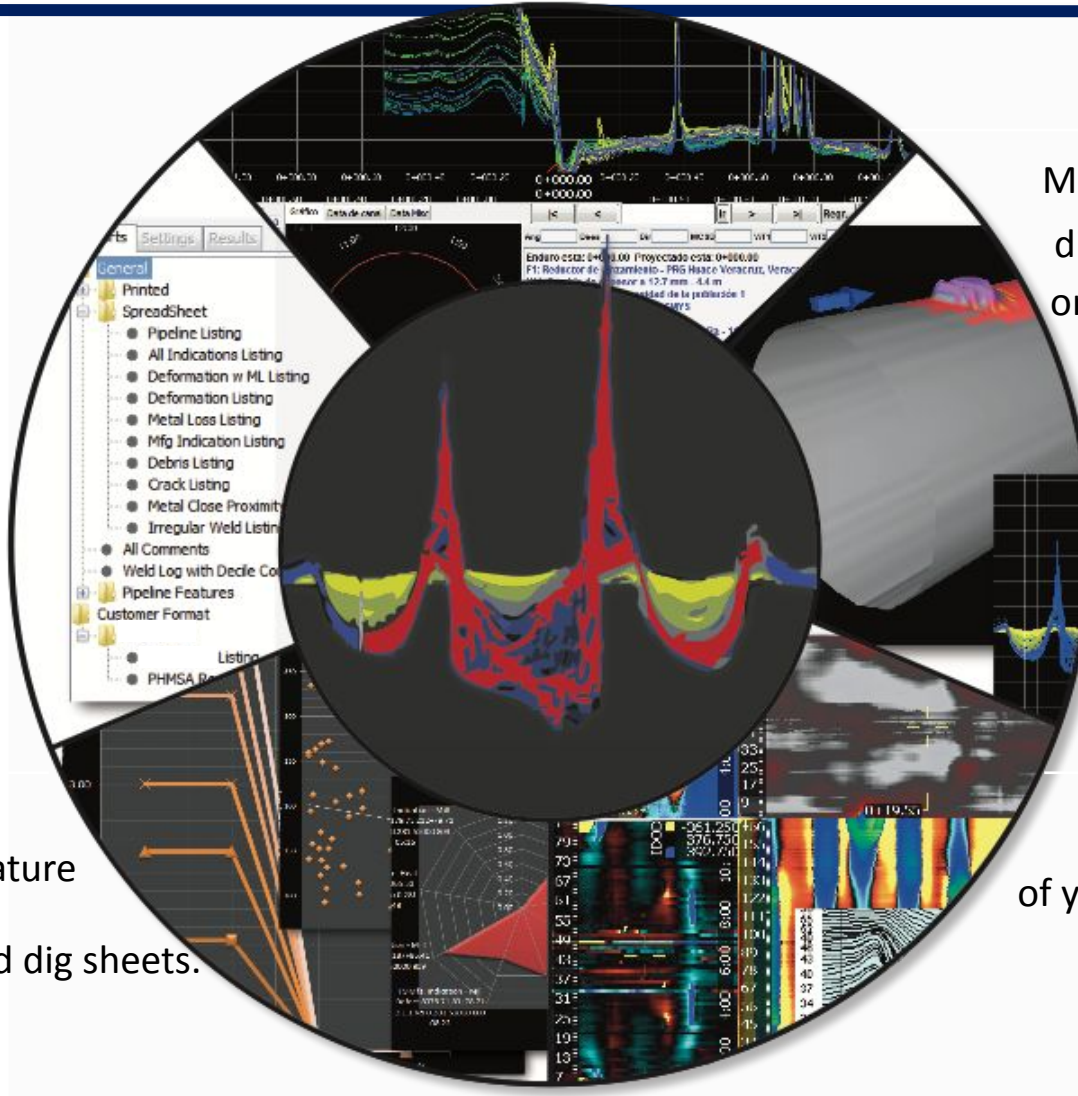
# Data Analysis

Multiple sensor displays for each on-board technology.

Intuitive navigation of your ILI data.

Easy export of priority feature lists, plots and dig sheets.
