## Corrosion Control in M&R Stations

3 main corrosion concerns:

1. Adequate Cathodic Protection
2. Atmospheric Corrosion
3. Internal Corrosion

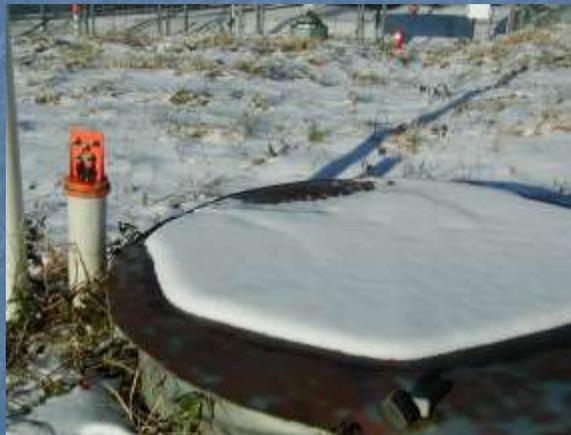
## M&R Cathodic Protection Options

- Insulated fittings (with test leads on both sides) should be installed at the tap valve. If the M&R is to be protected with mainline CP current then a continuity bond should be installed in the test station.

- This arrangement is easiest to install
- It adds a very small load to mainline CP system
- It simplifies collecting ON/OFF potential readings
- Allows problems in the M&R to affect mainline potentials

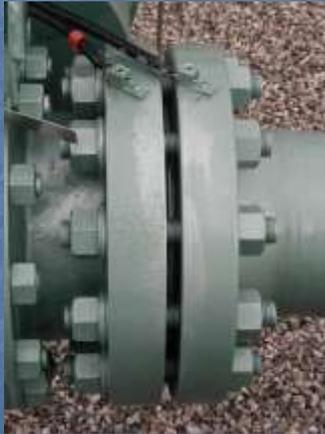
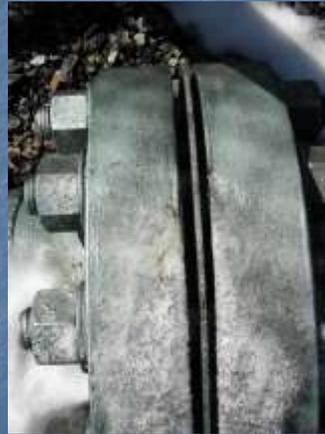
## Flange Insulation Kits

- Buy Good Ones
- Phenolic disc with nitril seal and phenolic washers on **both** sides of the flange with Mylar bolt sleeves.
- Stay away from 1 piece washer & sleeve combinations – they will compress and leak over time when buried.

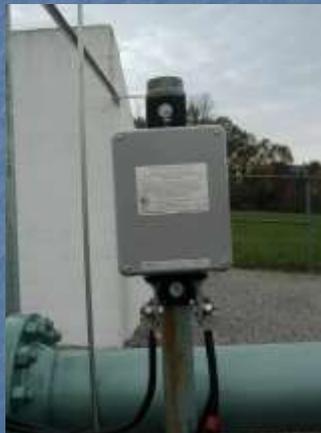
## Over Voltage Protection Devices

- Used to prevent lightning from destroying flange insulation kits. Normally these devices are seen as an open circuit to CP systems, then short circuit under surge conditions.
  - Zinc grounding cell – connected to each side of an insulated flange and buried much the same way as a large sacrificial anode. Disadvantage is the size and weight.
  - Solid state device – connected to each side of an insulated flange and pole mounted.

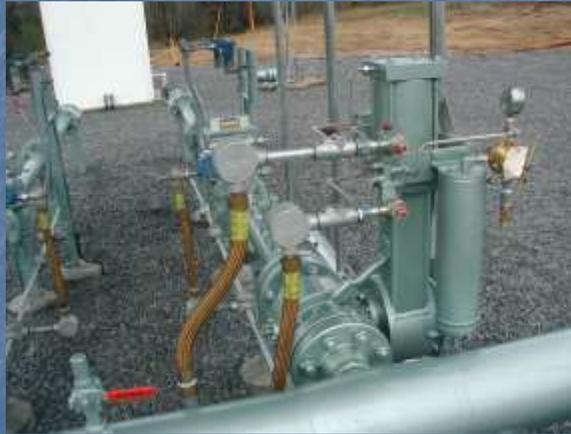
## Inlet, M&R Runs and Transducers

- Telemetry equipment is sensitive to transient spikes (lightning). To minimize damage transducers should be isolated from cathodically protected piping and connected to a grounding grid of some kind.
- Transducers and solenoids (including ones that control automatic valve operators) connected to an RTU via metallic conduit ultimately provide to the electric utility's grounding system, unless properly isolated.
- Isolation is accomplished by:
  - Installing insulating fittings at each transducer
  - Insulating meter runs from inlet and outlet piping

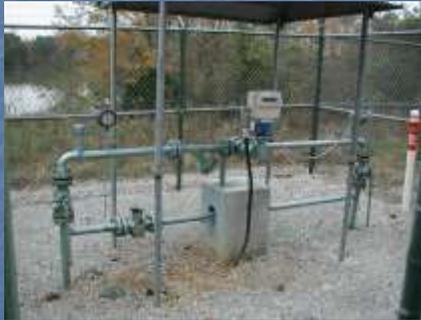
## Outlet Piping and Insulator

- When meter runs are insulated from inlet and outlet piping care must be taken to insure that outlet piping is cathodically protected.
- This can be done by:
  - Installing a bonding wire directly from the inlet side of the station to the outlet side.
  - Intentionally leaving a path for current to flow through M&R Piping
  - Using sacrificial anodes to protect the outlet piping.

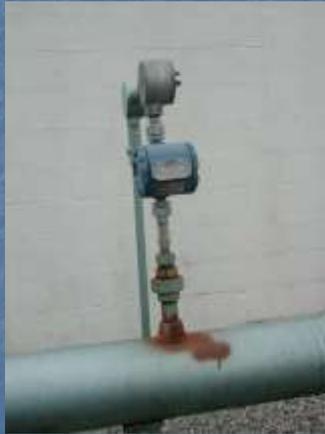
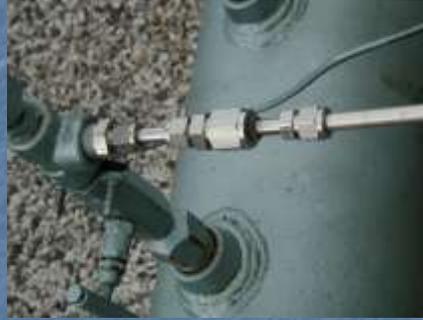
## Troubleshooting

- Most M&R low potential problems are caused by lightning or measurement technicians (improper maintenance):
  - Lightning turns insulating devices into conductors, allowing CP current to take other than desired paths.
  - Improper maintenance involves insulators being left out or being put in where they shouldn't be.
